# 2015 AML PROJECT SUMMARY

March 2016

## Scranton/Bowman Phase 3 & Wilton

Drilling and pressurized remote backfilling with cementitious grout

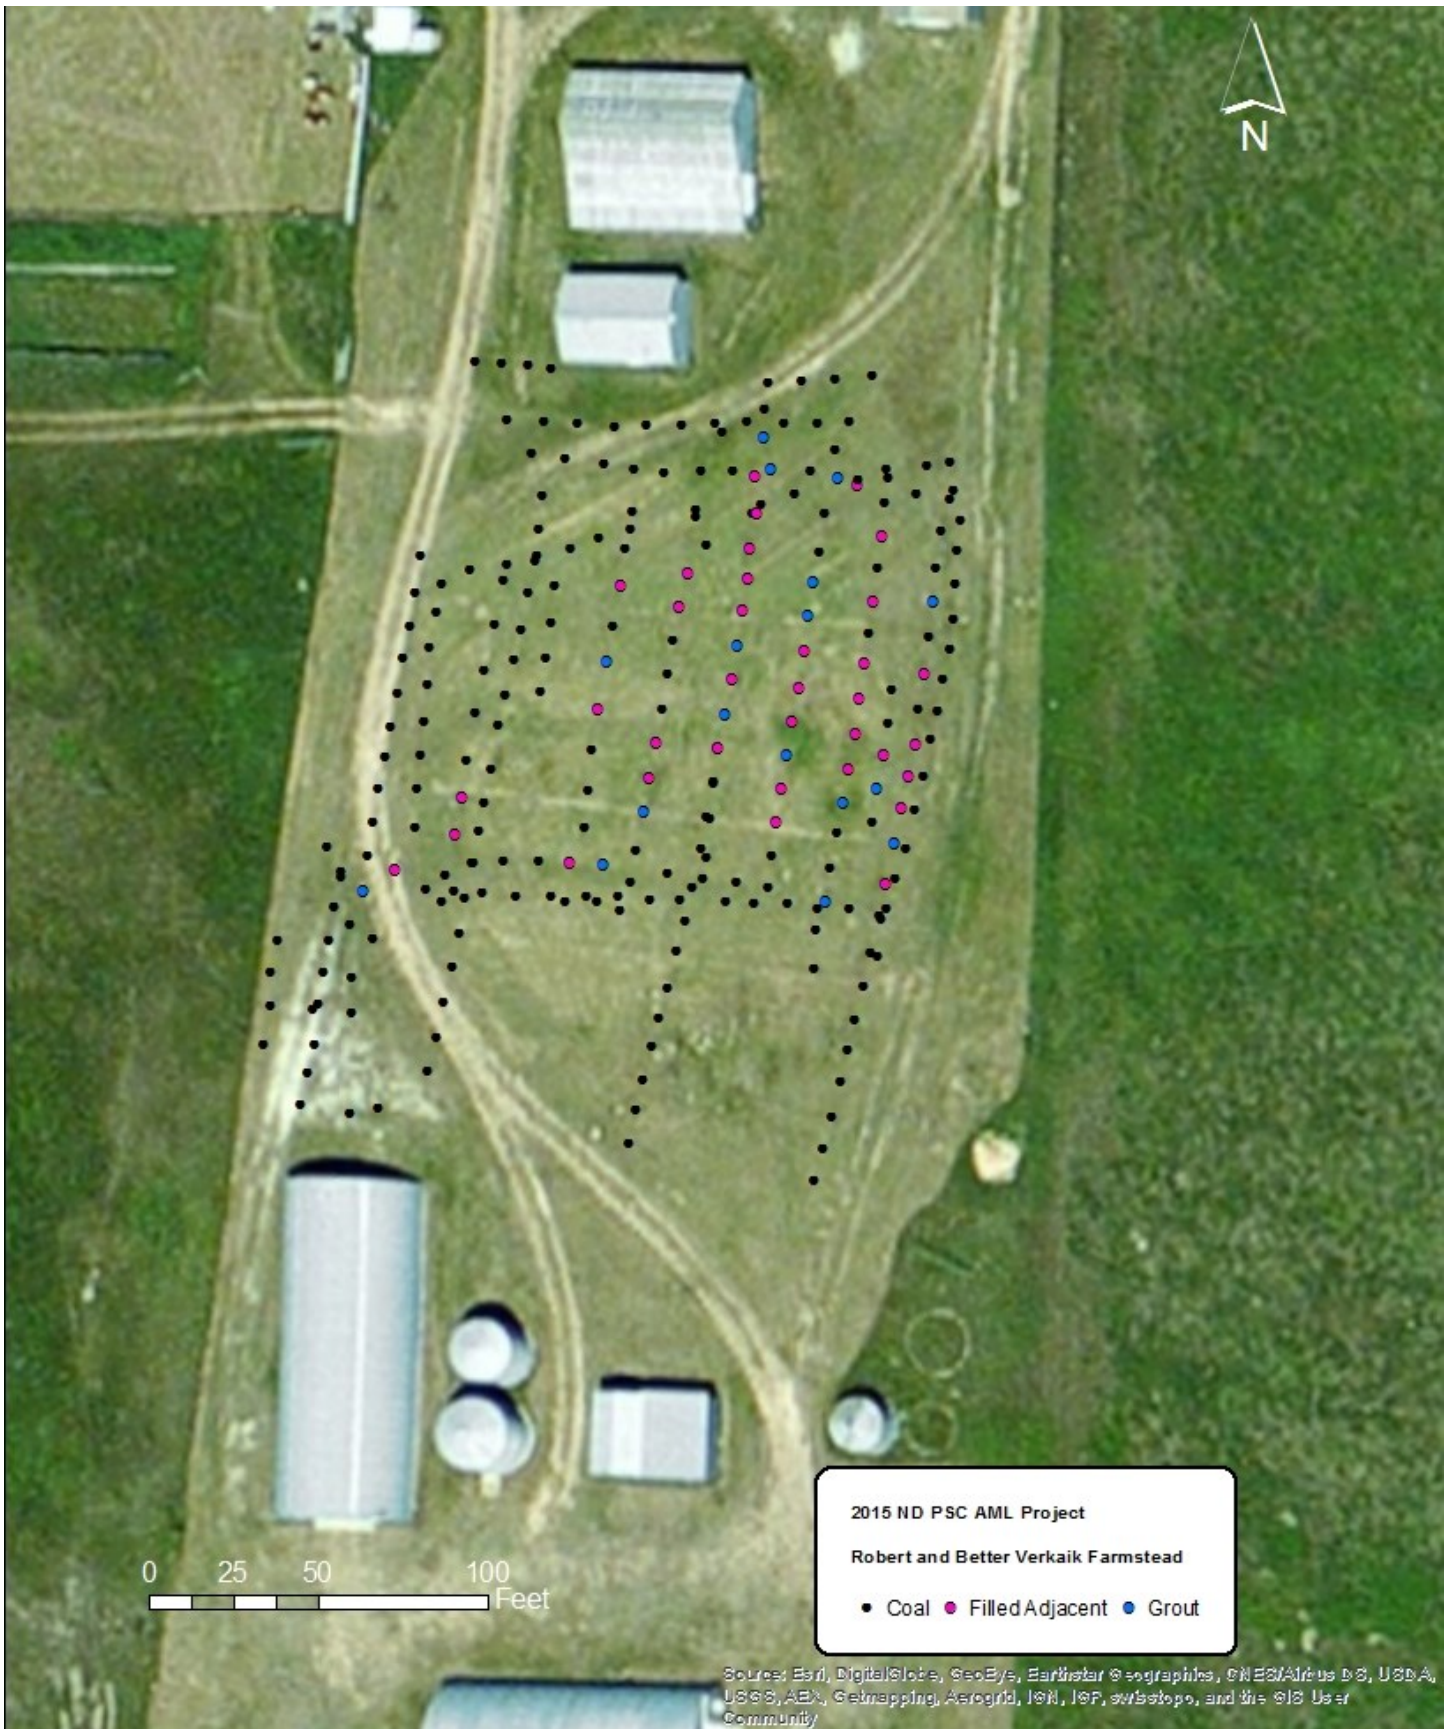
Map of the work done at Reeder. The black dots represent holes that were drilled and hit solid coal. The blue dots show where either a void or rubble was encountered when drilling. These were pumped with grout. The pink dots represent either void or rubble holes that were filled when grout being pumped on a nearby hole flowed into it. This map includes holes that were drilled in 1997, 2012 and 2015. The coal in the mine was about 30 feet below the surface.

Grout injection began on July 6 on the east side of the mine and worked toward the west. In several places the grout broke through the surface while being injected. In at least three places the ground surface was raised several inches. These occurrences show where the grout is flowing as it is being pumped. Much of the overburden in this area is a fine sand with very few rocks. Grout will find the path of least resistance when pumped into the mine. Sometimes that path leads to the surface. We can judge how well we have filled mine by these surface breaches.

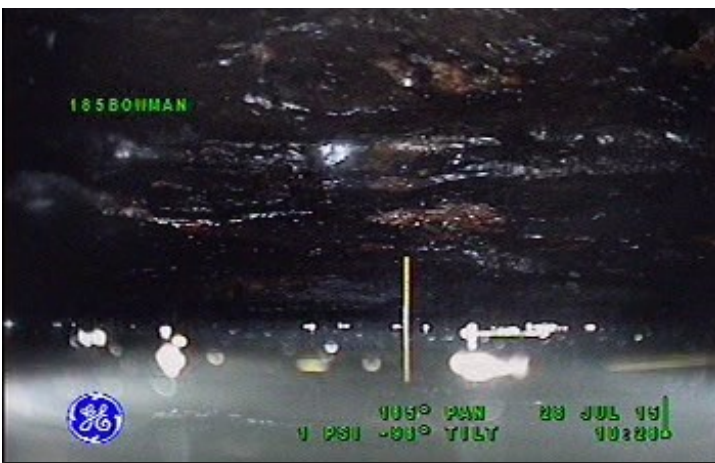
Halleck Mine: The vertical line is a tape measure in a drill hole ten feet away. This room extends well beyond the tape. At the top is the coal roof. At the bottom the mine is partially filled with water.

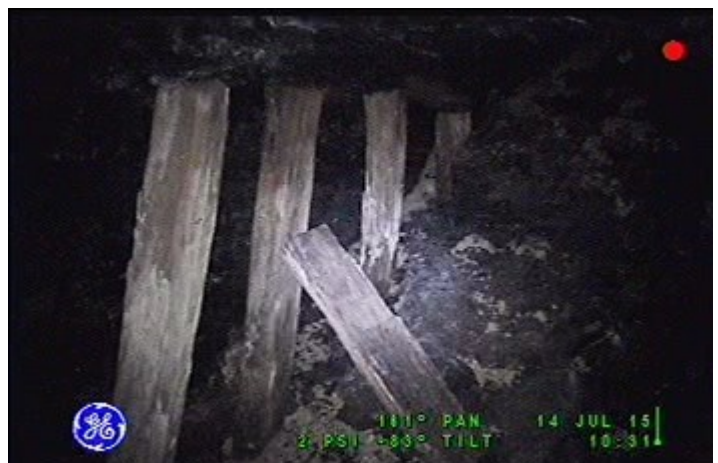
Halleck Mine: Timbers are part of the haul tunnel leading to the rooms. On the right the tunnel has partially collapsed.

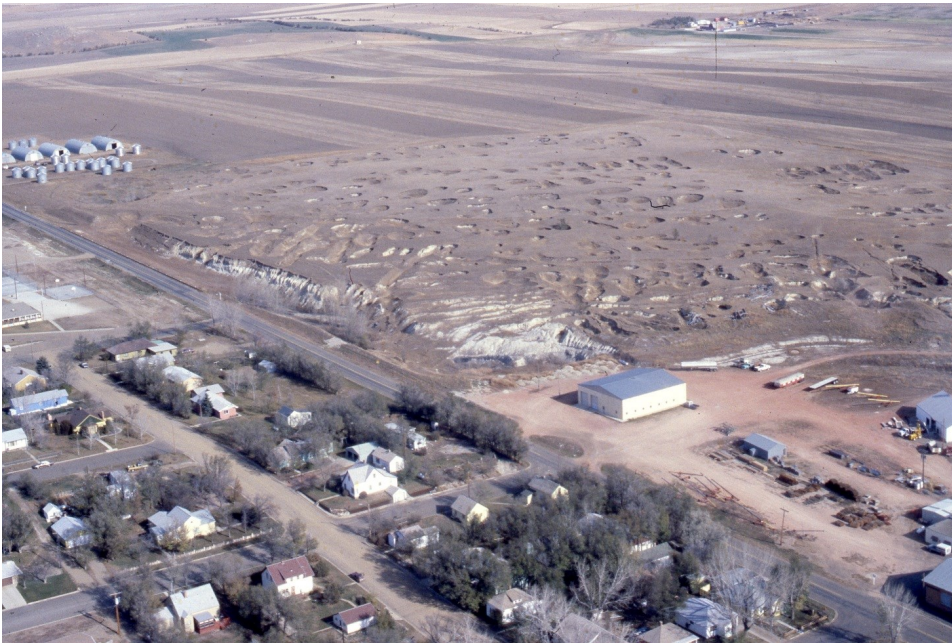
Scranton circa 1980. The pock marked surface of sinkholes shows the location of the abandoned Scranton Lignite Mine. Highway 67 runs diagonally across the picture. The surface portion of the mine is visible near the highway.

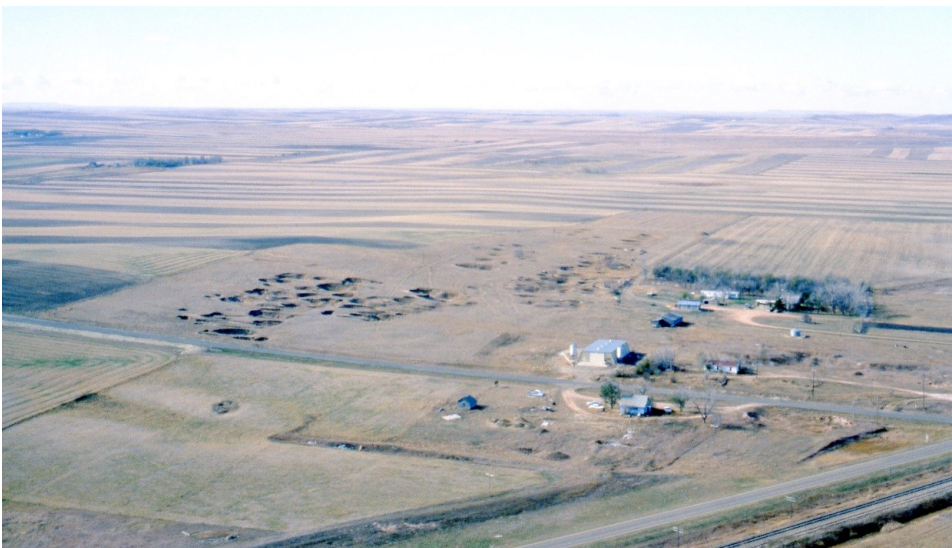
South of Scranton circa 1980. The pock marked surface of sinkholes shows the location of the abandoned Andy's Mine. US Highway 12 runs diagonally at the bottom of the picture. The current 133<sup>rd</sup> Avenue runs behind the tree row.

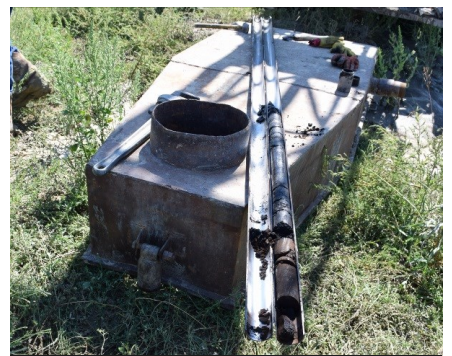
Andy's Mine Confirmation drilling: Solid coal was encountered on this confirmation drill hole.

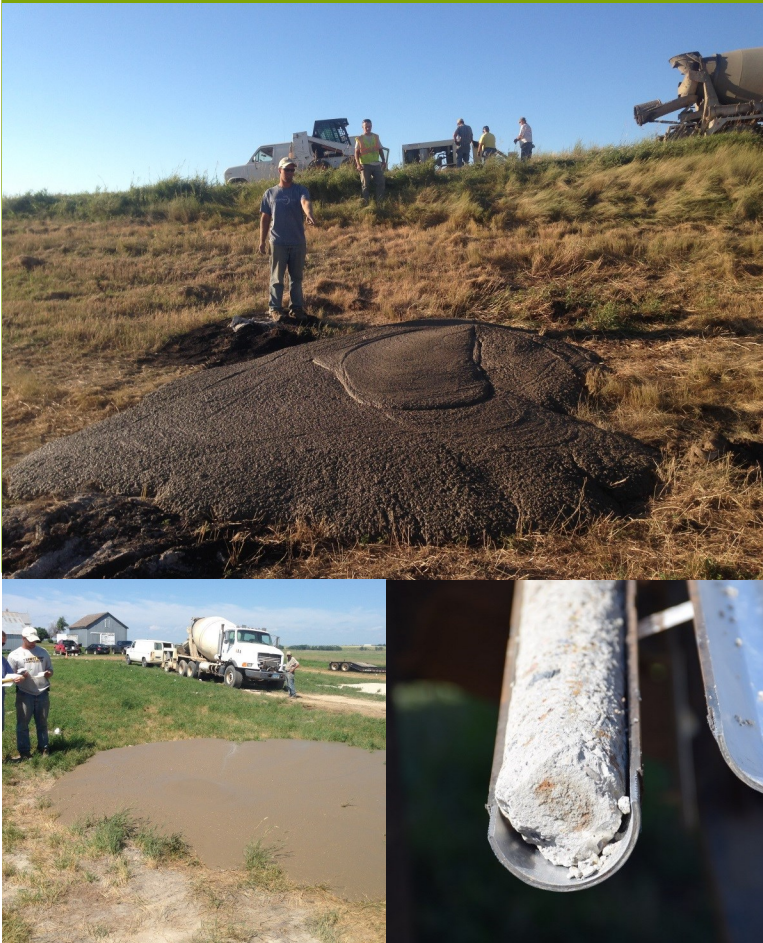
The top and lower left pictures show grout on the ground. Look closely at the photos. The pumping equipment is in the back ground. While pumping on a hole, the grout found the path of least resistance which led to the surface and what we term as a "blowout".

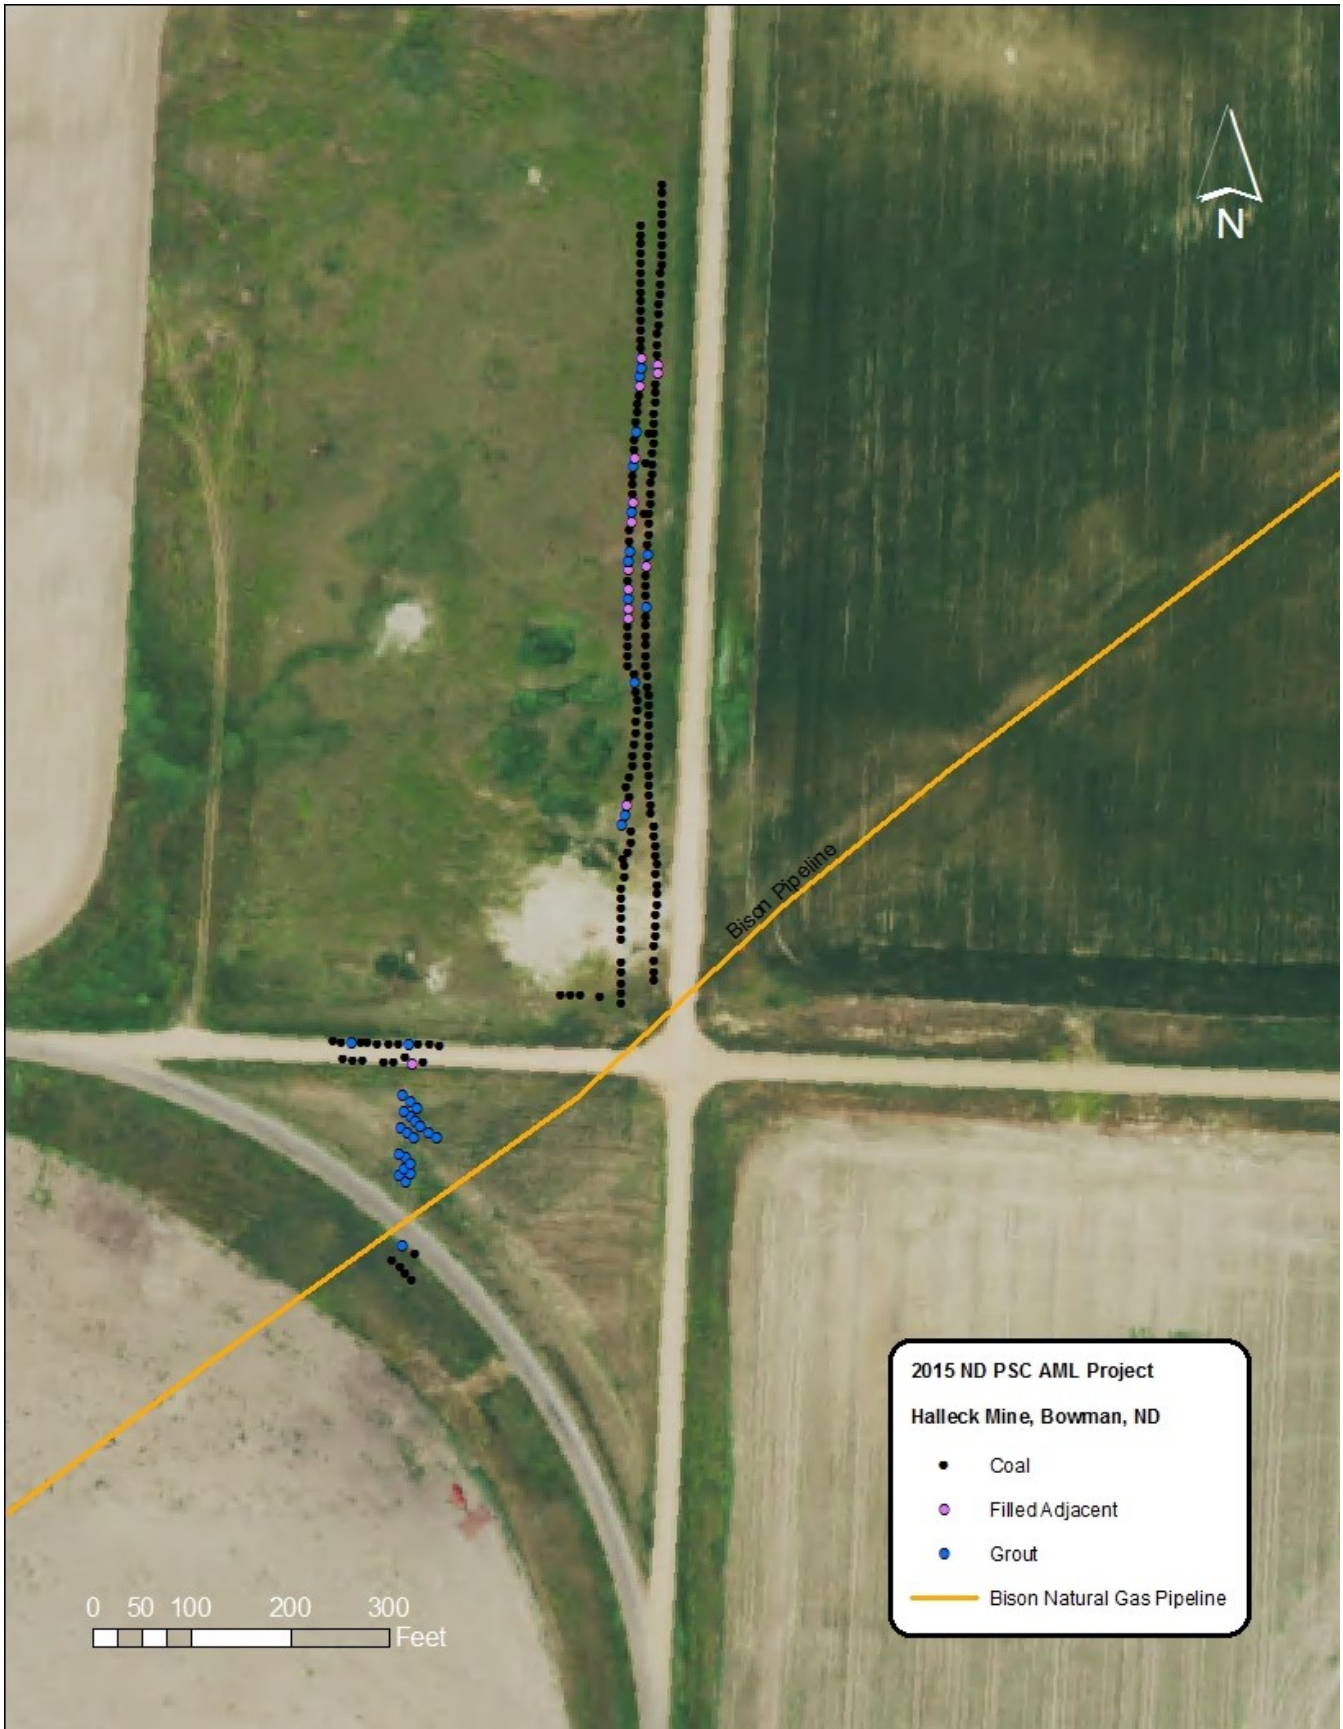
Map of the work done on the Halleck Mine near Bowman. The black dots represent holes that were drilled and only hit coal. The blue dots show where either a void or rubble was encountered when drilling. These were pumped with grout. The pink dots represent either void or rubble holes that were filled when grout being pumped on a nearby hole flowed into it. This map includes holes that were drilled in 2012 and 2015. As much as 20 feet of coal was mined out of the 30 to 40-foot coal seam.

grout. With two rows of drill holes (see map on page 11), the ones farthest from the road were pumped with a stiff grout to create walls as barriers to more flowable grout pumped into the holes closest to the road. Flowable grout was pumped to fill the void space between the road and the barrier wall. In total, 4,500 cubic yards (about 500

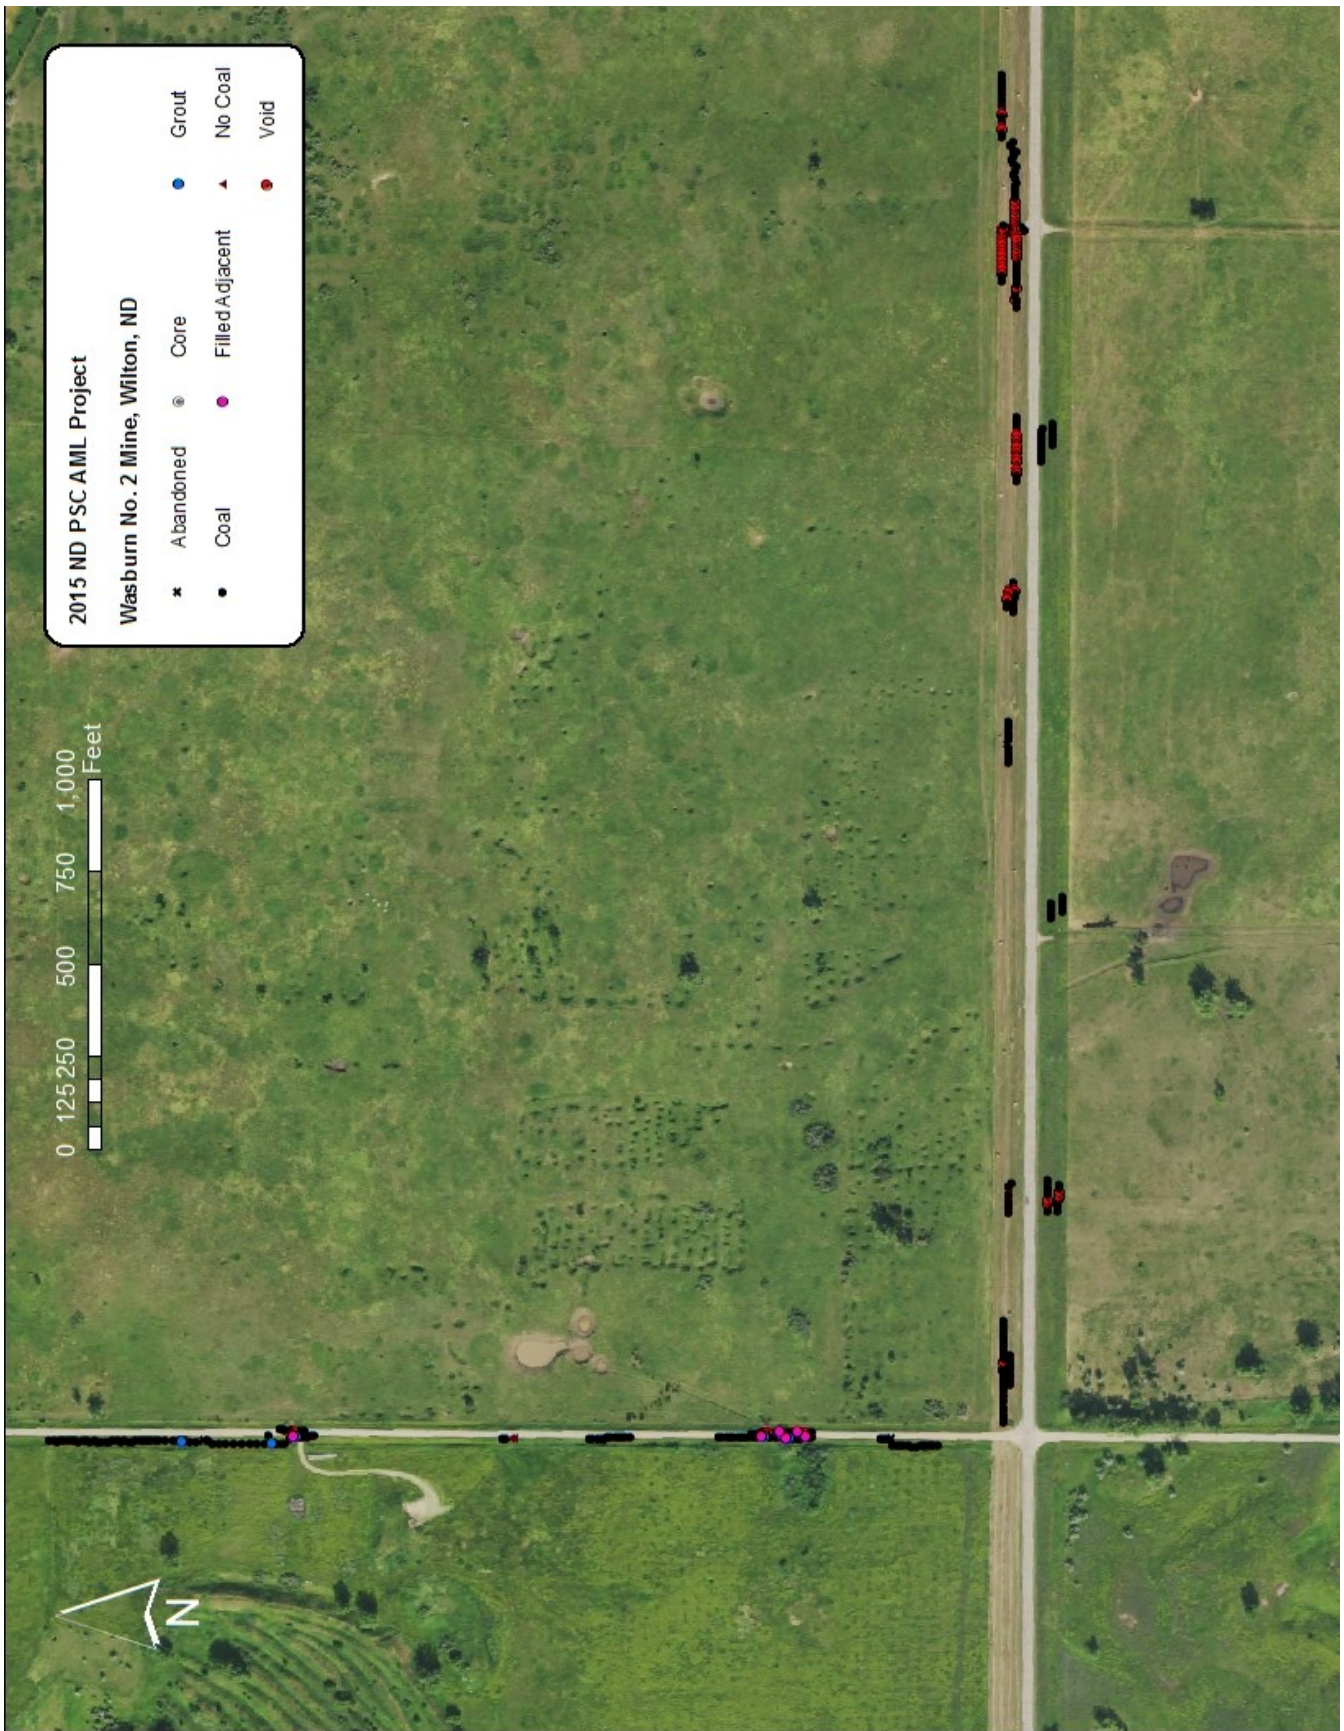
Map of the work done on the Wilton No. 2 Mine near Wilton. The black dots represent holes that were drilled and hit solid coal. The red dots are holes that intercepted mine voids and have not been filled. The blue dots are void or rubble holes that have been filled with grout. The pink dots represent either void or rubble holes that were filled when grout being pumped on a nearby hole flowed into it. This map includes holes that were drilled in 2014 and 2015. The pock marks in the center of the map are sinkholes caused by the collapse of the mine workings.

Drilling started in the northeast ditch of the intersection of Highway 36 and 41<sup>st</sup> Street. Drilling moved east in both the north and south ditch of Highway 36. Another 25 holes were cased, 142 holes encountered solid coal and over 11,000 feet were drilled. A second phase of the project is scheduled for 2016.

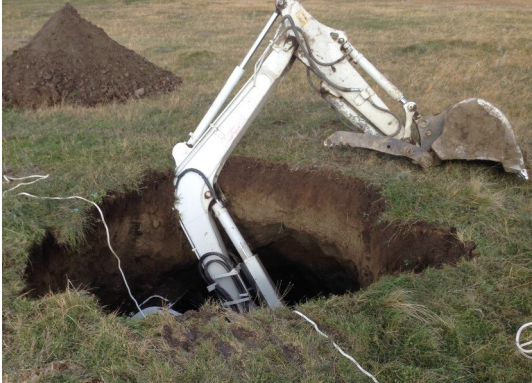
This happened in this photo in 2013. A sinkhole opened as a small excavator drove across the surface. The operator emerged unscathed. The excavator wasn't so lucky.
