2016 AML PROJECT SUMMARY

Wilton Phase 2

Drilling and pressurized remote backfilling with cementitious grout

Contract AM 757-16 (Construction)

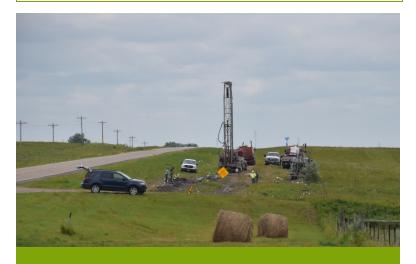
PSC staff are surveying drill holes as drilling continues in the north ditch of Highway 36 just west of the intersection of 52nd Street.

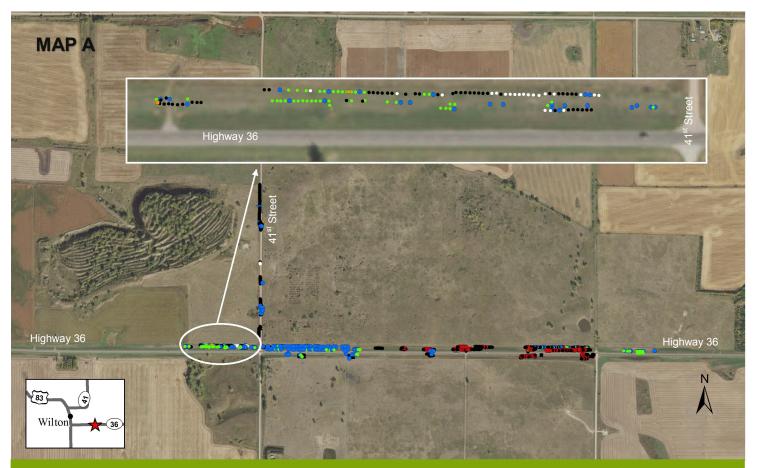
Maps A, B & C: North Dakota Highway 36 runs east and west. The north-south road is 41st Street. Each dot represents one drill hole. Blue dots were void holes that were pumped with grout. At **black dots**, drilling encountered solid coal. **Red dots** are holes that intercepted voids and were cased for future grouting. **Green dots** are holes that were filled with grout by pumping on another hole. **Orange dots** are core holes, and **white dots** represent no coal was encountered. All holes were filled with grout on Map A inset and Map B. Additional work is needed in both the north and south ditches of Highway 36 as shown on Map C.

In Map A and C areas barrier walls were built to keep the grout from flowing into the fields and outside the highway right-ofway. To do this holes were drilled near the fence line (these are the holes furthest to the north in the insets). A low-flow grout was pumped into these holes building a barrier to more flowable grout pumped into a second set of holes nearer the highway. The mine workings in the Map A area took over 4,000 cubic yards of grout. In Map C area, over 3,000 cubic yards of low-flow grout were pumped for barrier walls along the fence. Another 120 holes remain to be pumped in Map C area in a future project. Confirmation drilling, grout blowouts and surface cracking verified that the grout filled voids near Highway 36 reducing the likelihood of sinkholes forming.

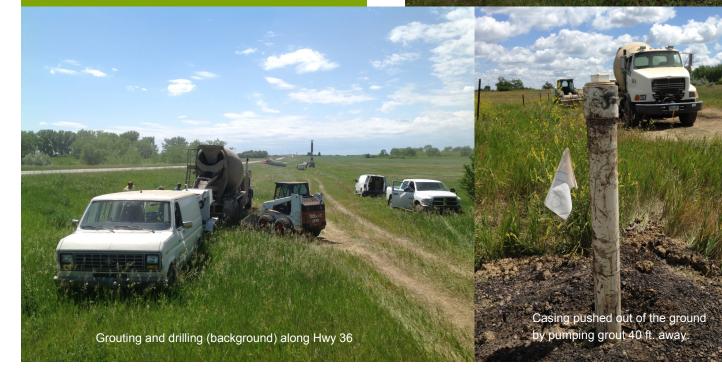
When pumping grout in the ditch of the area designated by Map B, grout filled holes on the shoulder of the highway. As a precaution, the highway was monitored by a laser level to detect surface lifting of the highway. Careful pumping and constant monitoring prevented any surface lifting of the highway. This area took nearly 900 cubic yards of grout.

Laser level monitoring Hwy 36 for surface lifting.
