Project Summary

2019 Morton County Phase 2 AML – Project

Abandoned Mine Lands Division

North Dakota Public Service Commission

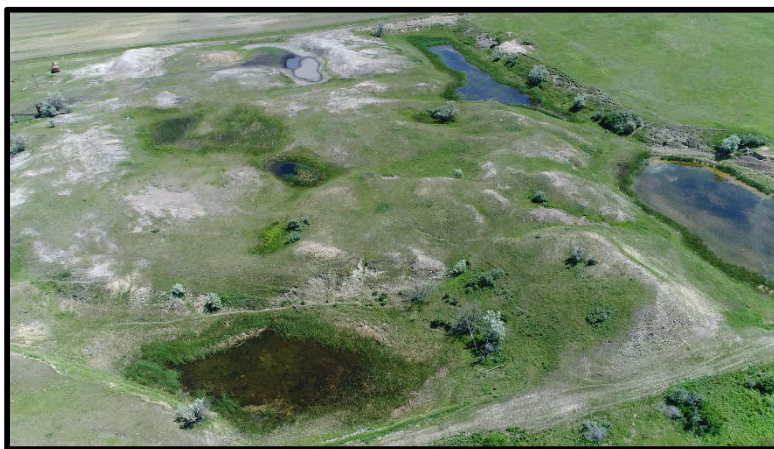
The Helm Brothers site was the largest of the five project areas. The site contained three dangerous highwalls that total 2,000 feet in length and averaged twenty-five feet in height. The site also contained three water filled pits and several pieces of historic mining equipment. The property owner requested that the mining equipment not be disturbed. The abandoned mine site is primarily used for grazing cattle and hunting, with a portion of highwall bordering cropland. A well-established trail allowed public access to the highwalls. The property owner was also concerned about erosion in the southeast corner of the site.

Photo 1 - Helm Brothers Pre-reclamation (looking southeast)

At the request of the property owner, the site was fully reclaimed and all of the existing ponds were eliminated. The site was graded to an average slope of 3.2%. Approximately 101,300 yd³ of earthen material was moved at this site. A small hill, which supports the abandoned mine tibble, was reshaped and left in place. All of the historic mining equipment remained undisturbed throughout the project.

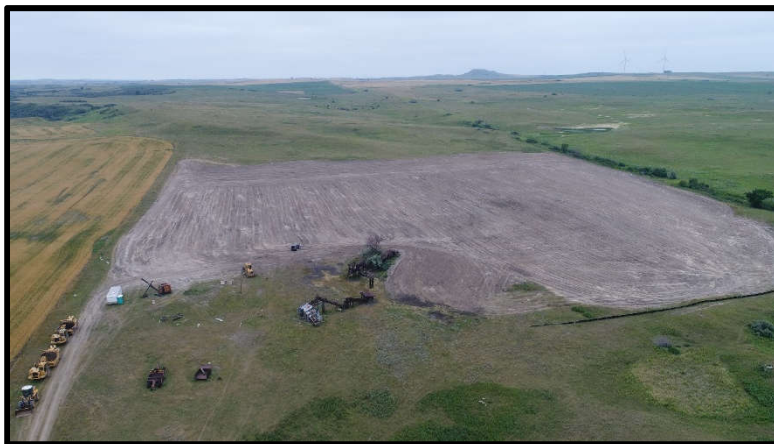
Photo 2 - Helm Brothers Post-reclamation

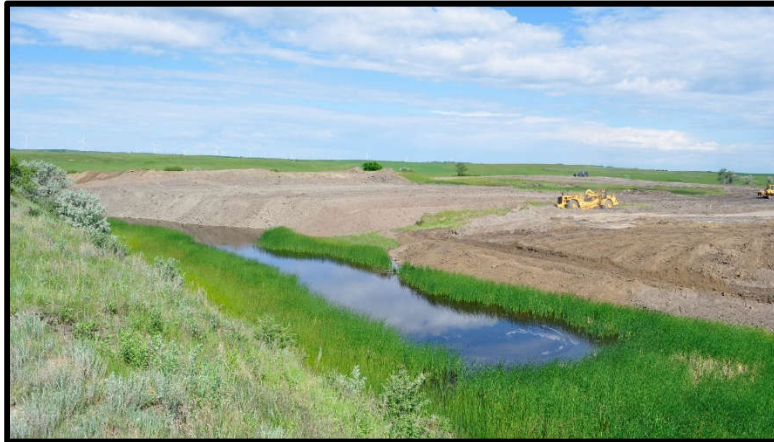
Photo 3 - Contractor backfilling the Southeast pit (looking northwest)

Earthmoving operations on the Helm Brothers site began June 18 and were completed July 25. Topsoil re-spread was completed on July 29. The contractor primarily utilized two Cat 627B Scrapers and one 1050K JD Dozer for earthmoving operations. The water in the southeast pit was first moved into the southwest pit. Water was then drained from the southwest pit to the center of the project site where it evaporated and infiltrated the newly graded ground. No water was discharged off site.

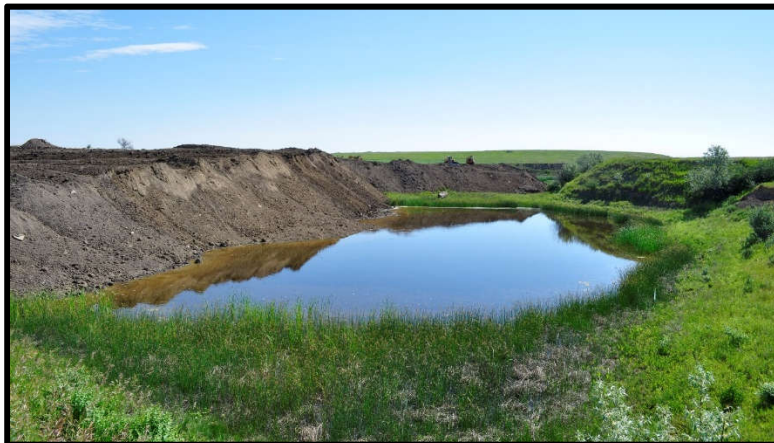
Photo 4 - Contractor backfilling the Southwest pit (looking northeast)

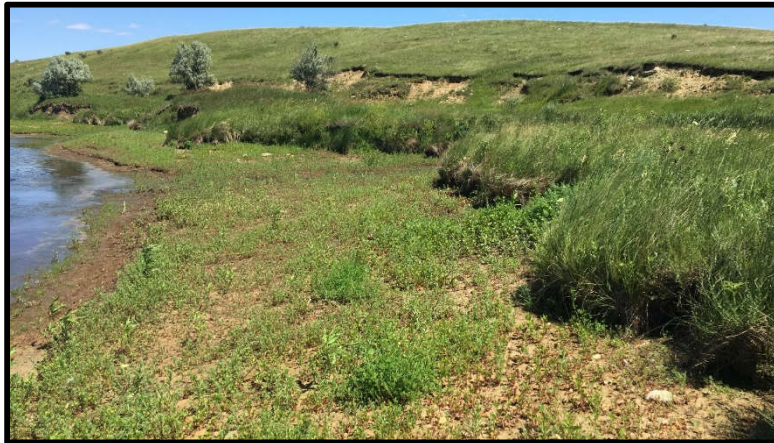
The Hoger site was the smallest site in the project. Two separate areas were reclaimed. The east portion of the site contained one highwall with spoil piles that were partially submerged in a man-made pond. Before the project began the property owner, Wayne Hoger, opened the outlet structure to partially dewater the pond. The exposed spoil piles were used to backfill the highwall and match the existing grade. The reclaimed highwall slopes range from 20% - 40%.

Photo 5 - Spoil piles and highwall on the East Site

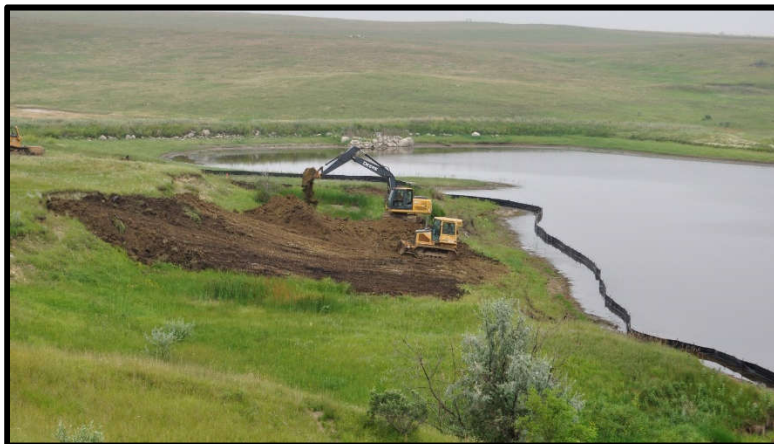
Photo 6 - Contractor backfilling the highwall on the East Site

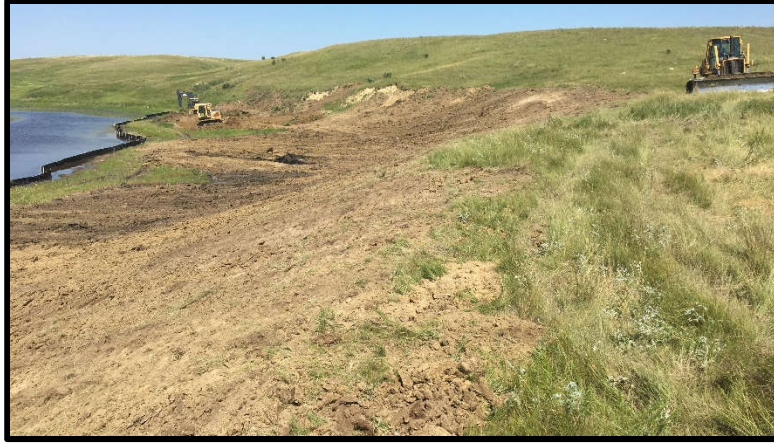
Photo 7 - Contractor backfilling the highwall on the East Site

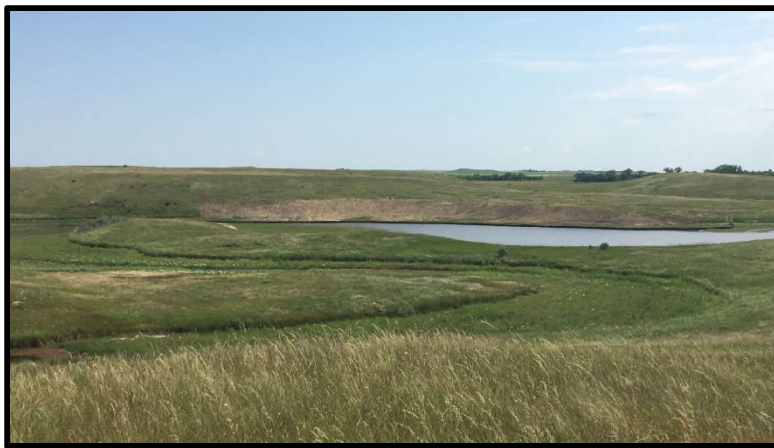
Photo 8 - East Site after reclamation

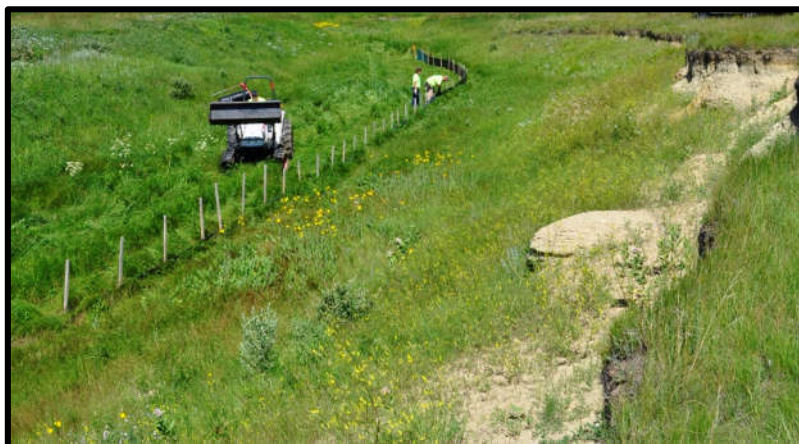
Photo 9 - Subcontractor installing silt fence on the West Site

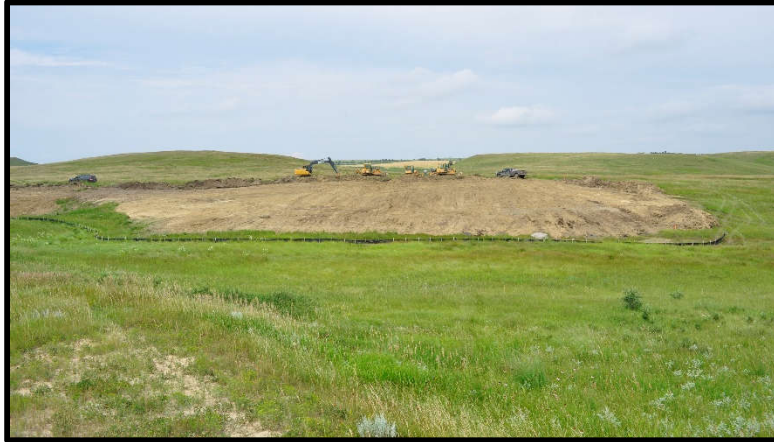
The west portion of the site involved backfilling a pit and reshaping the 10 foot highwall.

Photo 10 - Contractor backfilling the pit at the West Site

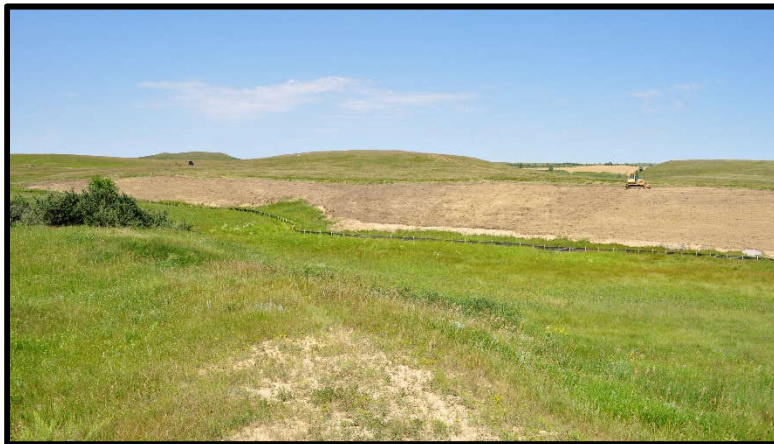
Photo 11 - West Site after reclamation

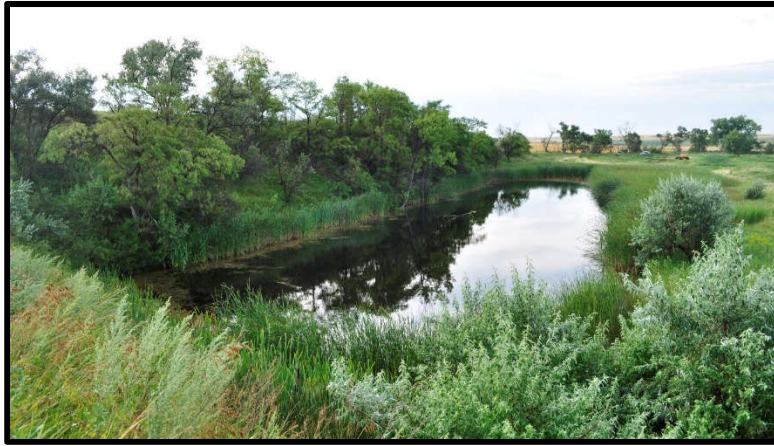
The Flemmer site contained one highwall, approximately 25 ft high, and one water filled pit. The spoil piles, located on the west side of the pit, were not used in the reclamation process. Instead, the design consisted of backsloping the highwall approximately 100 ft into a cultivated field owned by the property owner. The post-reclamation topography has an average slope of 9.1%.

Photo 12 - View of the pit and highwall (looking southeast)

The original design relocated the water by constructing a new pond to the south of the existing pit. After construction began it was discovered that the ground was too saturated to accomplish this task. The property owner was informed of the conditions and it was decided to direct the water into an adjacent drainage ditch owned by the property owner.

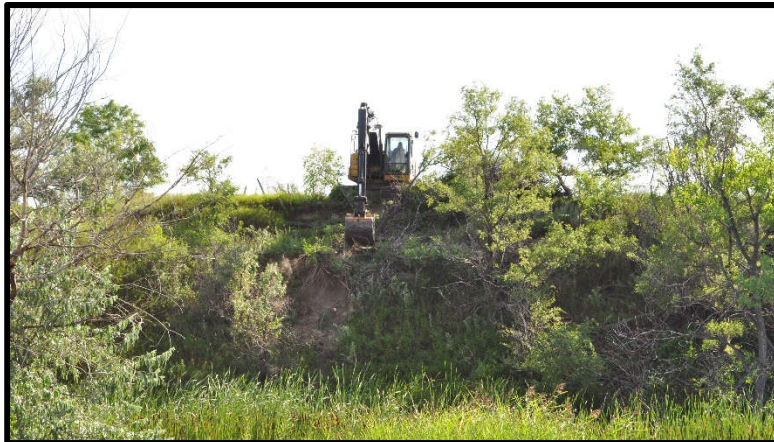
Photo 13 - Contractor clearing trees from the highwall

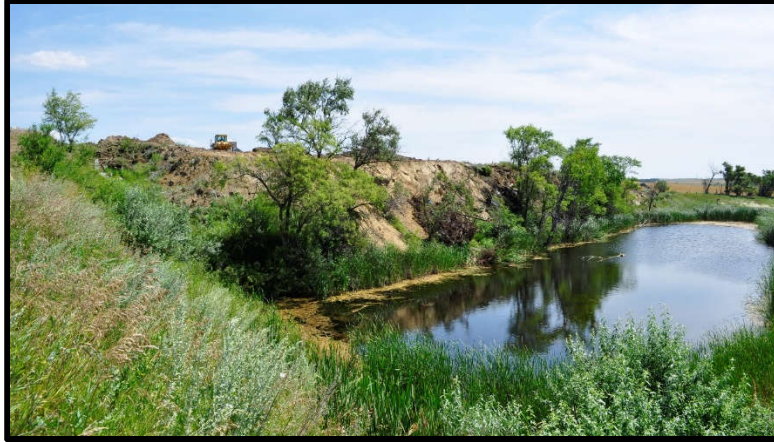
Photo 14 - Contractor stripping topsoil and removing trees and other vegetation

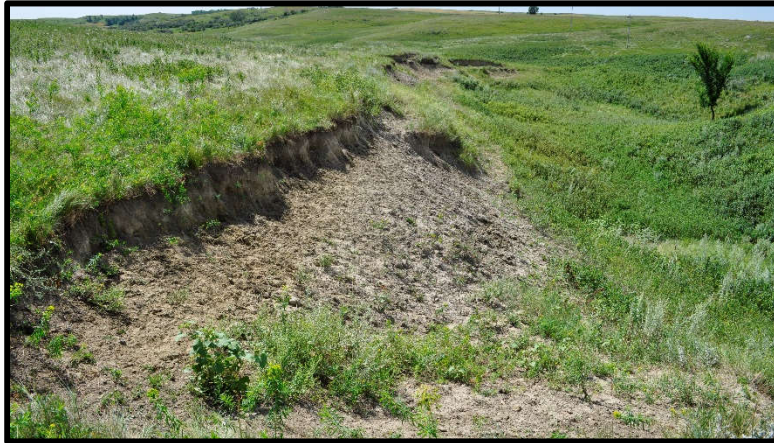
The Adolph Thiel site contained one small highwall approximately 20 ft in height. The property owner requested that the spoil material be used to backfill the highwall and that the reclaimed topography be graded to a slope with allows an ATV to safely pass through the area. The reclaimed area will once again be used as grazing ground for cattle.

Photo 16 – Highwall pre-reclamation

Earthmoving operations began at the Adolph Thiel site on August 14 and were completed August 19. Topsoil re-spread was completed on August 22. The contractor used two 850C JD Dozers. Approximately 6,100 yd³ of material was moved at this site. The average slope of the reclaimed topography is 12.6%. This grade easily accommodates the property owner's request to pass through the site on an ATV.

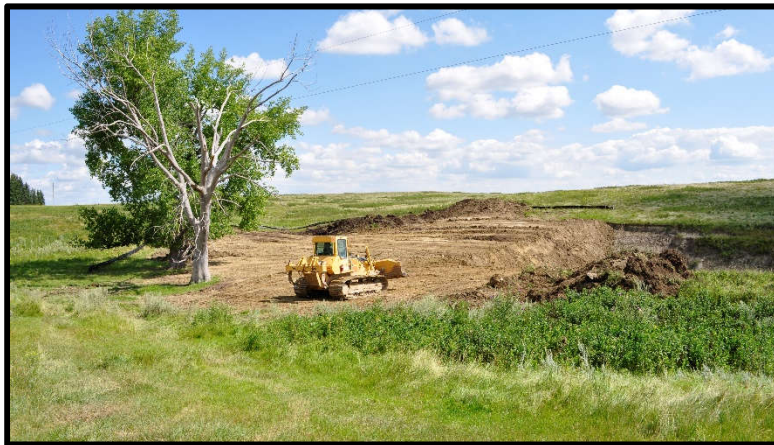
Photo 17 - Contractor backfilling the highwall

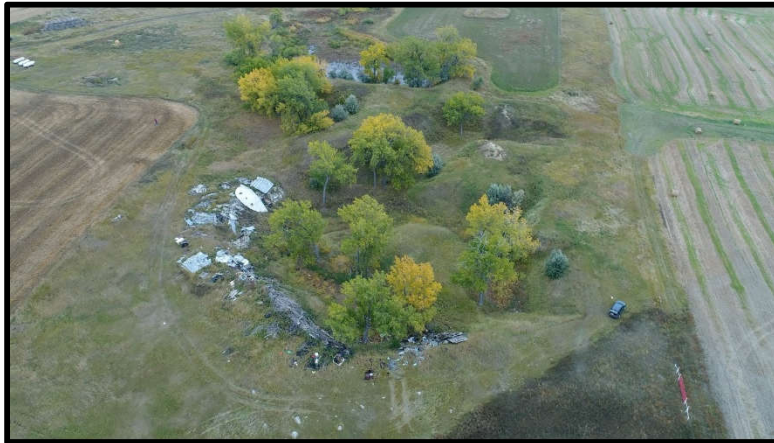
This site contained one dangerous highwall approximately 25 ft height topped by a substantial amount of inert waste. The pit also contained inert waste. The inert waste was buried on site following the North Dakota Department of Environmental Quality guidelines. The landowner requested that the site be tied into the field to the north, but the site lacked sufficient spoil material. The result is a bowl shape area that may experience ponding during storm events.

Photo 18 - Timpe pre-reclamation (looking east)

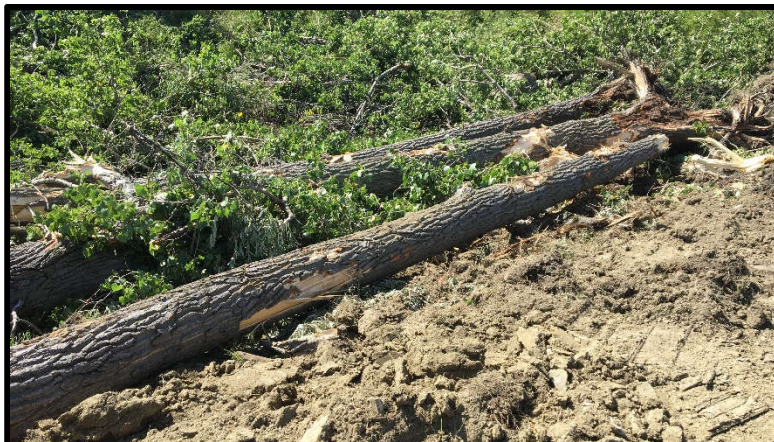
The site also contained 30 mature cottonwood trees. The trees were removed as part of the contract. The branches were buried as inert waste in the deepest part of the pit. The trunks were stock piled on site at the request of the property owner.

Photo 19 - Some trees that were felled by the contractor

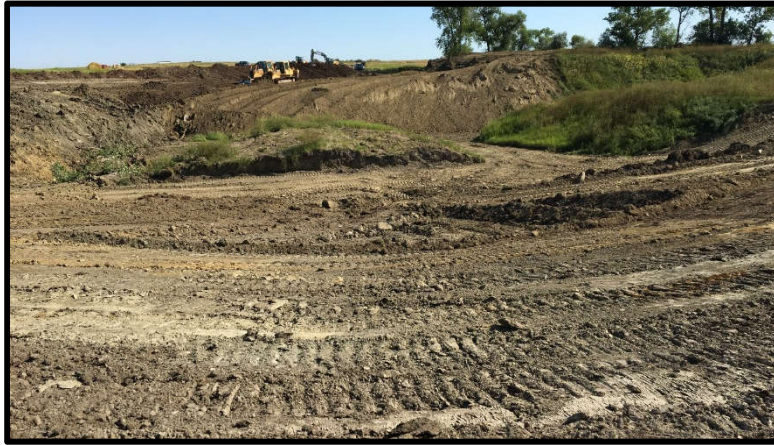
Photo 20 - Contractor moving dirt to the pit

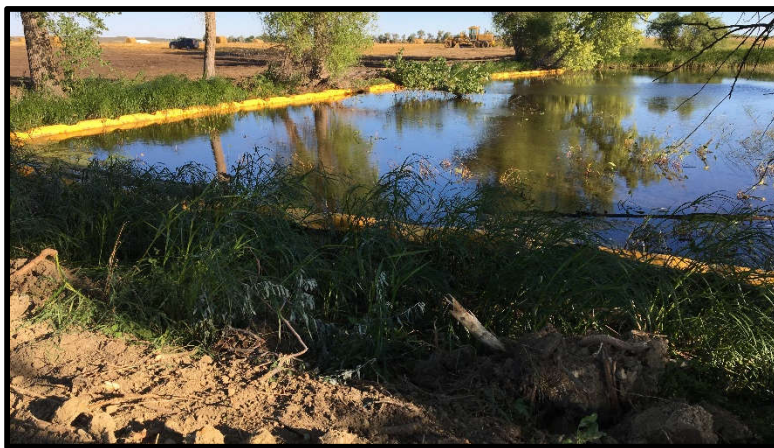
Photo 21 - Silt curtain protecting the wetland from runoff

The site was deep tilled, fertilized and planted with a native grass mix in October. Fiber rolls were placed to prevent erosion before vegetation can be established. A silt curtain was placed around the perimeter of the wetland to prevent any sediment from entering the wetland.
