Project Summary
2014 Beulah/Zap Phase 15
Contracts AM-695-14 & AM-396-14

March, 2015

**North Dakota Public Service Commission
2014 AML Project Summary
Beulah, North Dakota**

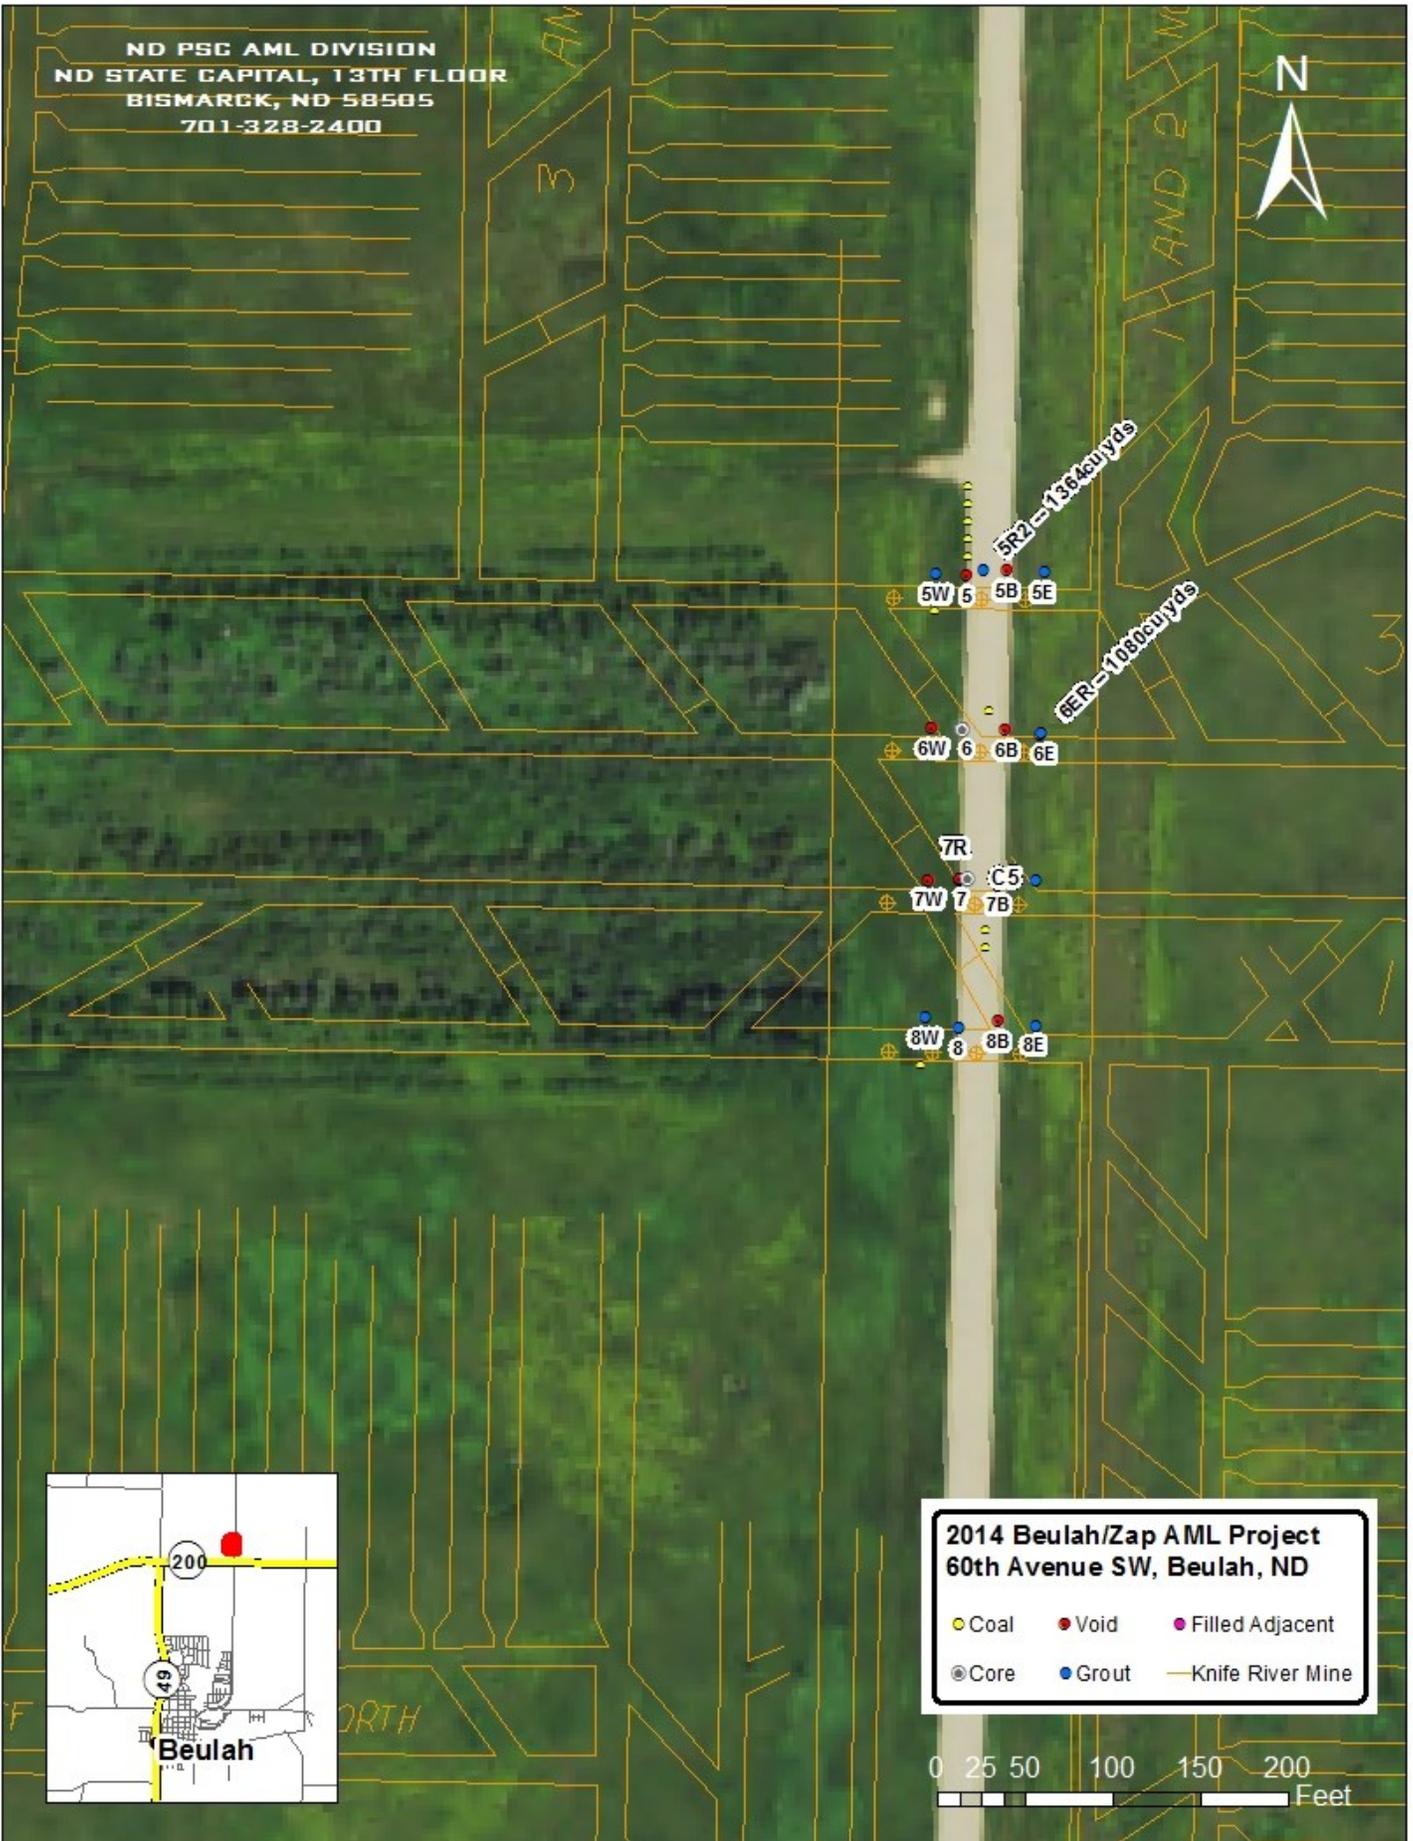
Map 1: 60th Ave. SW, just north of HWY 200 & between Sec. 13 (T144N, R88W) Sec. 7 (T144N, R87W).

Grout injection for the 2014 Beulah/Zap Phase 14 AML project began September 5, 2014 on 60th Ave SW approximately 1/4 mile from the intersection with Highway 200 and near the tree rows on the ND Game and Fish property. At this location, four haul tunnels run perpendicular to 60th Ave. (Map 1) In 2013 and 2014, cased holes in the ditches (except 7W and 6E) were pumped as barrier walls. Barrier walls are comprised of lower slump (thicker and less flowable) grout creating a barrier to grout flow. The goal was to confine as much grout as possible under the road. Many of the casings for the holes on the road were blocked or broken and the sandy subsurface proved difficult to get casing cleanly into any newly drilled holes. Hole 6E, in the east ditch, was pumped with high slump highly flowable grout rather than as a barrier wall. This hole took 1,080 cubic yards of grout. Hole 5R2 (a redrill of 5A) was still taking after 1,364 cubic yards of grout in spite of the barrier walls and needs to be completed in the next phase. Confirmation drilling indicated that additional work needs to be done near Holes 7 and 7B (on the road).

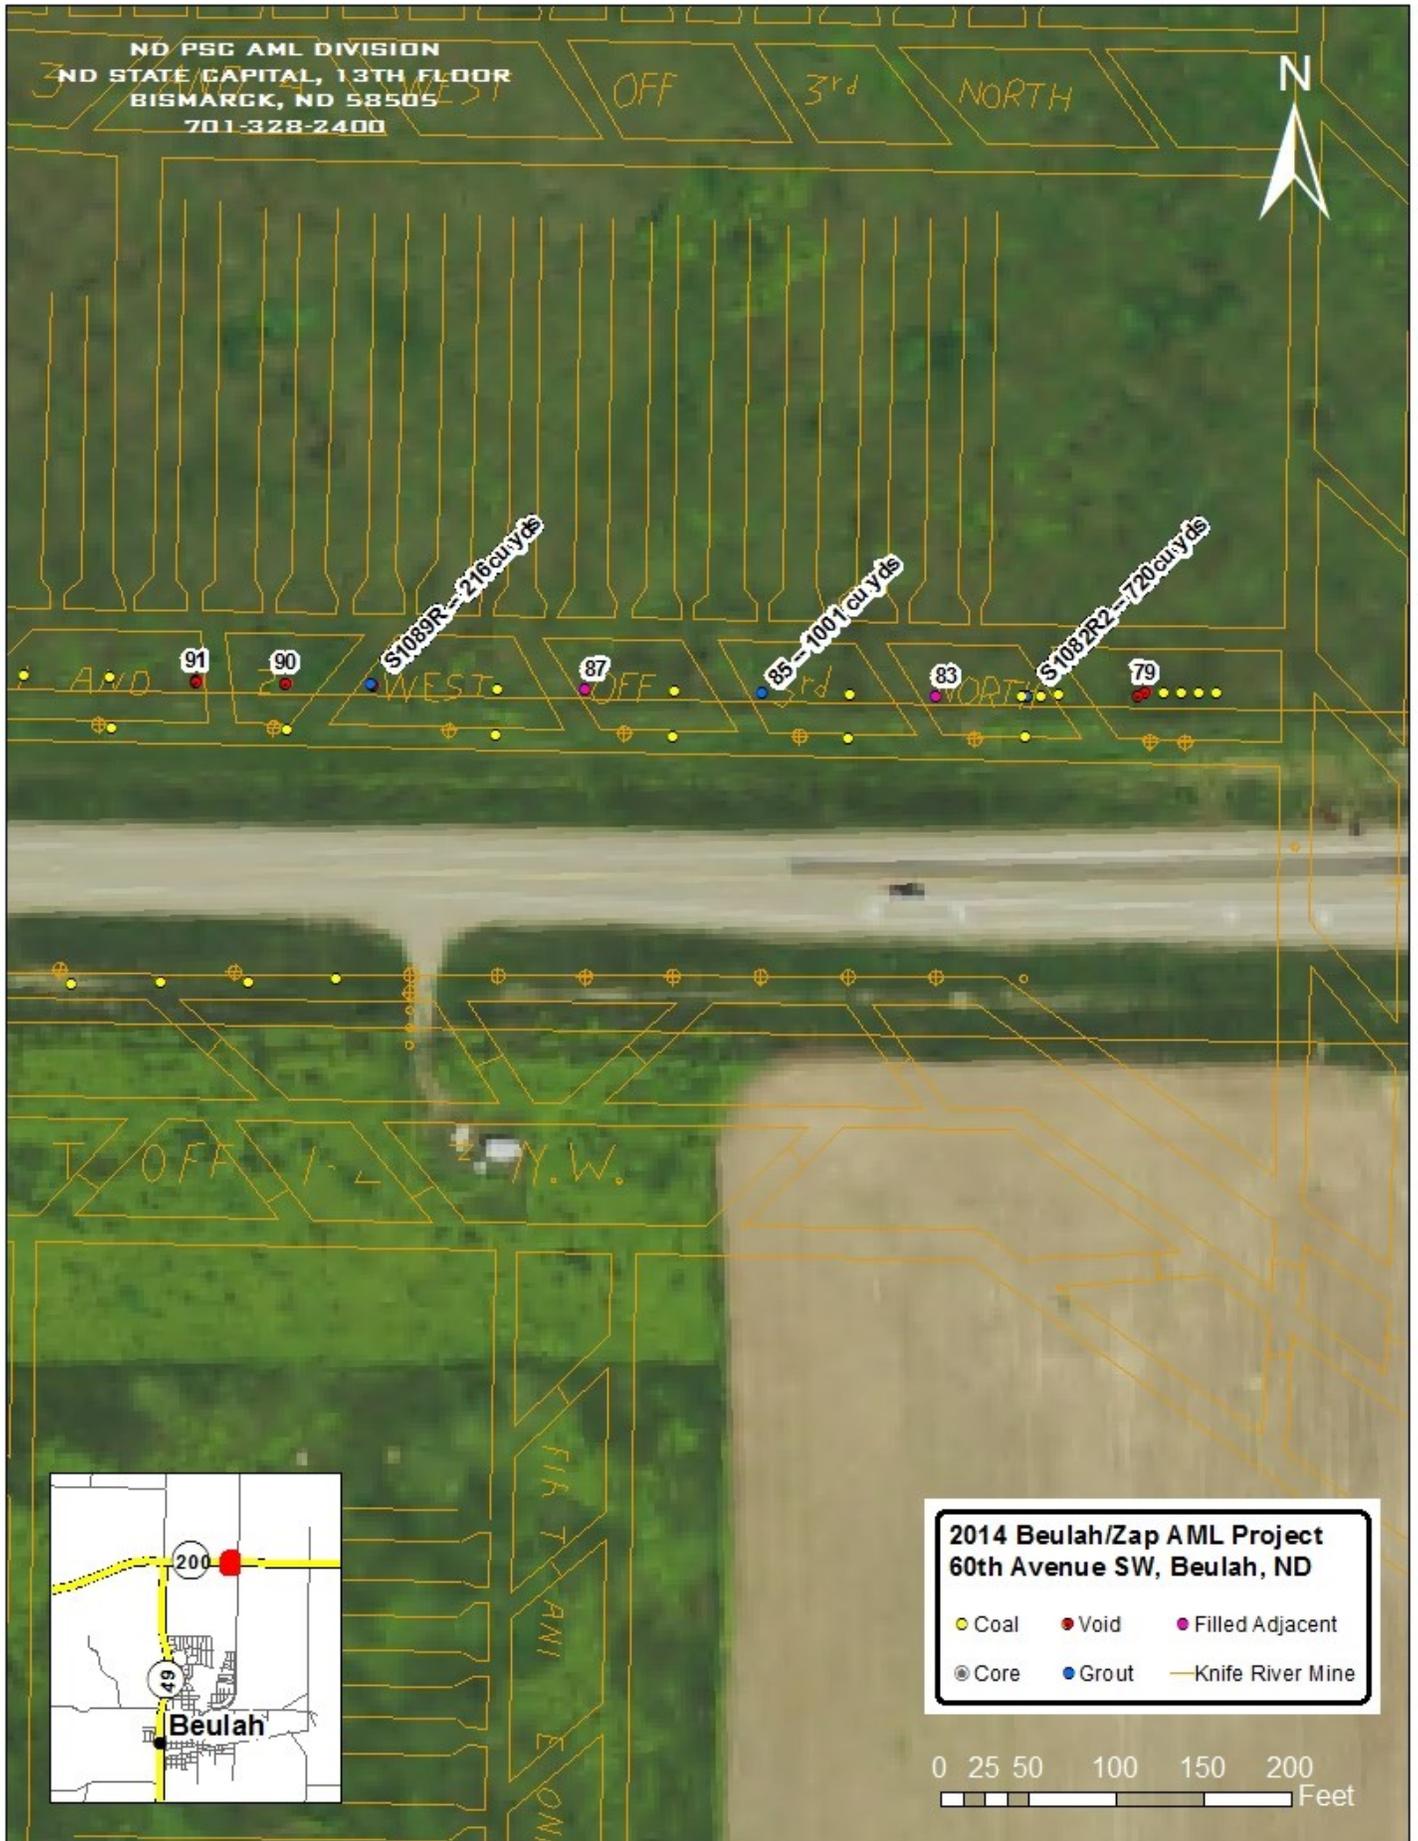
Map 2: HWY 200 just west of 60th Avenue SW.

Grout was also pumped on a series of holes that were drilled in 2010 near Highway 200 (Map 2). The original holes were drilled at an angle toward the ditch. As along 60th Avenue SW, many of the casings that were installed in 2010 were plugged and were redrilled at an angle. Over 1900 cubic yards of grout were pumped into 3 holes and a total of 5 holes were filled. Holes 79, 91 and 91 will be worked on in the next phase.

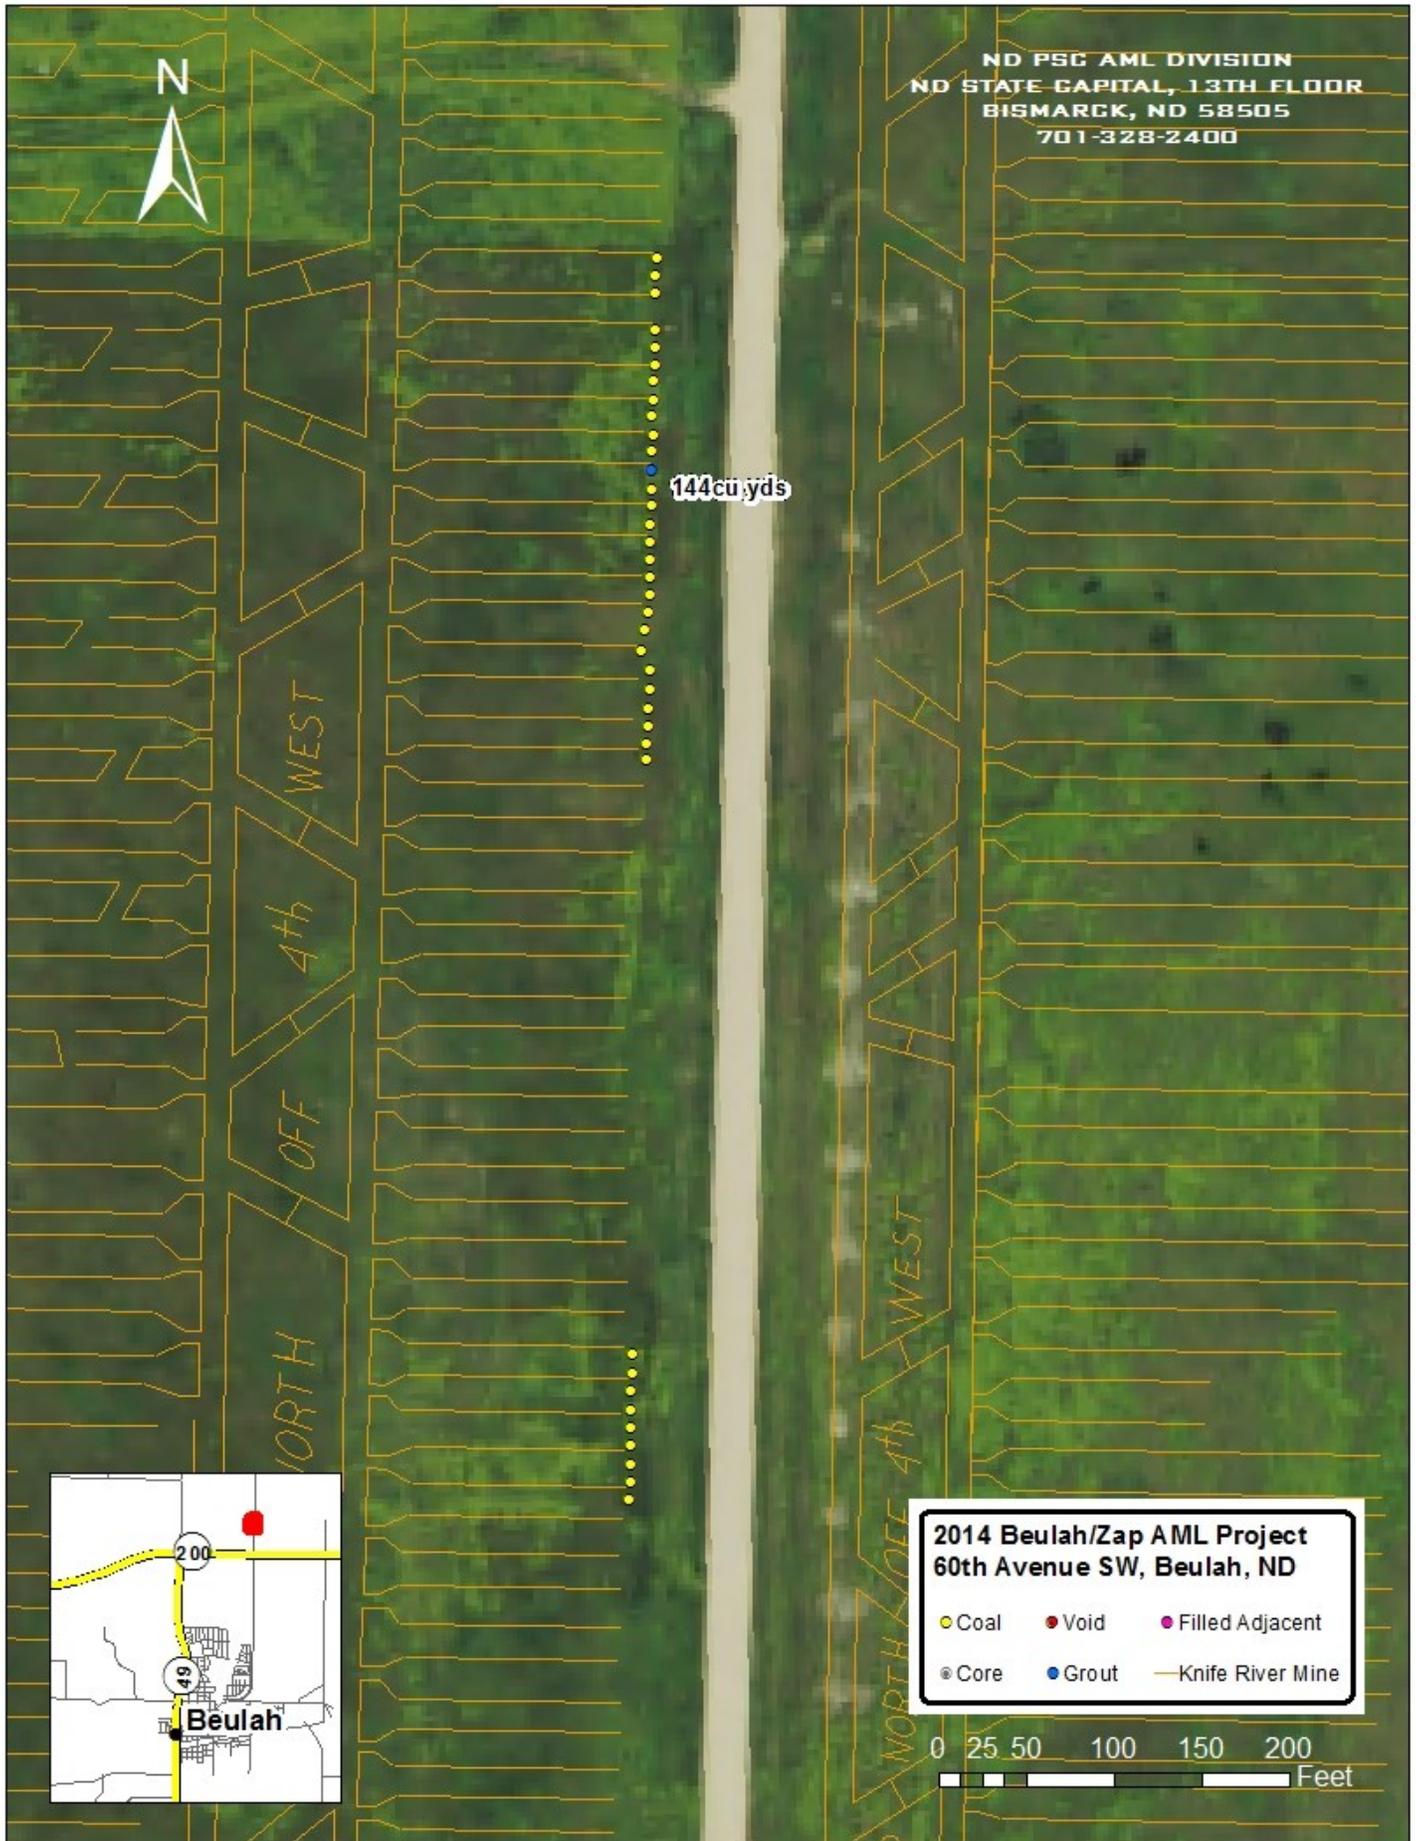
Map 3: 60th Avenue SW, between Section 13 (T144N, R88W) and Section 7 (T144N, R87W).

Project drilling was done at the fence line on the Game and Fish property, west of 60th Avenue SW about 2000 feet north of Highway 200 where the mine map indicates rooms endrd near the road (See Map 3). One void was intercepted in this area and it took 144 cubic yard of grout. Drilling continued in the north ditch of Curt Michaelson's driveway starting at the bottom of the hill and moving toward 60th Avenue SW. Of the 21 holes drilled on the driveway, 5 intercepted voids. (Map 4). These will be grouted in the next phase. Confirmation drilling of work done in 2013 on 60th Avenue indicated good grout contact under the road.

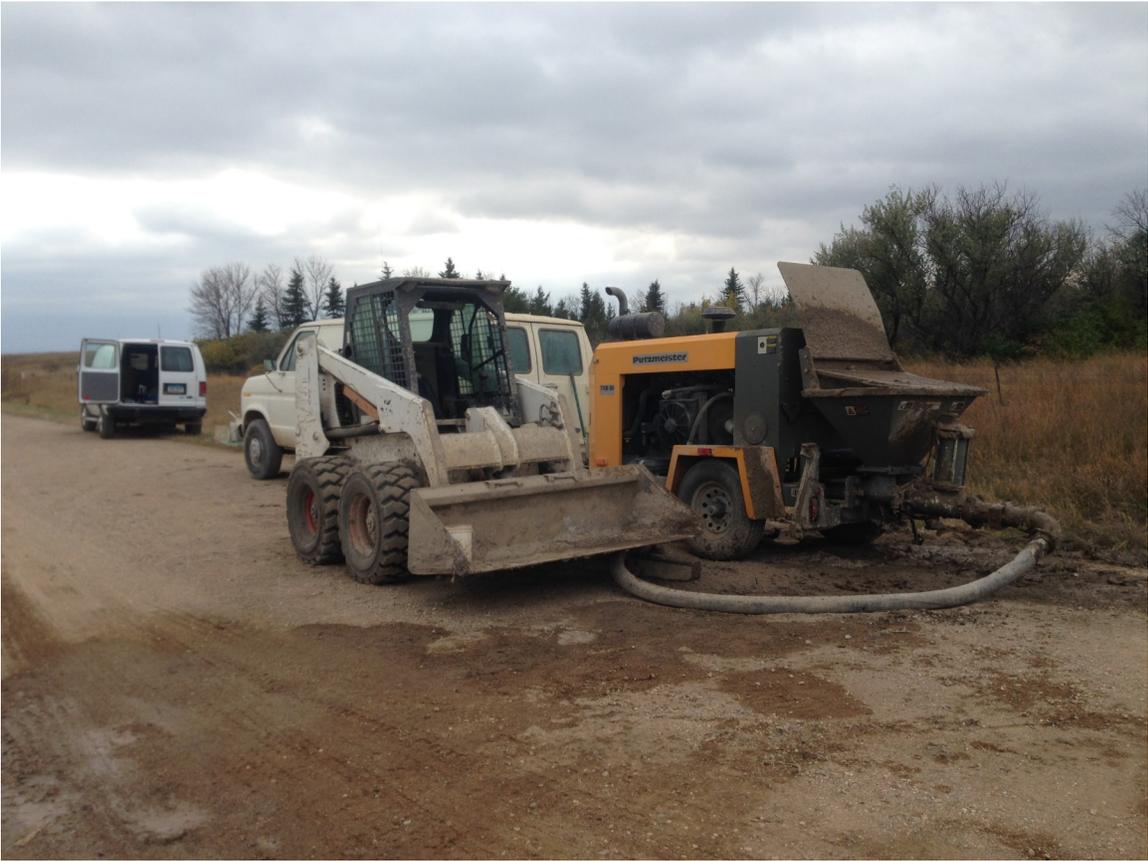
Above: Grout pump set up on Hole 5 on 60th Ave. SW (see Map 1). This hole took 1364 cubic yards of grout.

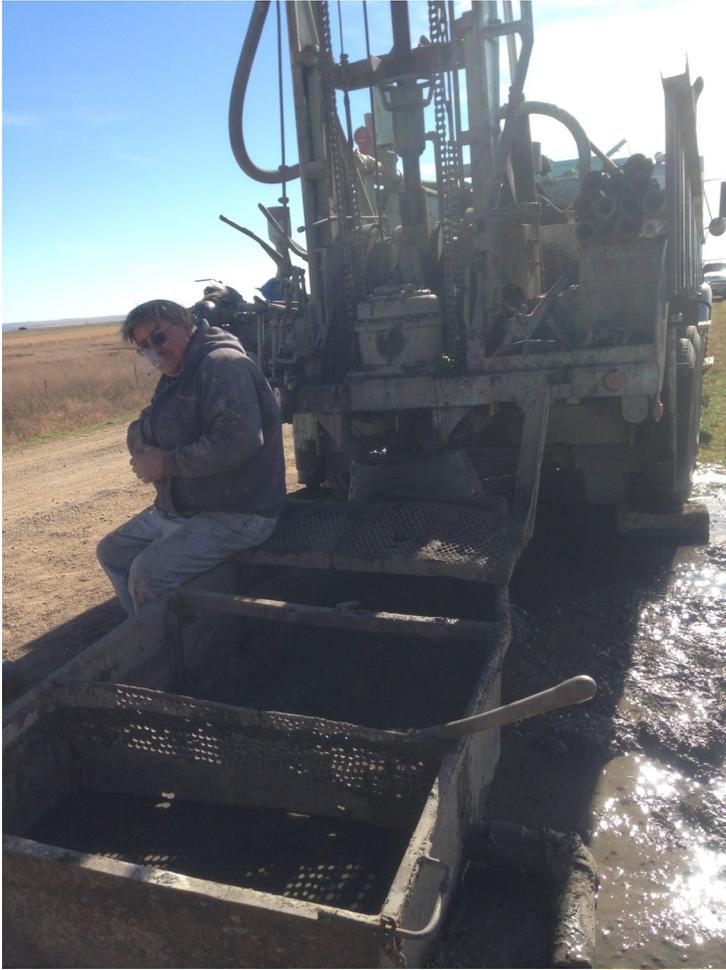
Mud pit attachment to the drilling rig. A slurry of “mud” is injected into the hole to keep the hole from collapsing which was a problem for the holes on the southern end of 60th Ave. SW.

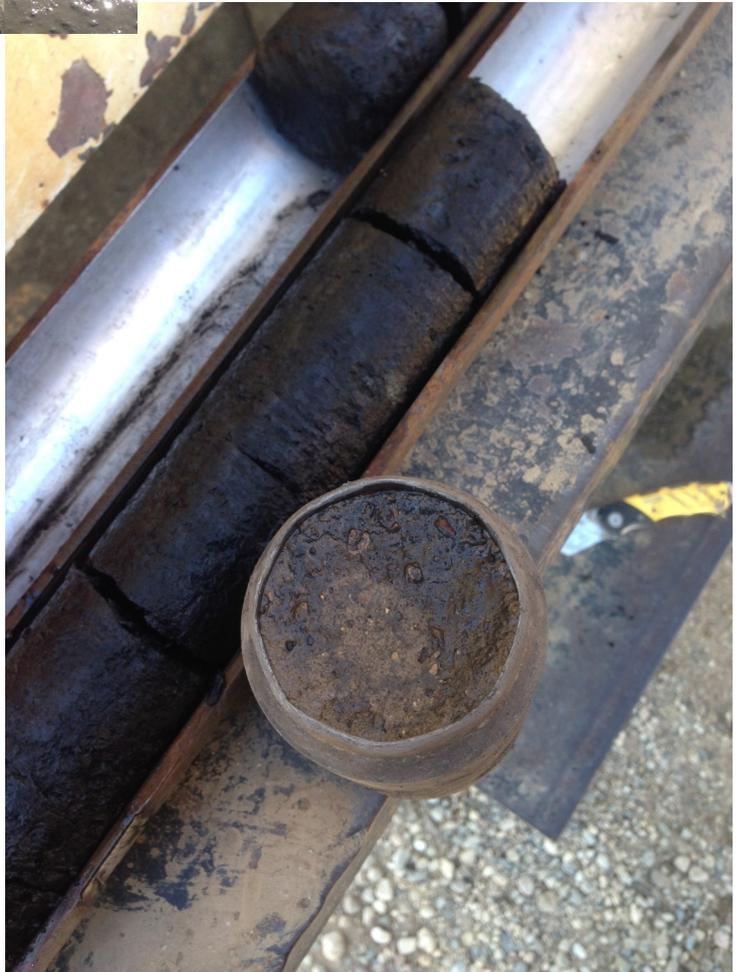
Solidified grout in the core barrel tip. The remainder of the core barrel was filled with coal. This area was grouted in 2013
