ND ONE-CALL COMPLAINT

PU-15-629 Filed: 8/7/2015 Pages: 15
North Dakota One Call Complaint (7-13-2015, 10:32 a.m.)

Subject: Dickinson - South of 198 40th St E - Main Repair (BILLABLE - NORTHERN IMPROVEMENT)

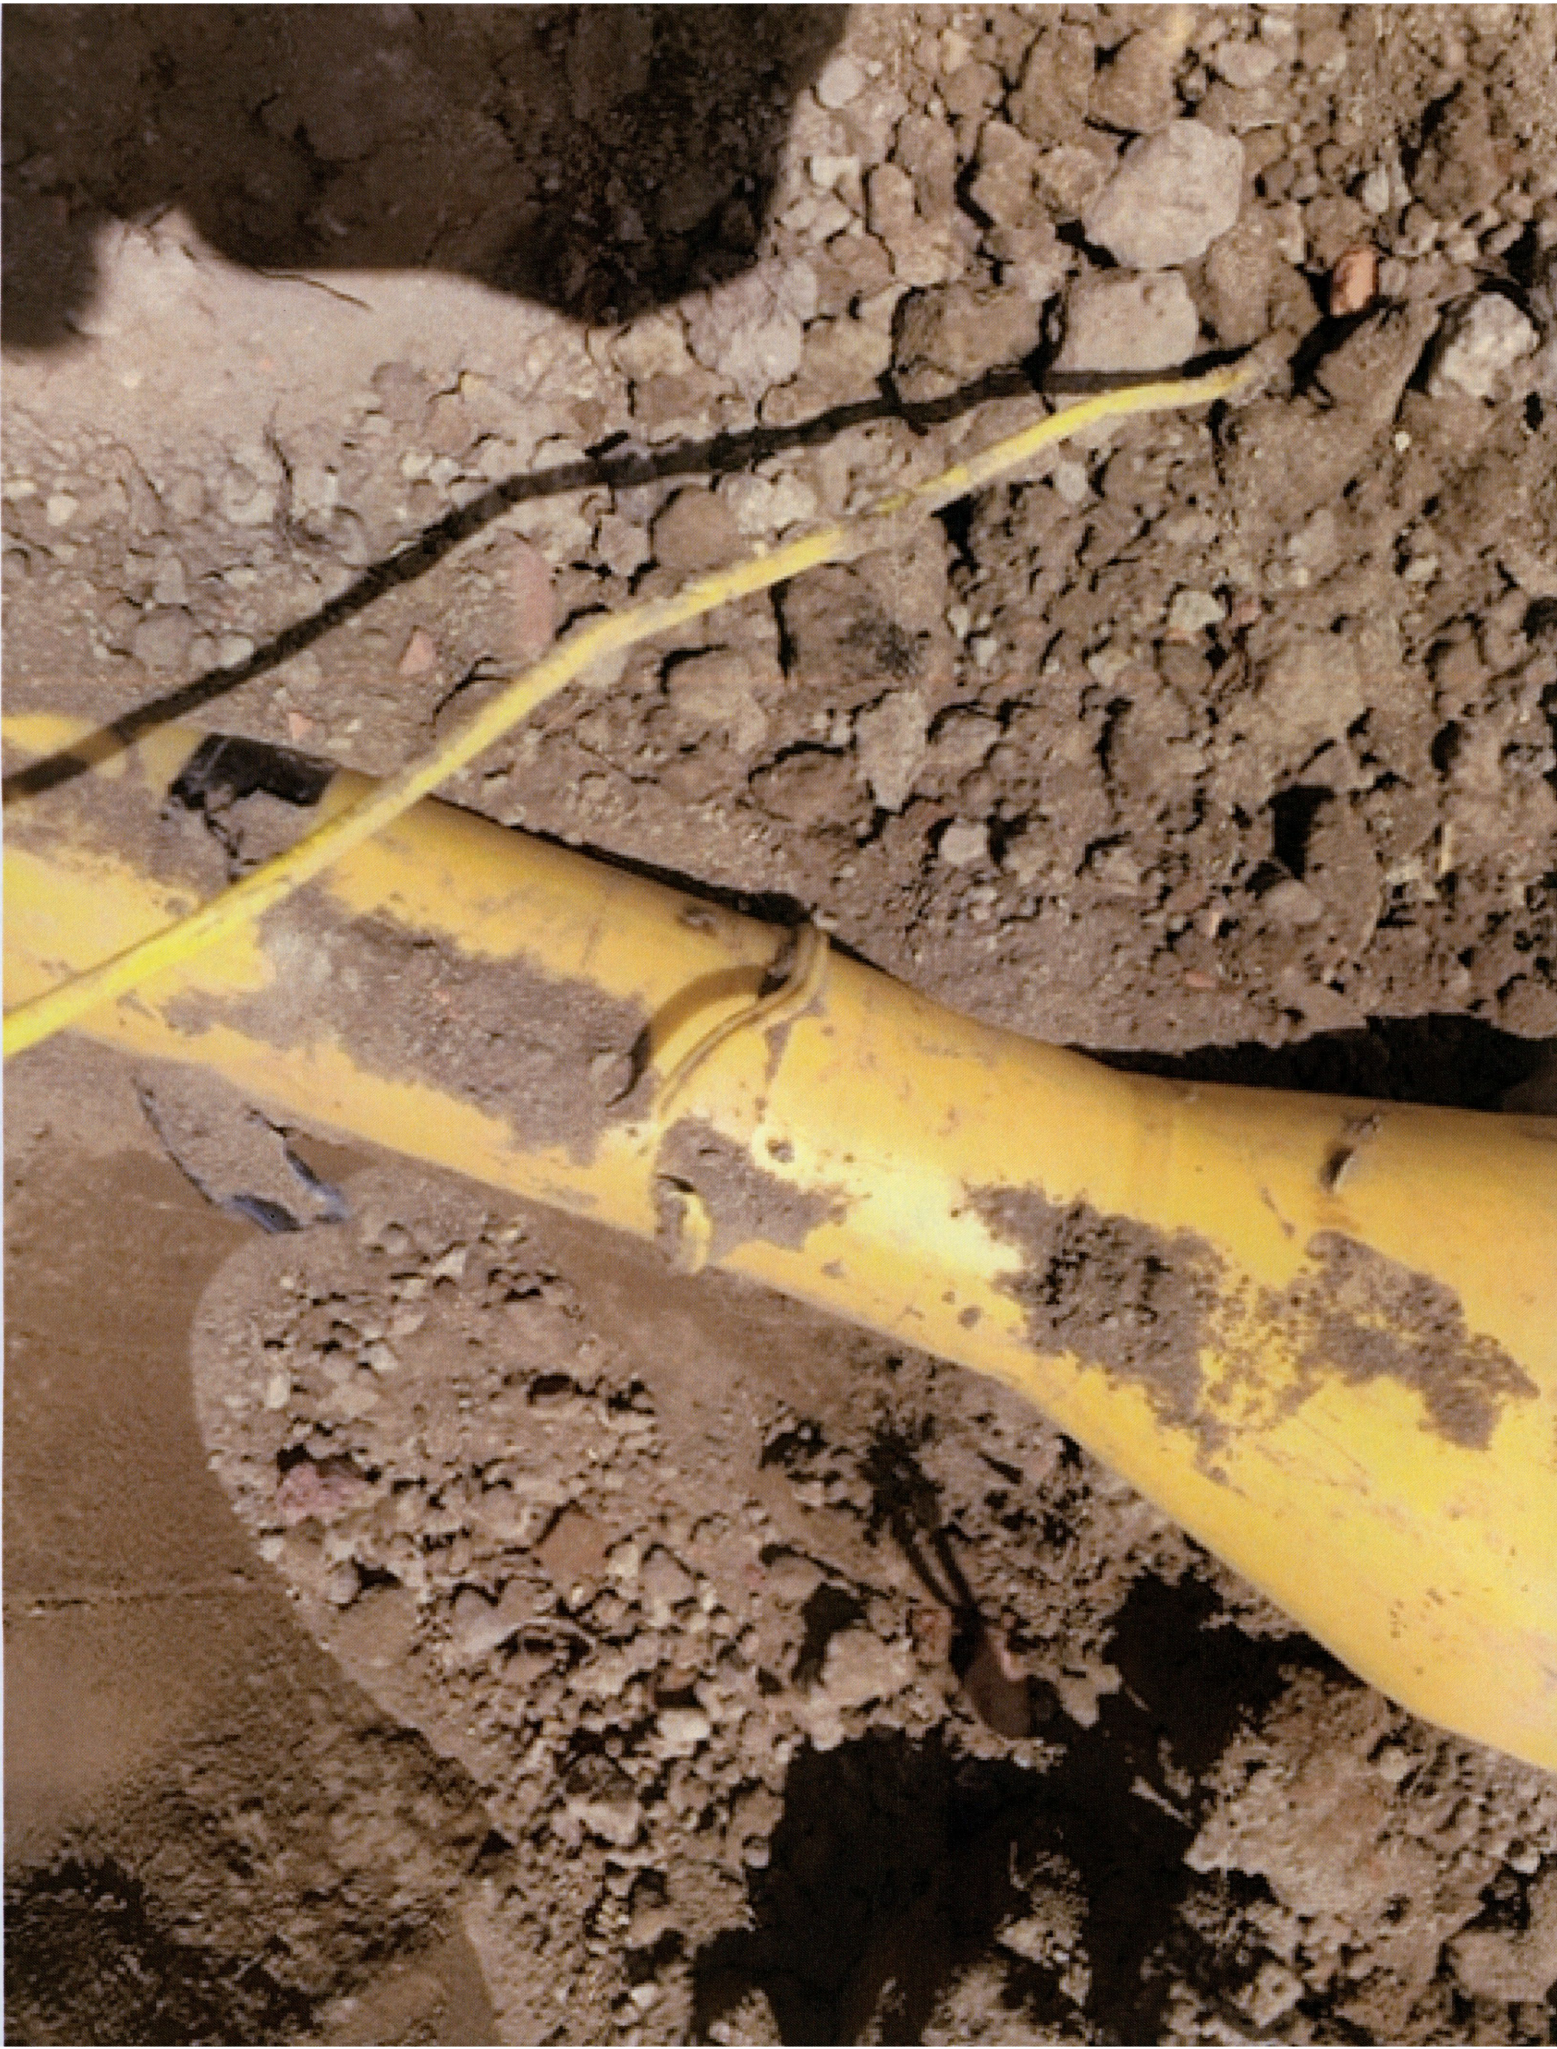
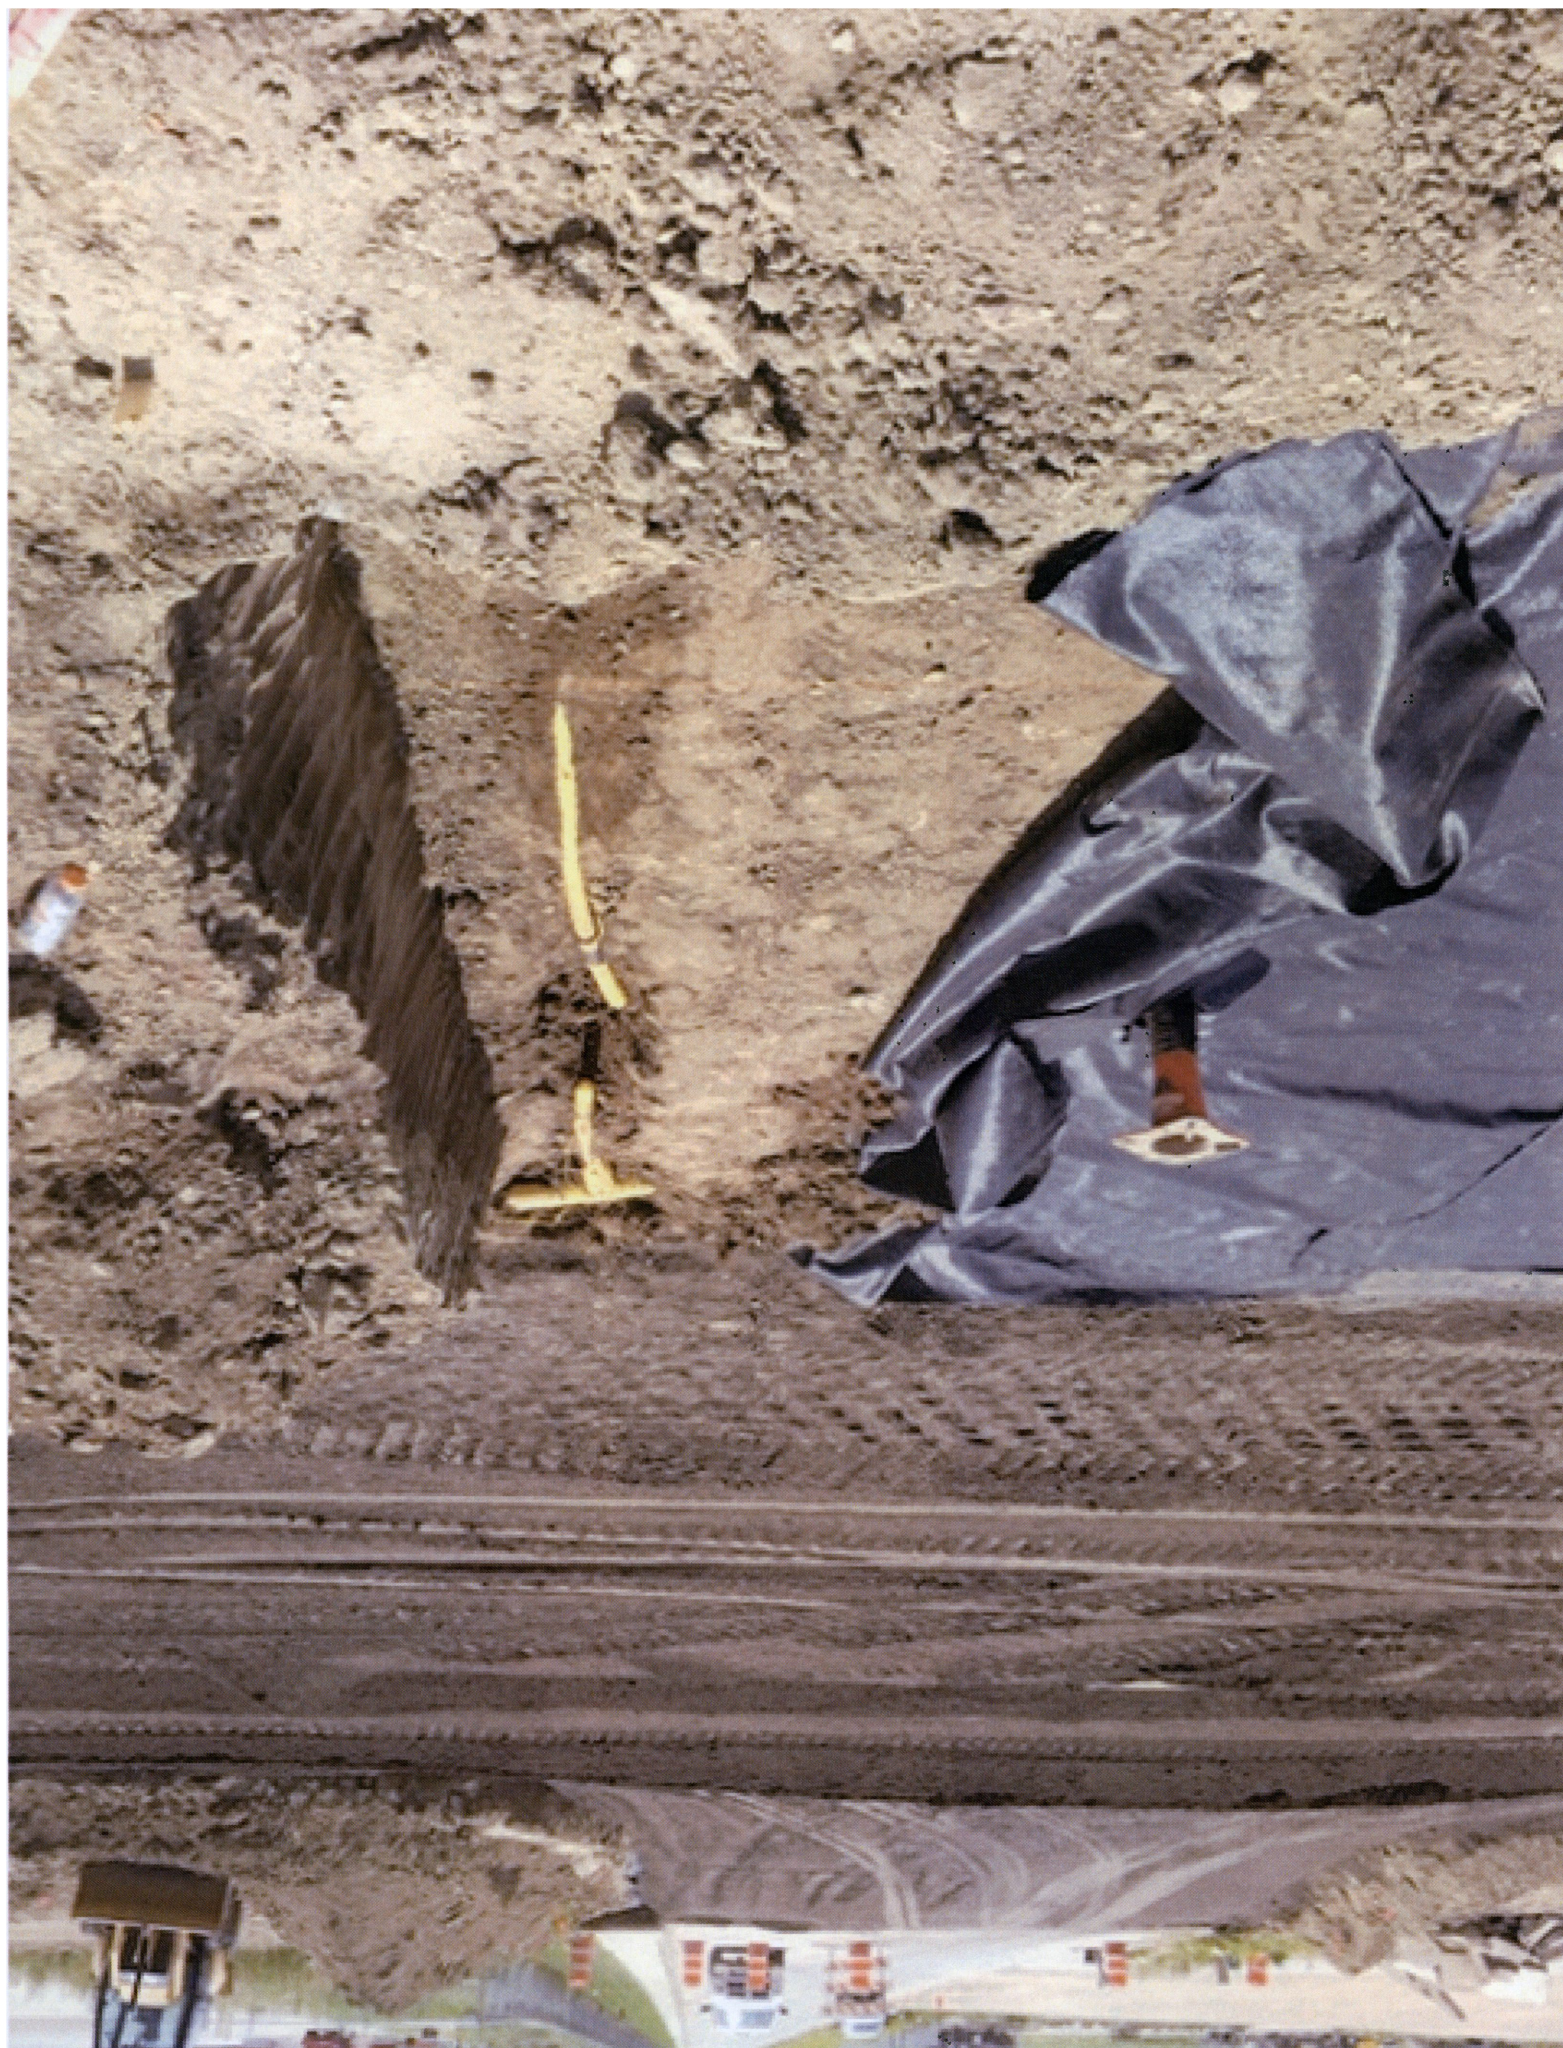
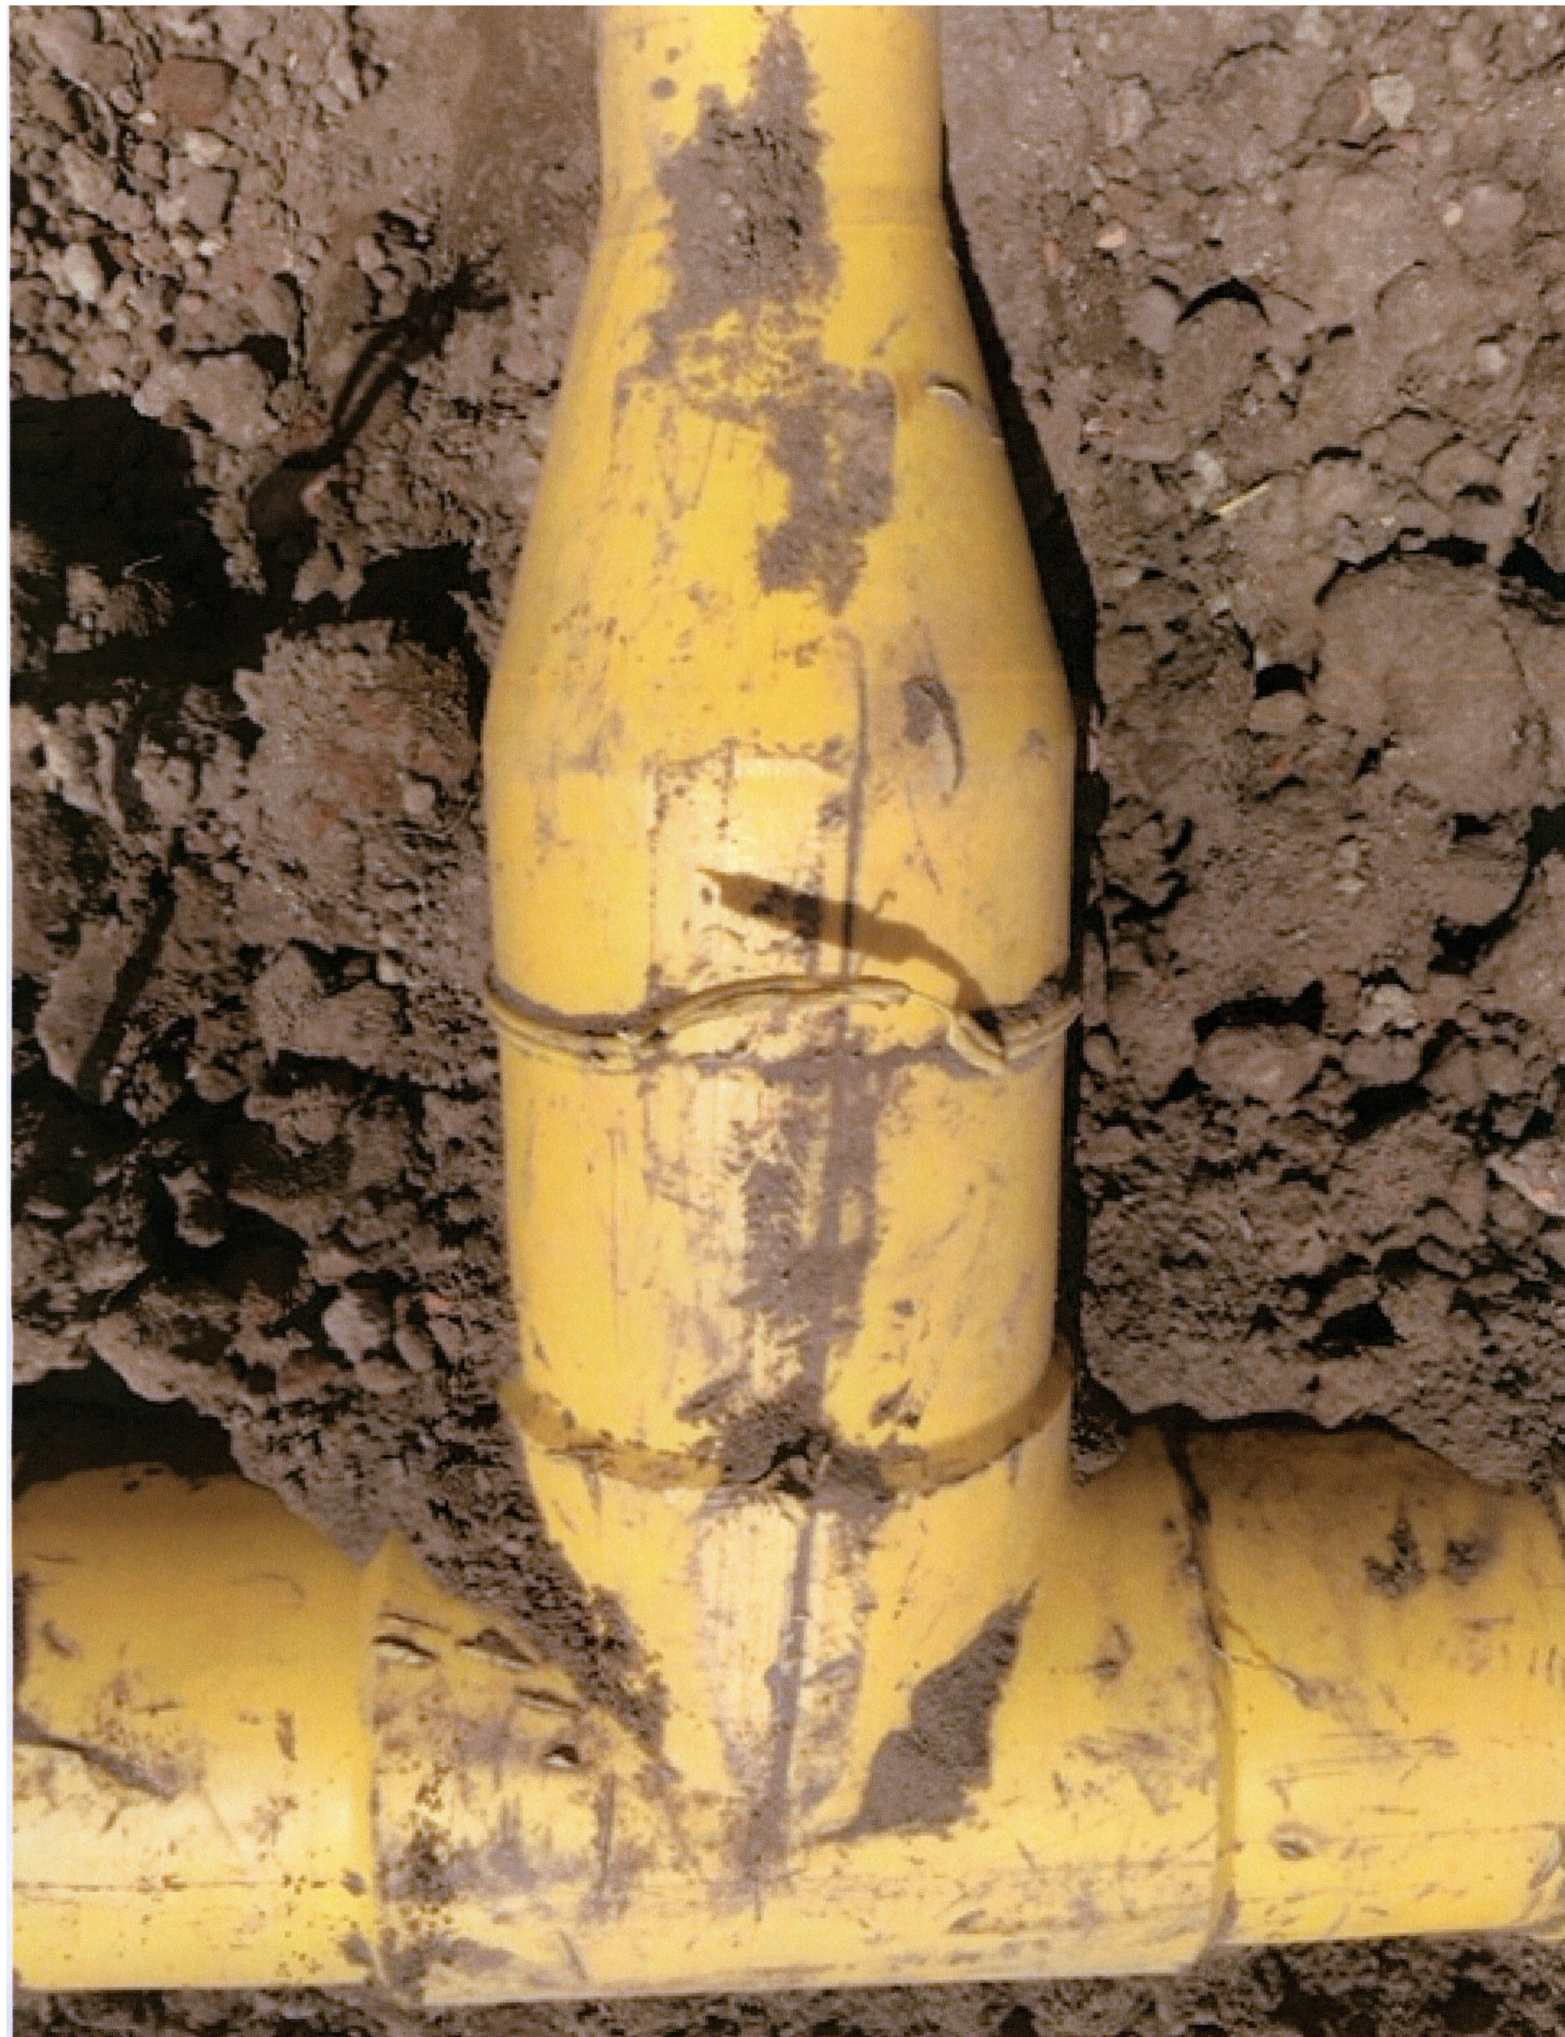
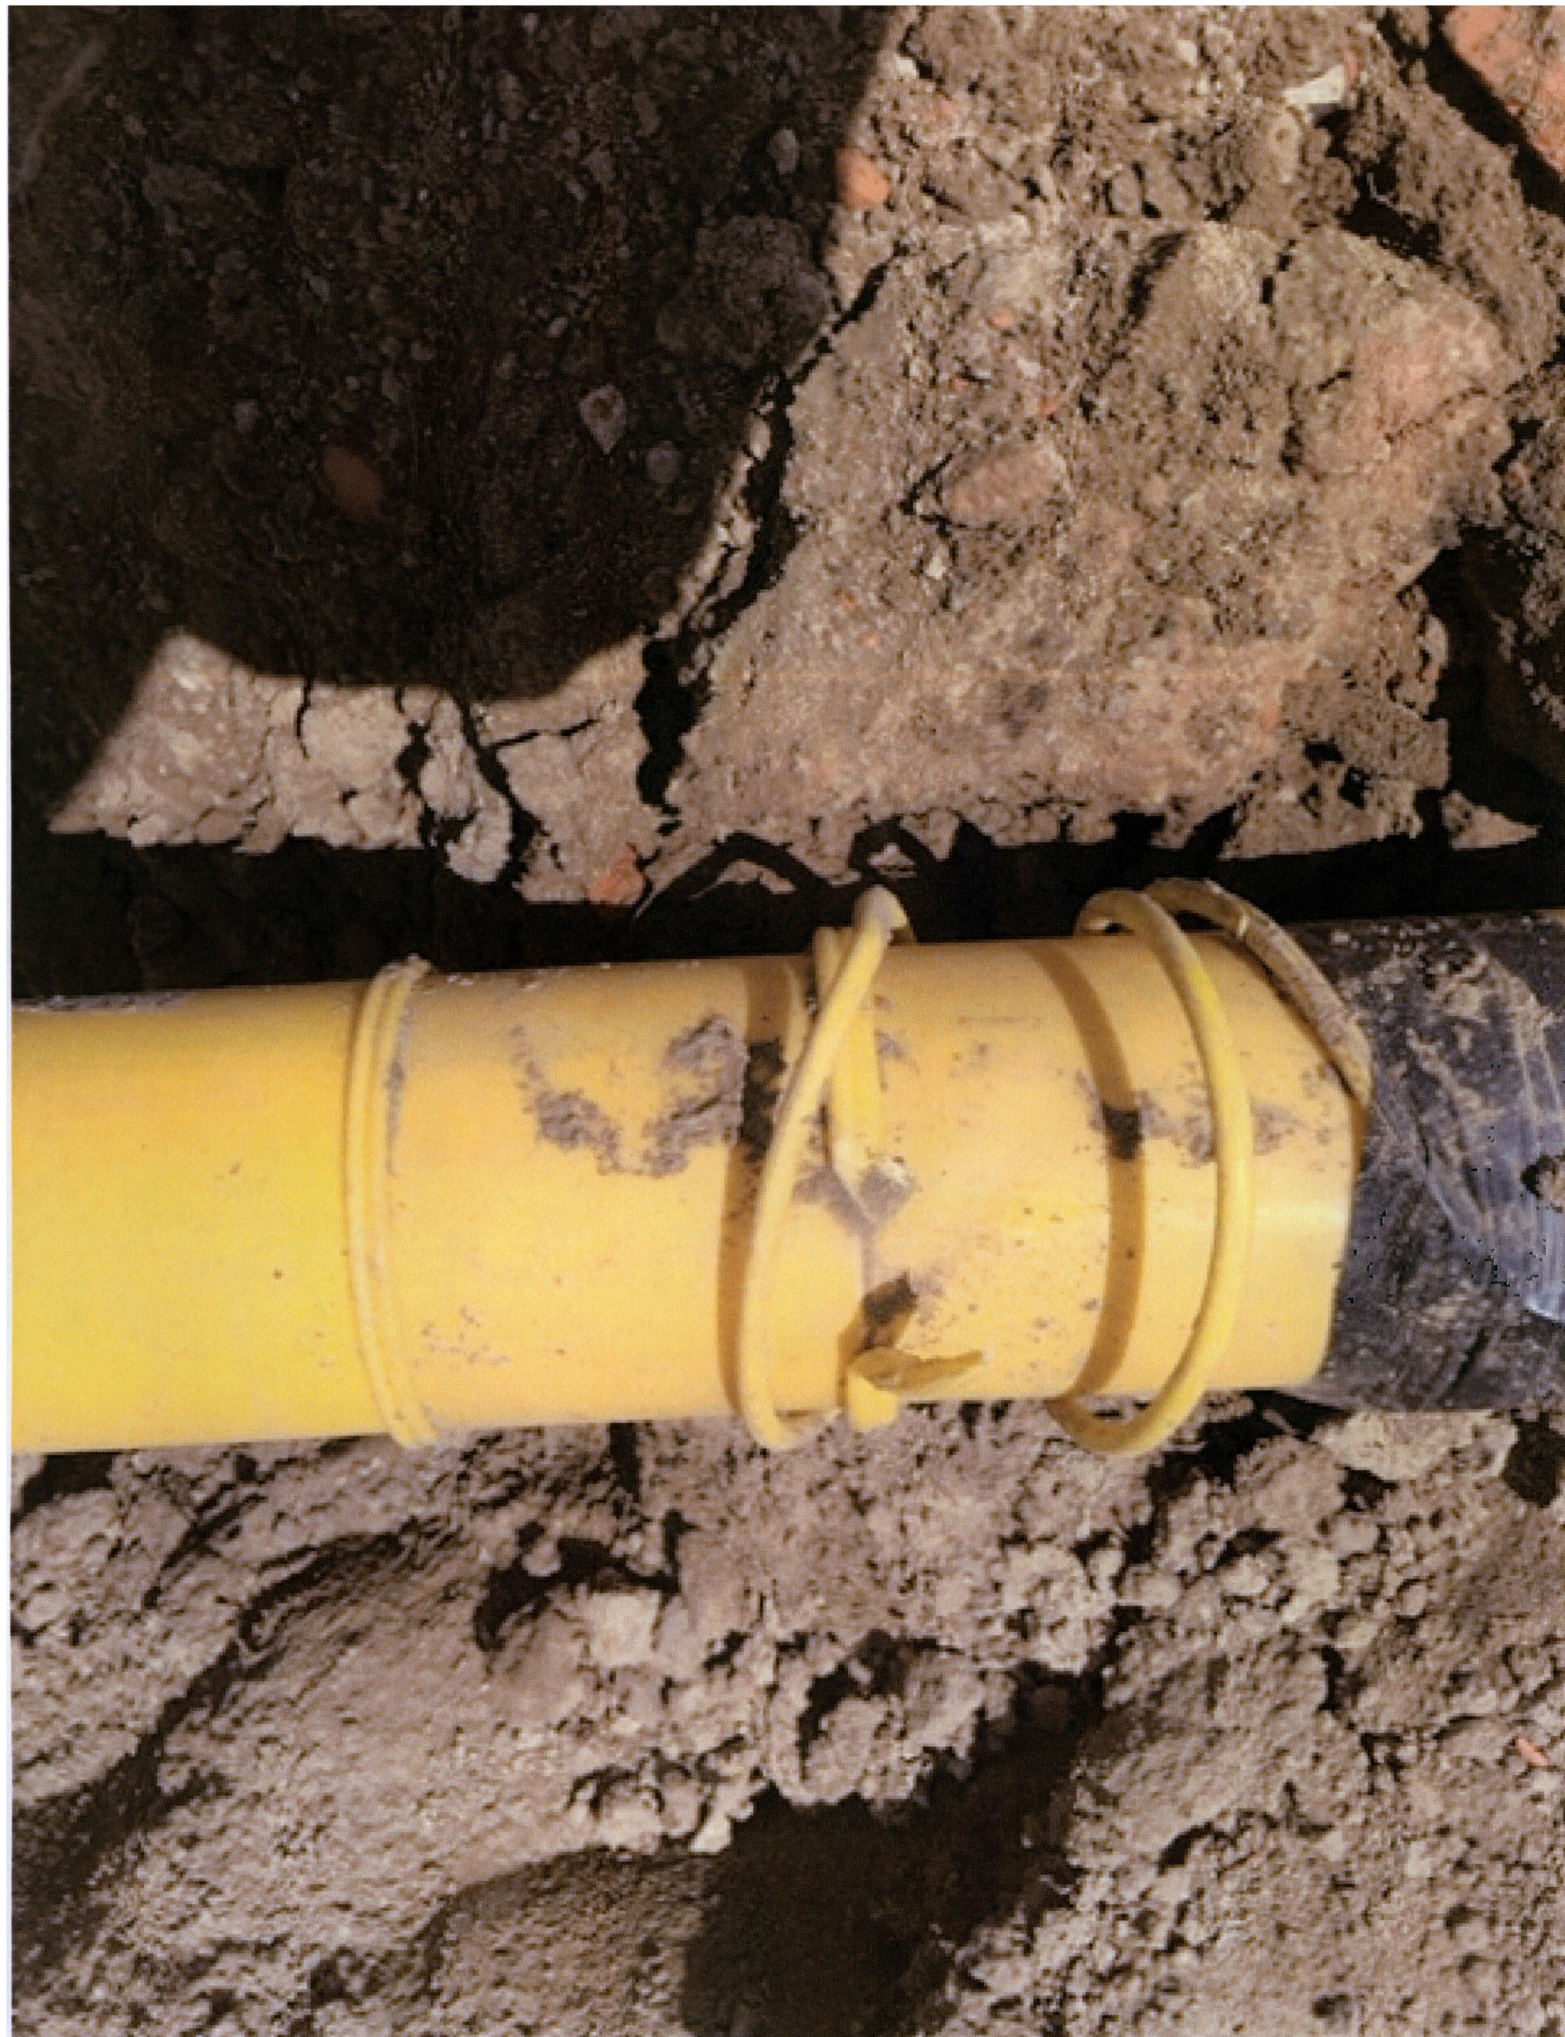
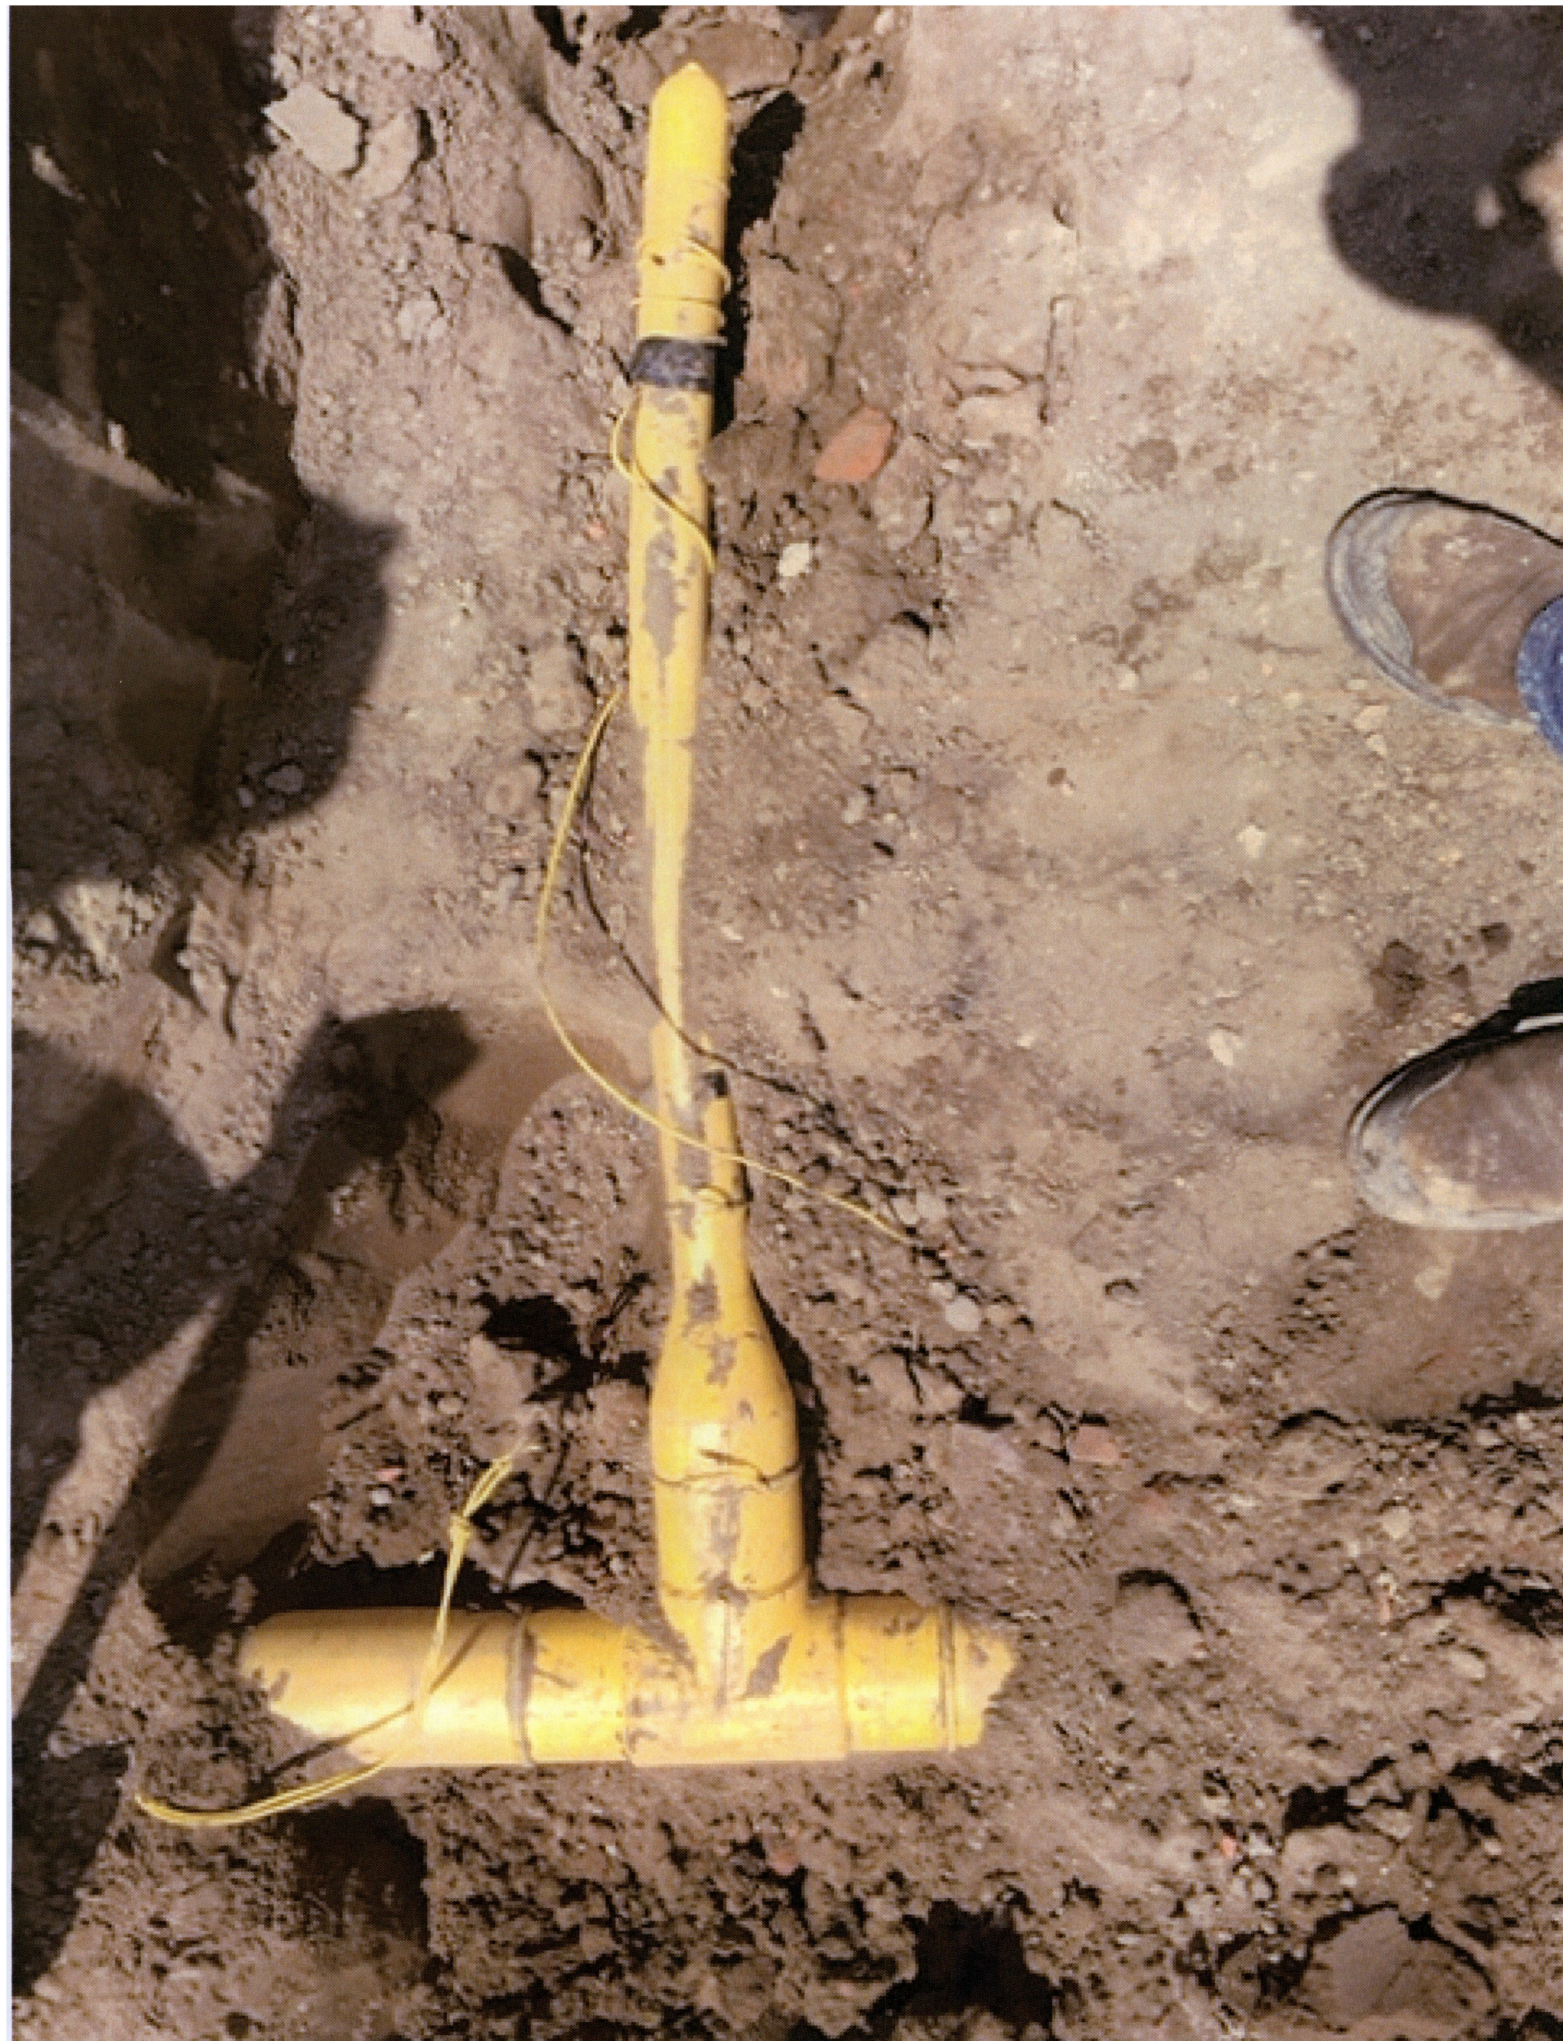
Northern Improvement struck 2" Distribution Gas Main with backhoe while exposing main. Further damage was found to tee where main transitions to 4" Distribution Main. MDU gas crew made a repair, but left 4" main to let Northern Improvement proceed with work. On 7/20/2015 Scott MacLean attended Northern Improvements safety meeting and spoke on safety and integrity of MDU's facilities. Shortly after meeting gas crew was sent to repair 4" gas main where they found extensive damage to 4" main that wasn't reported to MDU. MDU Gas Crew found the damaged pipe while air testing to make the repair. The damage was found where Northern Improvement laid down matting and gravel. Appeared that Northern Improvement tried to cover gas main and hide damage.

Northern Improvement cut off loop fed 2 inch gas main with backhoe

Method of Repair: replace 80' of damaged 4" main, 10' of 2" main
