Structural Monitoring at a Pressurized Grout Remote Backfilling AMLR Project at Beulah, North Dakota

William E. Dodd

North Dakota Public Service Commission
Abandoned Mine Lands Division
600 East Boulevard Avenue
Bismarck, ND 58505-0480

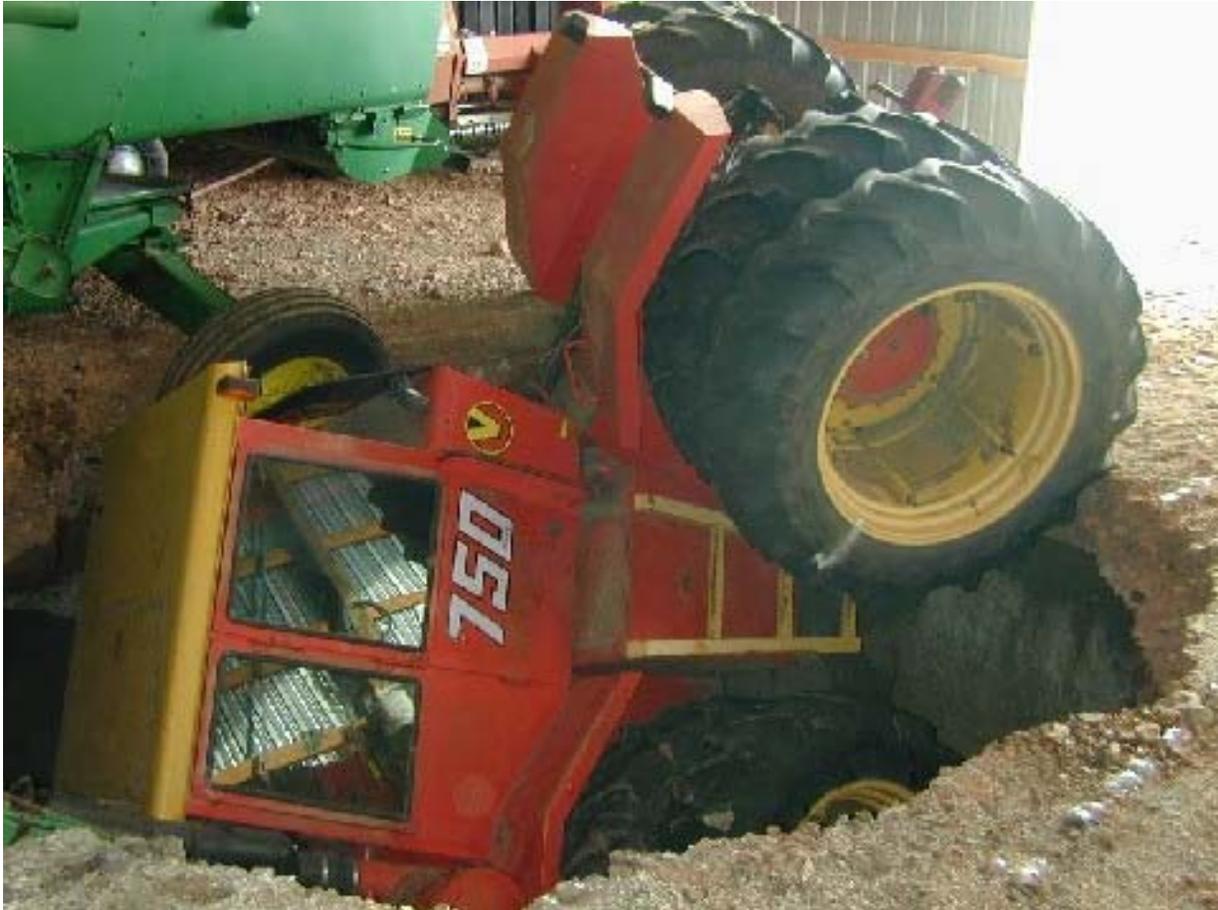
subject of most of the remainder of this paper. As recently as February 2001 two serious sinkholes surfaced in a machine shed about two miles north of Beulah. Figure 1 depicts one of these, about 20' diameter and 12' deep, that “swallowed” a tractor⁷.

Figure 1: Underground mine subsidence “swallowed” this tractor in a machine shed north of Beulah, ND.

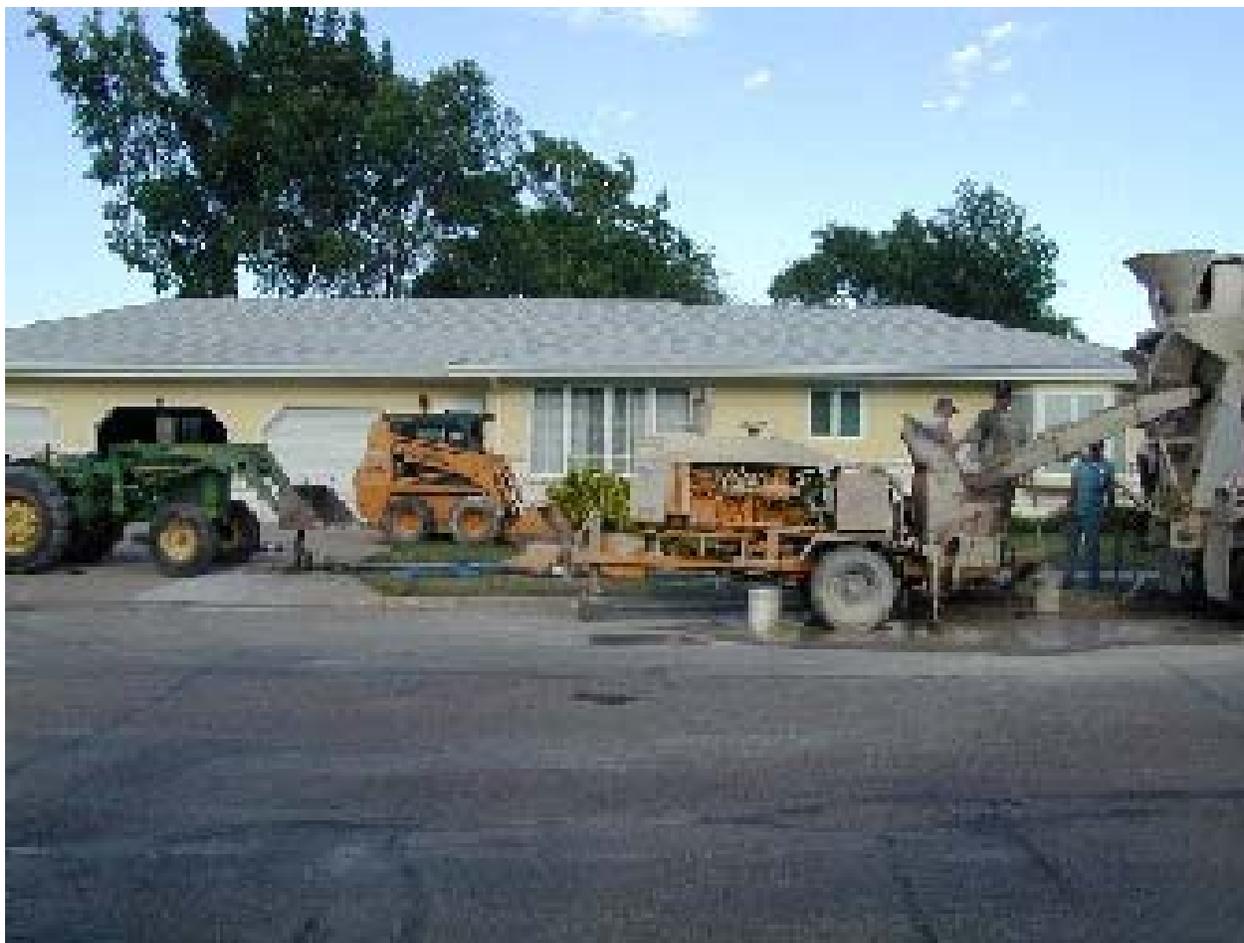
Figure 2: Pressurized grout remote backfilling near the Jack Thielman residence in Beulah.

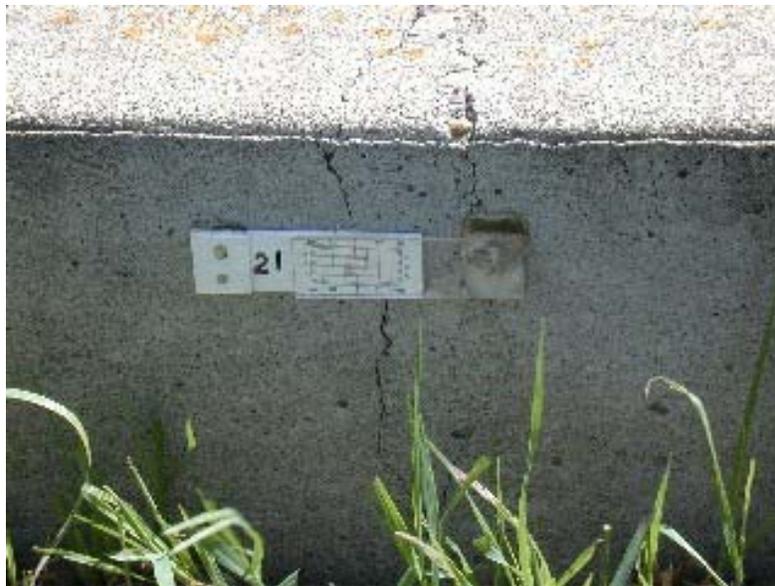
Crack monitors were installed on representative cracks chosen during the visual inspections. Crack monitors are simple gauges used to measure movement of cracks in brick, concrete, and masonry structures. The crack monitors used during this project were purchased from Avongard Products, Ltd., Irvine, CA. Twenty-one crack monitors were installed. Most were installed on the exterior face of foundation walls; one was placed on an exterior slab; three on an interior wall; and one was placed on a retaining wall (see Figure 3). Crack monitors were inspected daily during grout pumping and each inspection was recorded on a crack monitor progress sheet¹².

Figure 3: Crack Monitor installed on a crack in a retaining wall at the Beulah City Site.

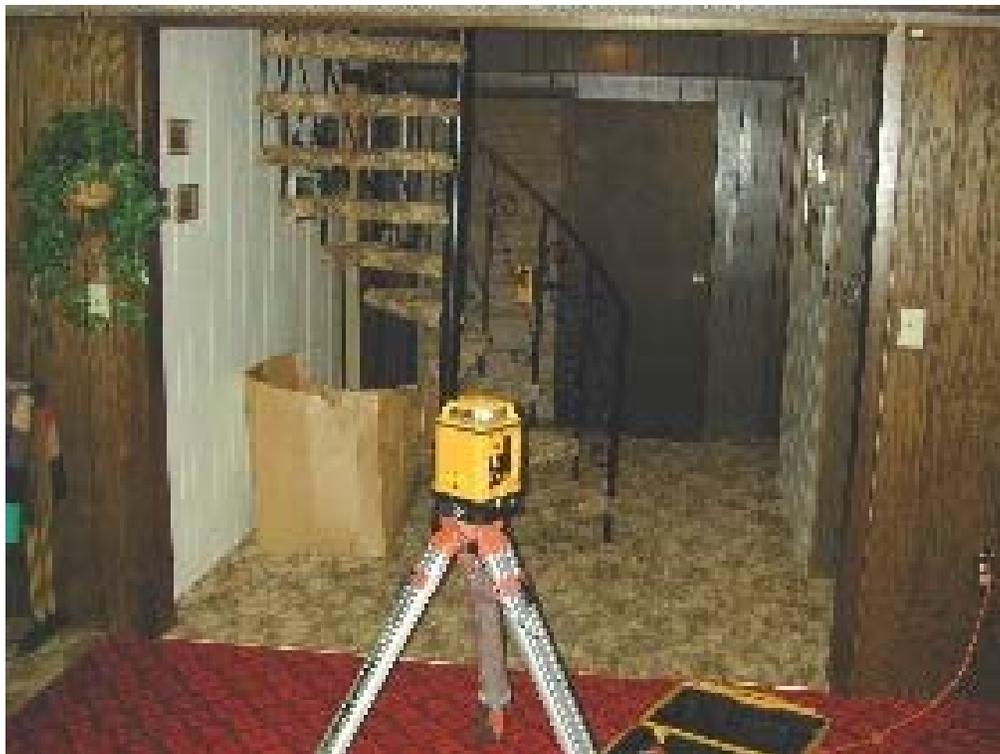
Figure 4: Laser level and target used to monitor structural movement in Thielman's basement.

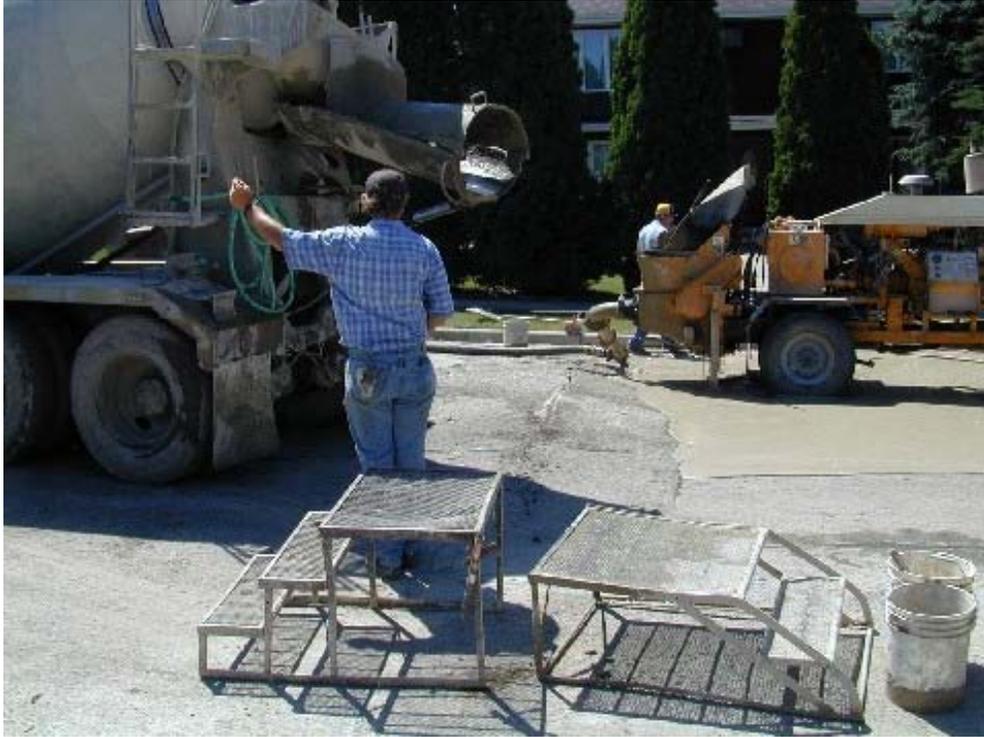
The first instance was in the back yard of a residence and resulted in the “blowout” mentioned earlier. The second was in the back yard of another residence and resulted in a surface bulge about fifteen feet in diameter and one foot high. This caused some damage to a fence and clothesline and required repair. The third instance, which occurred on July 7, 2000, was the most dangerous. It occurred on a city street and caused a bulge in the asphalt surface about twenty feet long, fifteen feet wide and one foot high (see Figure 5). Grout seeped out of cracks in the street. This required extensive cleanup and repairs. Water and sewer mains running under the street had to be checked but fortunately were not damaged. Earlier on June 30, 2000, a loaded mobile mixer truck had dropped a wheel into a sinkhole that caved through the asphalt just a few feet from where the lifting feature occurred (see Figure 6). Each of these lifting features occurred with less than 50 PSI pumping pressure and the last occurred with only 10 PSI.

Figure 5: Surface lifting caused by pressurized grout remote backfilling on 1st Ave. in Beulah.

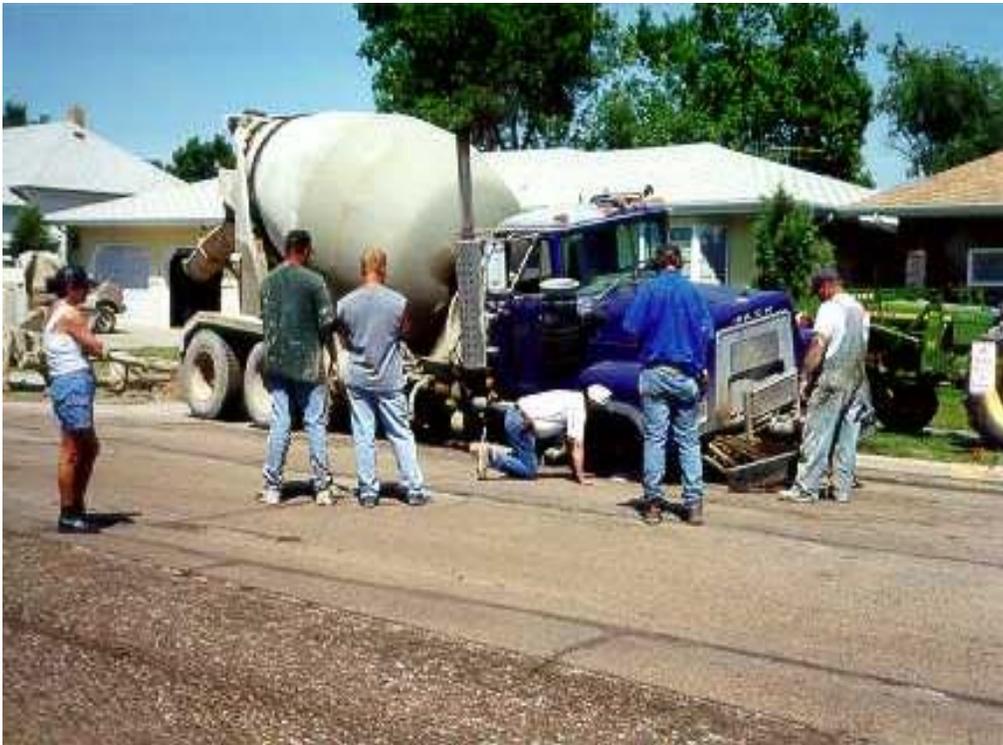
Figure 6: Loaded grout truck dropped its front wheel into a sinkhole on 1st Avenue, Beulah
