Public Service Commission  
Division of Railroad Safety

# Annual Stakeholder Meeting 5/27/2020

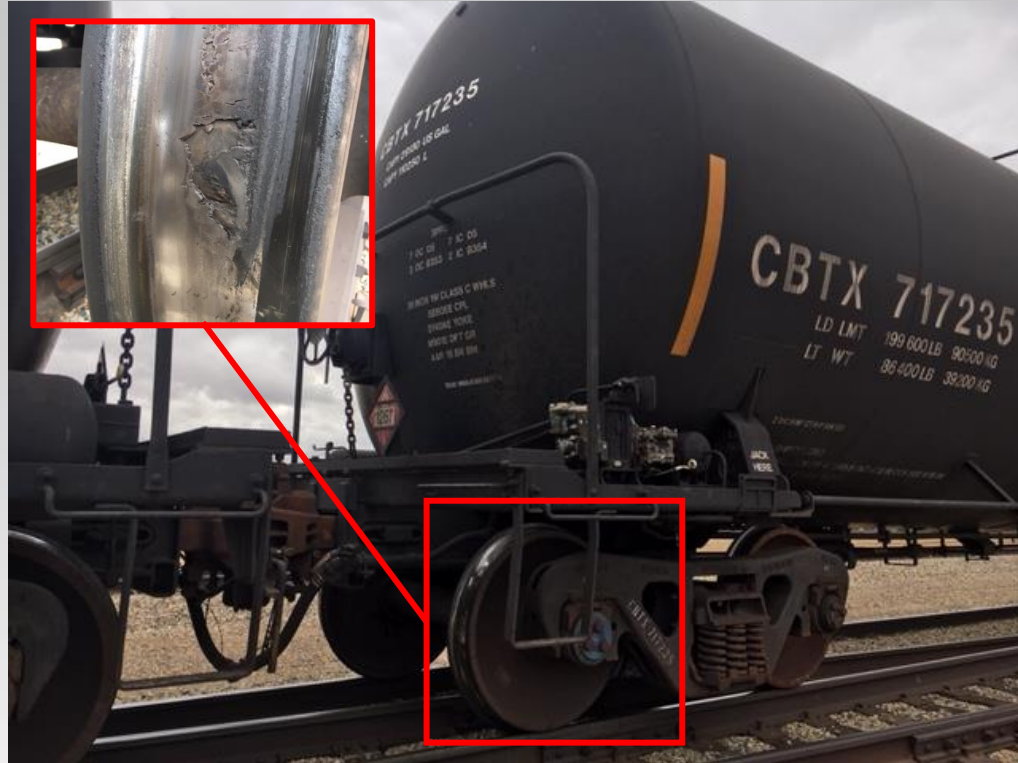
- Oct 24, 2019 Tioga, ND
  - HESS Transload Facility
  - Crude Oil Tank Car CBTX 717235
  - Inspected previously by railroad
    - Tank car was inspected by the mobile inspectors that day and was in line to be loaded for shipment.
  - Defective right number 1 wheel having a shelled spot 2.5 inches or greater

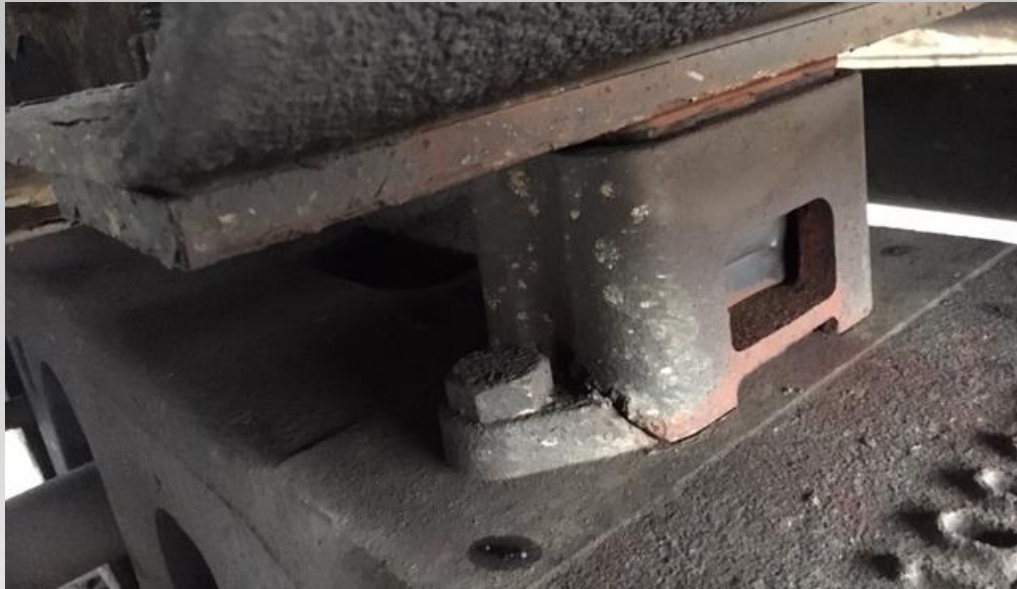
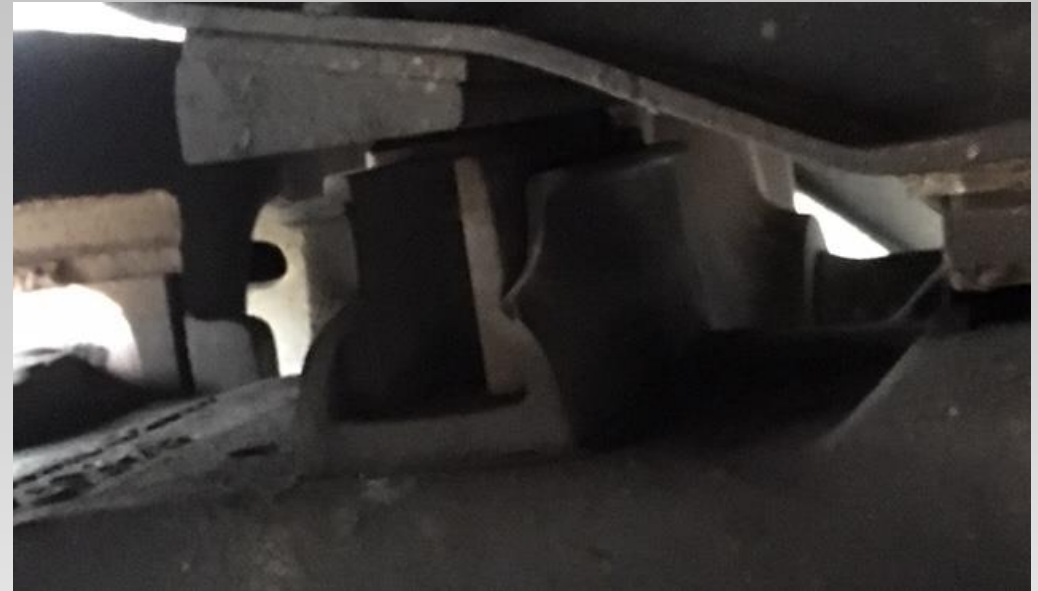
SOO 116590 (Left) and CP 606363 (Right) located in at Rogers, ND on 11/20/19. Identified to have broken side bearings within days of having a mechanical inspection completed. During the inspection conducted by the railroad there were zero defects identified, my inspection of 100 freight cars found 59 total defects on 41 defective cars.

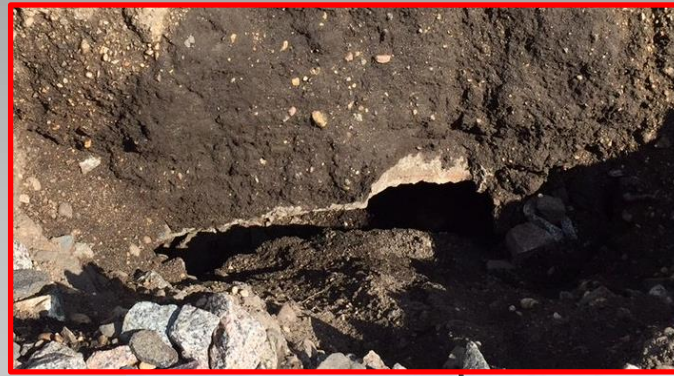
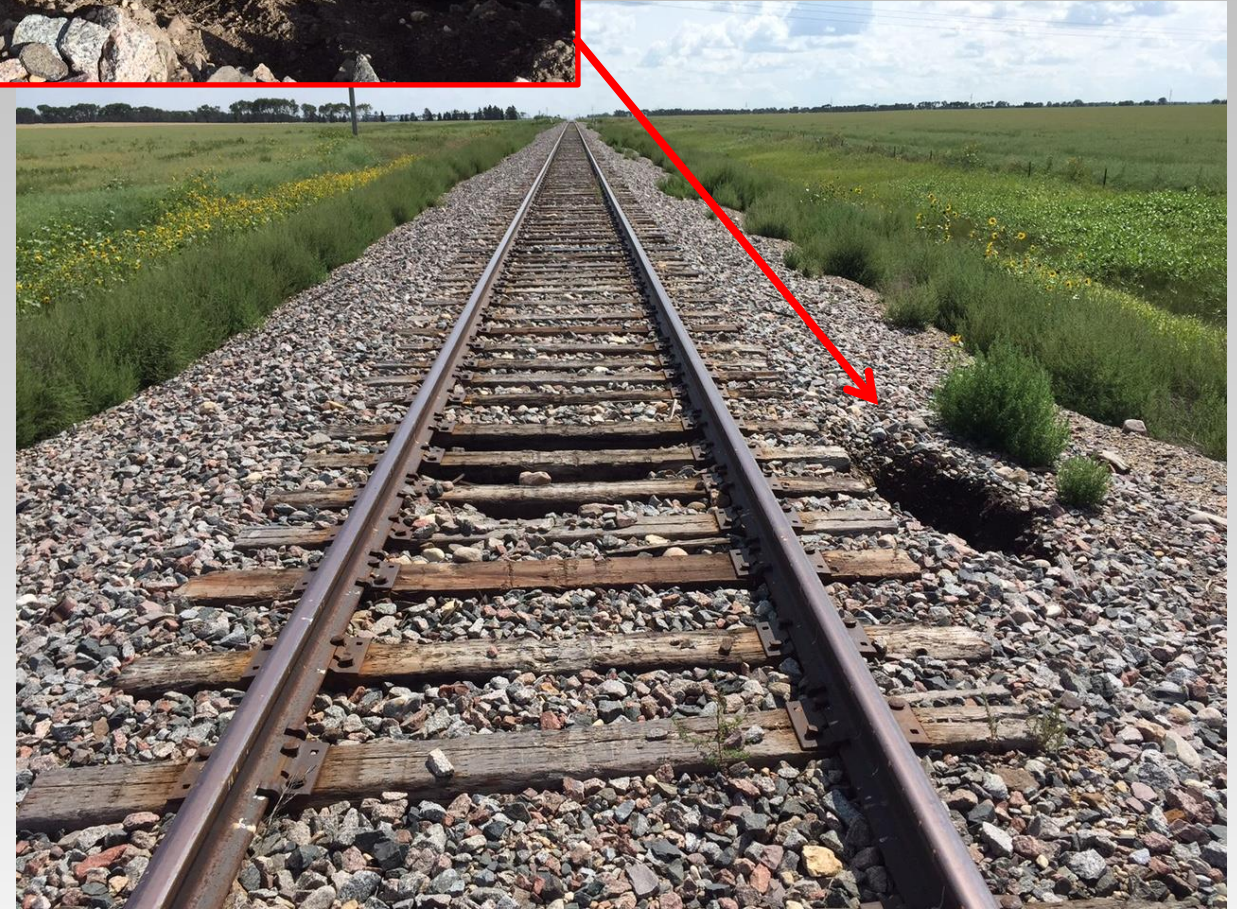
One of the most essential elements of track maintenance is a comprehensive drainage system. Openings under the track are used to channel and divert water from one side of the roadbed to the other. Failure of these drainage facilities, such as culverts can have a significant adverse affect to the track structure. Plugged culverts can lead to saturated or softened roadbed or enough pressure on one side can push out the whole subgrade from under the track. Broken or separated culverts (pictured) can also lead to a plugging of culvert or erosion of ballast and grade used to support the track itself.
