# **Project Summary 2014 Sinkhole Filling Contract AM-679-13**

**North Dakota Public Service Commission  
2013 Sinkhole Filling AML Project Summary  
Fall 2014 Sites**

Project Type:	Surface backfilling of dangerous sinkholes caused by subsidence of underground mines and repair of erosion features
Primary Locations:	Ten properties near the cities of Haynes, Dickinson, Richardton, New Salem, Beulah, Garrison and Wilton, North Dakota
Project Dates:	October 6 to November 14, 2014
Contractor:	Pleasant & Sons Construction of Greenville, KY
Project Cost:	\$81,487 during this period. The total contract cost was \$233,721

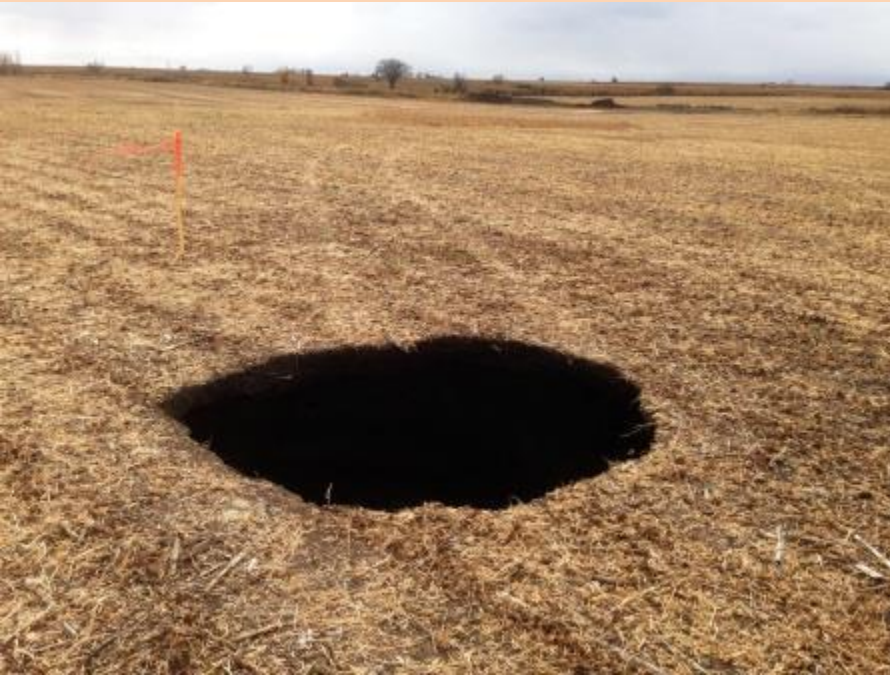
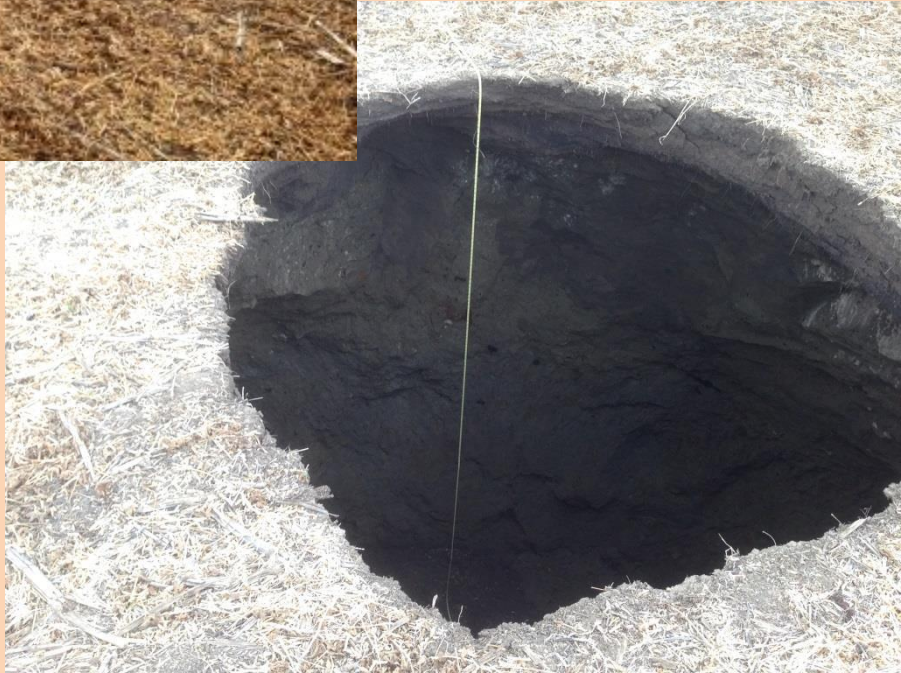
**Cover Photo:** *The cover photo shows a sinkhole on property owned by Garner Sailer, north of Beulah. It collapsed suddenly on October 25 or 26, 2014. It was only 6-8 feet across at the surface but about 16 feet in diameter just below and 18 feet deep. If you look at the first picture, you will see indentations where a vehicle was driven right over where the sinkhole collapsed. Those tracks are mine from when I was staking out nearby sinkholes only a day or two before the sinkhole appeared. I drove over the area just a day or two before the sinkhole collapsed. I was lucky not to have dropped into it. **Sinkholes are a serious hazard.***

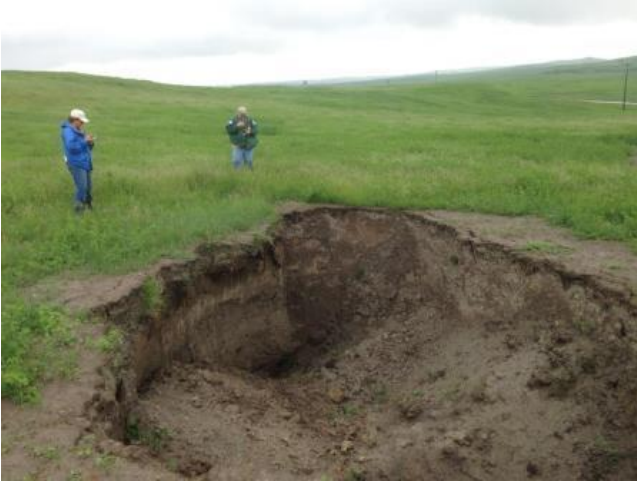
This picture, taken June 11, 2014, shows a dangerous sinkhole at the Haynes site, near the South Dakota border. It was about 30 feet long, 15 feet wide and 10 feet deep.

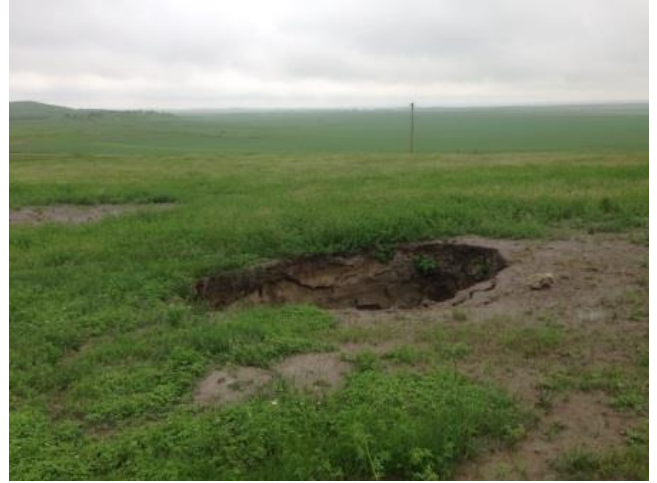
Several of the sinkholes at Haynes were very near where sinkholes had been filled in 2013.

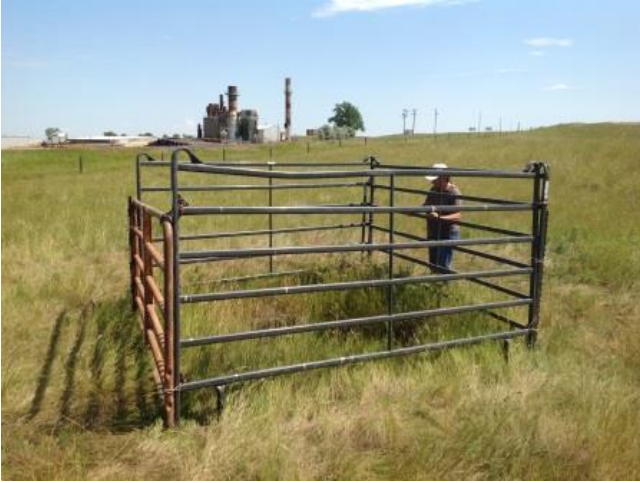
This sinkhole was reported July 1, 2014, by property owner Mike Wolf. He placed gate panels around it to keep livestock out. It was about 13 feet in diameter and 13 feet deep.

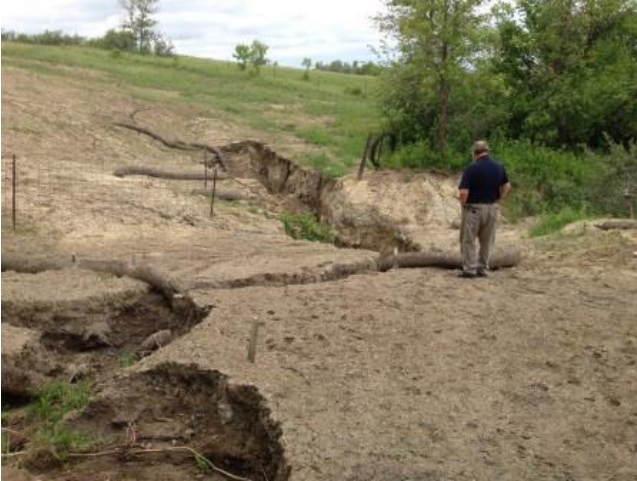
This shows erosion leading to a large sinkhole on property owned by Dave Zimmerman, near Richardton. This was the site where a large sinkhole was filled in 2013.

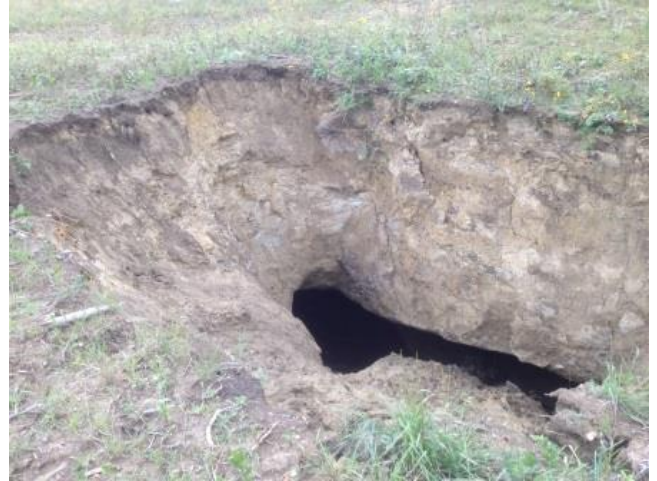
This is a close-up of the sinkhole at the terminus of the erosion features. It was about 25 feet long, 18 feet wide and 22 feet deep.

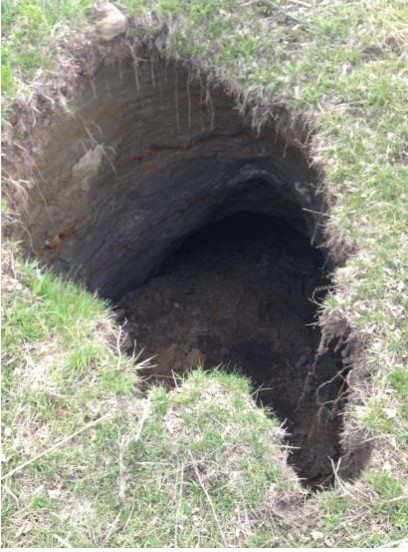
This sinkhole was located on property owned by Rose Marie Gerhardt. It was inspected on May 12, 2014, with renter, Zane Wicks. It was about 6 feet long, 3 feet wide and 12 feet deep.

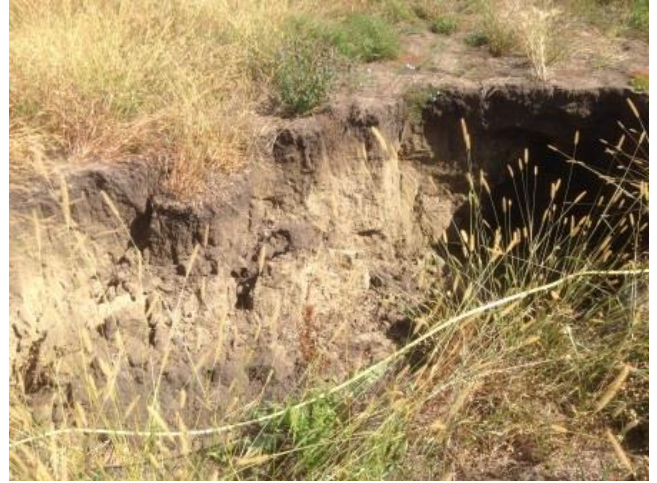
This shows one of the sinkholes in a cropland field at the New Salem Site. It was about twenty feet long, ten feet wide and five feet deep. Seven truck loads of dirt were needed to fill it.

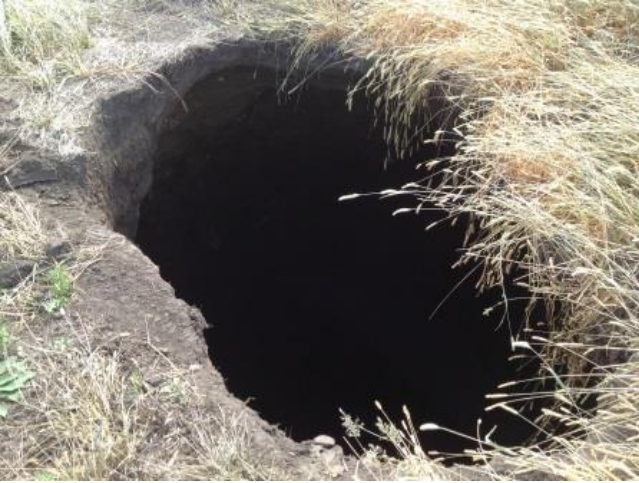
This sinkhole was on a farm trail on Garner Sailer's property located about 2 miles northeast of Beulah. It was over 20 feet deep and a hunter dropped the front wheel of his Suburban into it.

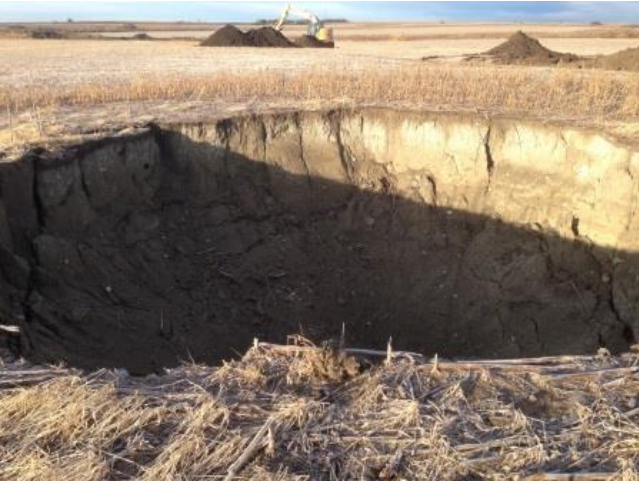
This is another of the sinkholes that were filled on Garner's property. It was about 32 feet in diameter and 12 feet deep.

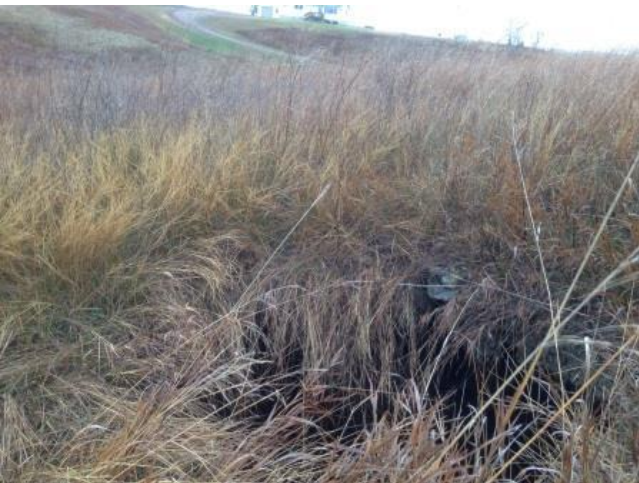
This shows a sinkhole on property owned by Mike Eslinger, north of Beulah. It was about 8 feet in diameter below the surface and 10 feet deep. It was very dangerous because it was difficult to see until you were right on top of it.

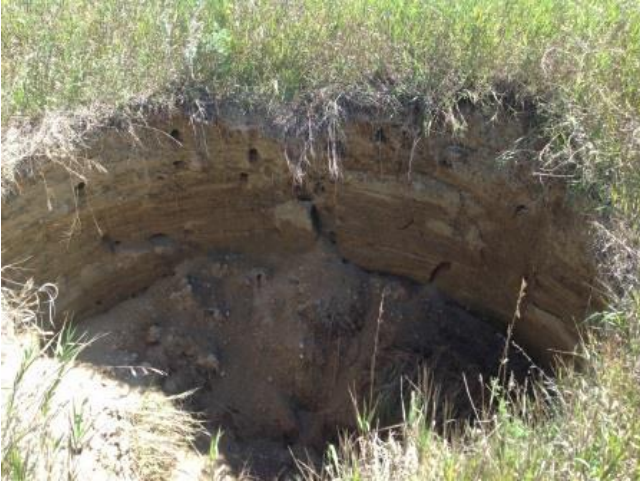
This is a photo of one of the sinkholes at the 2014 Garrison Site, owned by David Mautz. It was about 8 feet across and 8 feet deep.

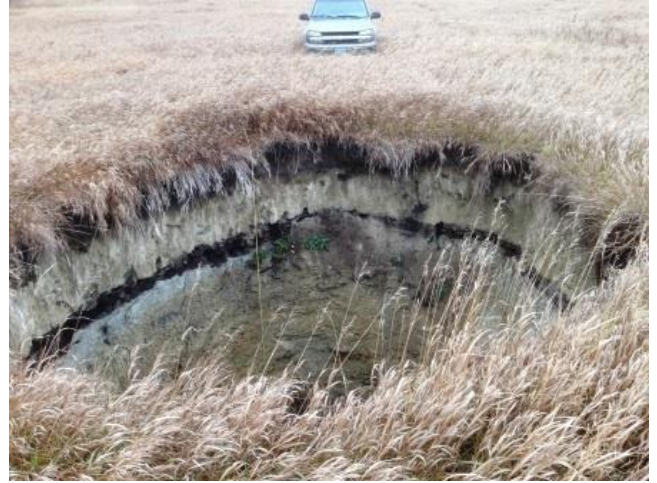
This shows another sinkhole at Garrison, about 18 feet across and 12 feet deep. Note the coal stringer 3-4 feet below surface. These sinkholes were close to businesses on the south side of Garrison.

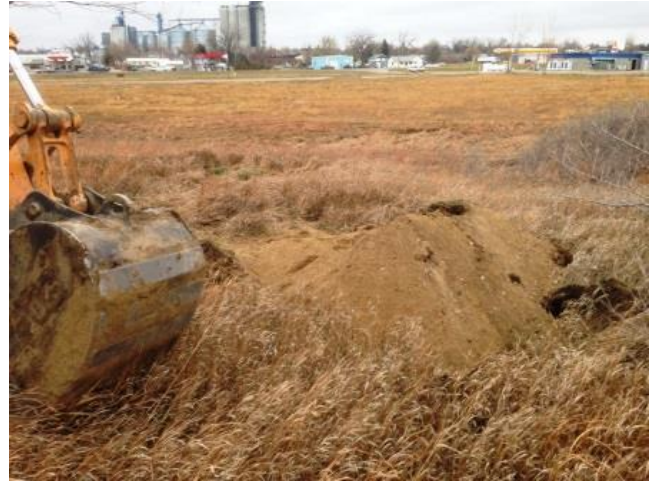
This shows the proximity of Garrison to the sinkholes. The gas station in the upper right hand corner is about 300 feet from the sinkhole.

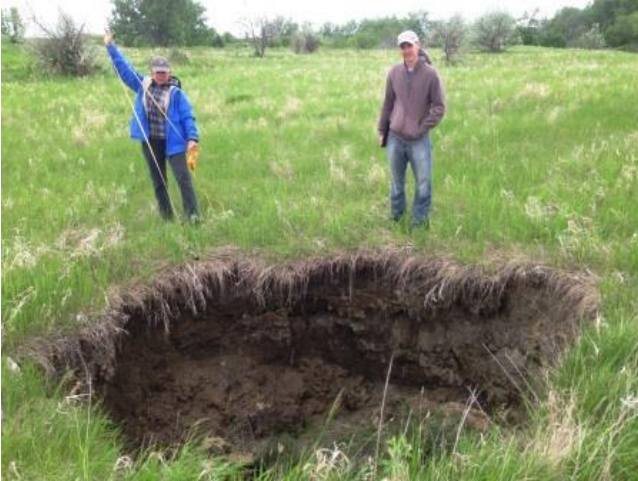
This photo shows two AML Division employees measuring a sinkhole on property owned by Betty McGinnis about 3 miles southeast of Wilton. It was about 12 feet across and 8 feet deep.

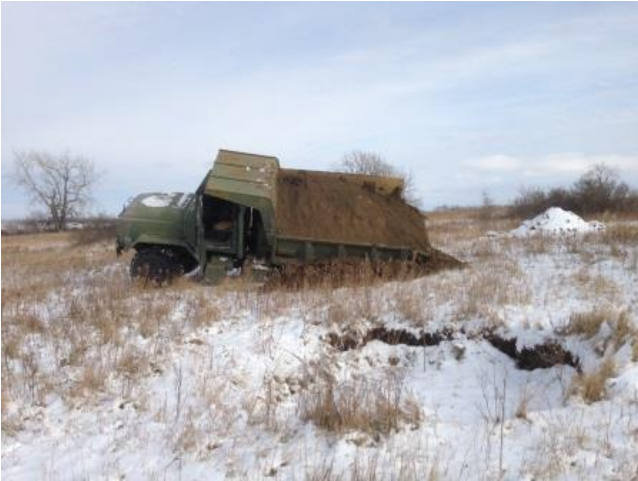
This sinkhole, on Jim Krzmarzick's pasture, was found when the back wheel of a loaded truck dropped into it.

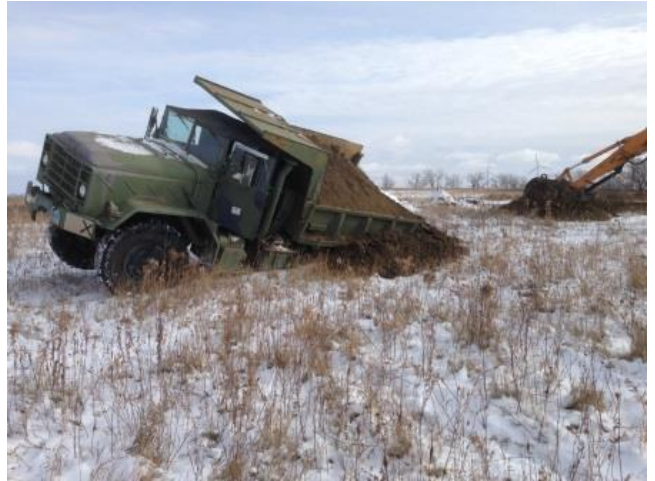
The contractor removed most of the soil from the truck with an excavator and pulled it out of the hole.

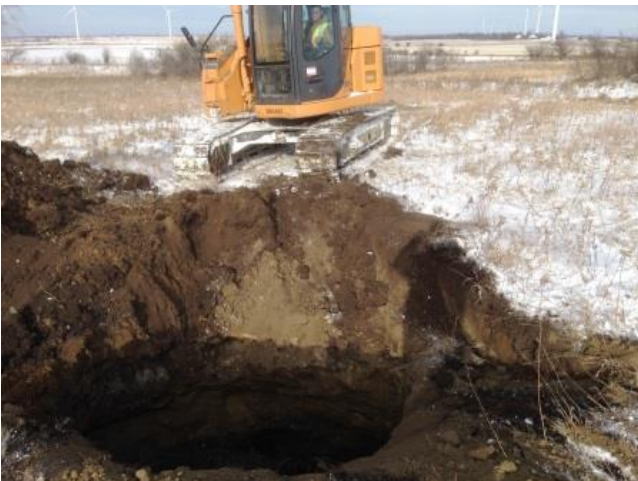
This is the same hole after the truck was pulled out and topsoil was removed. It was about 12 feet across and 10 feet deep. No one was injured and the truck was not damaged. A close call.
