Project Summary 2015 Sinkhole Filling Contract AM-720-15

January 2016

**North Dakota Public Service Commission
2015 Sinkhole Filling AML Project Summary**

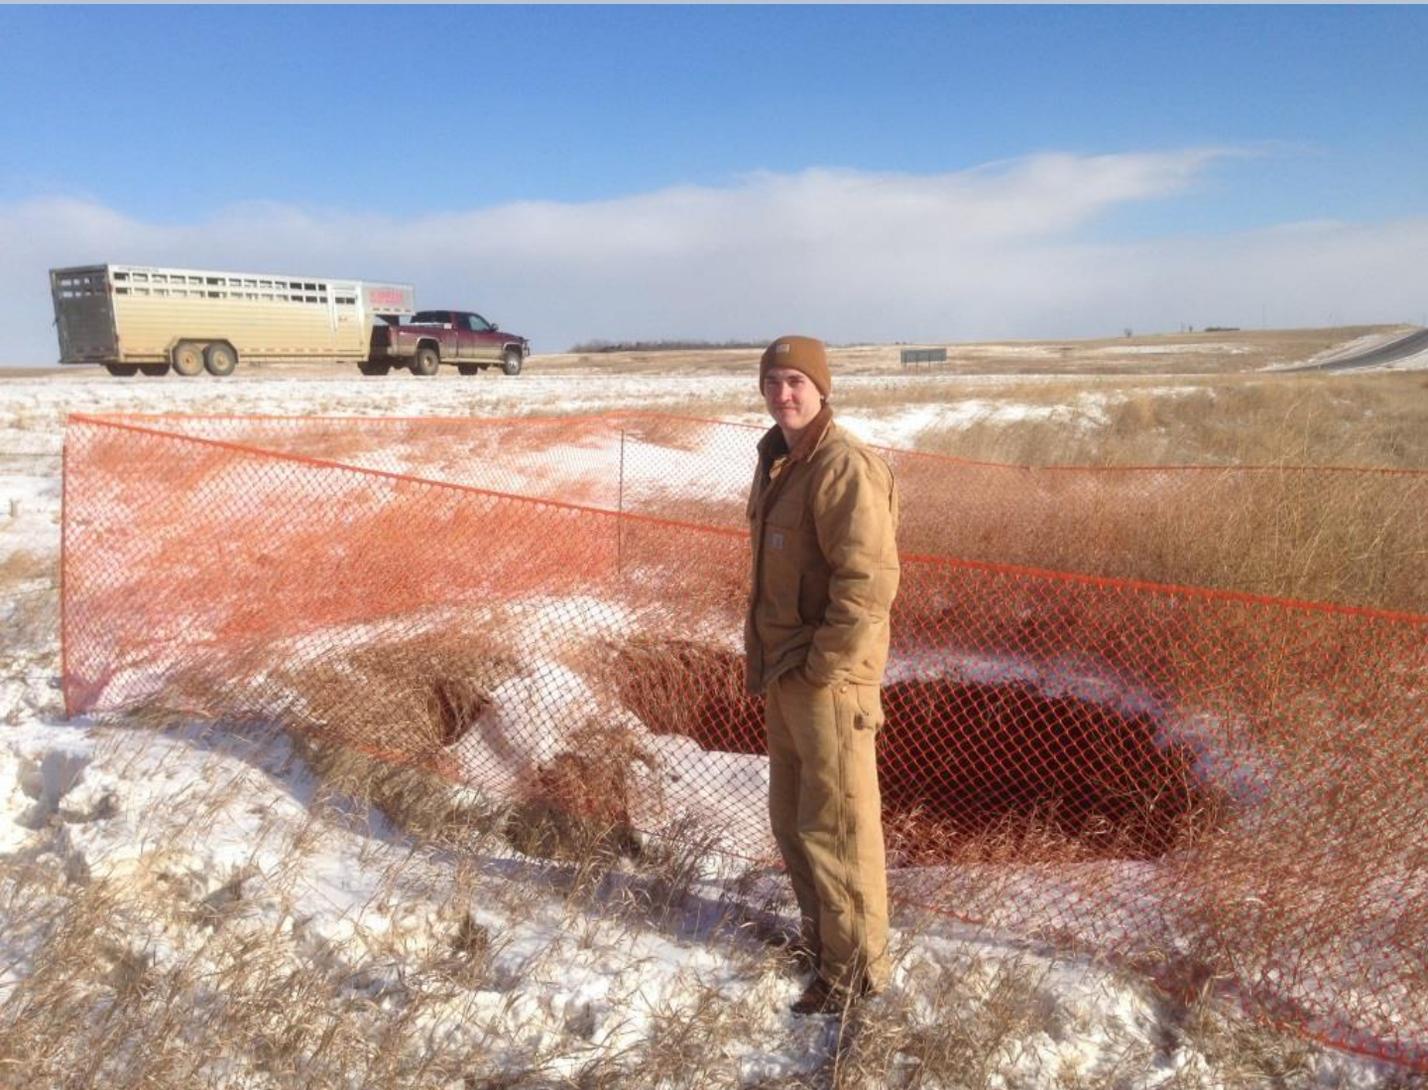
Cover Photo: *The cover photo shows Matt Fischer, NDPSC, standing near a sinkhole on the south ditch of North Dakota Highway 200, about a mile north of Beulah. It was reported by Russ Duppong, Beulah City Administrator, on January 14, 2015. A fiber-optic cable was exposed in the hole and the owner of the cable, West River Telephone constructed a safety fence around the sinkhole. This sinkhole was about 13 feet diameter and 8 feet deep. It was filled and reclaimed on June 24, 2015.*

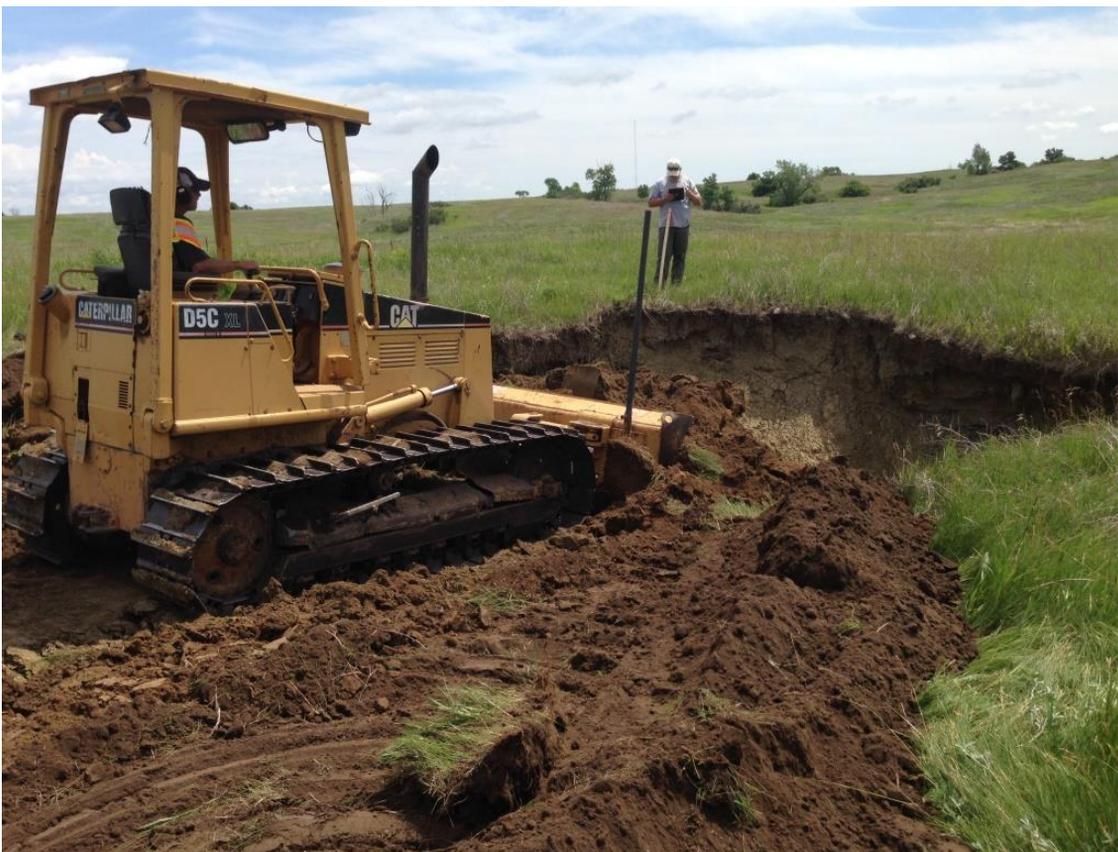
This dangerous sinkhole was located on property owned by Mike Dettman just east of Beulah. Fourteen sinkholes were filled on Mike's property and twenty six sinkholes were filled near Beulah on June 24-26. The approximate cost at Beulah was \$11,622.

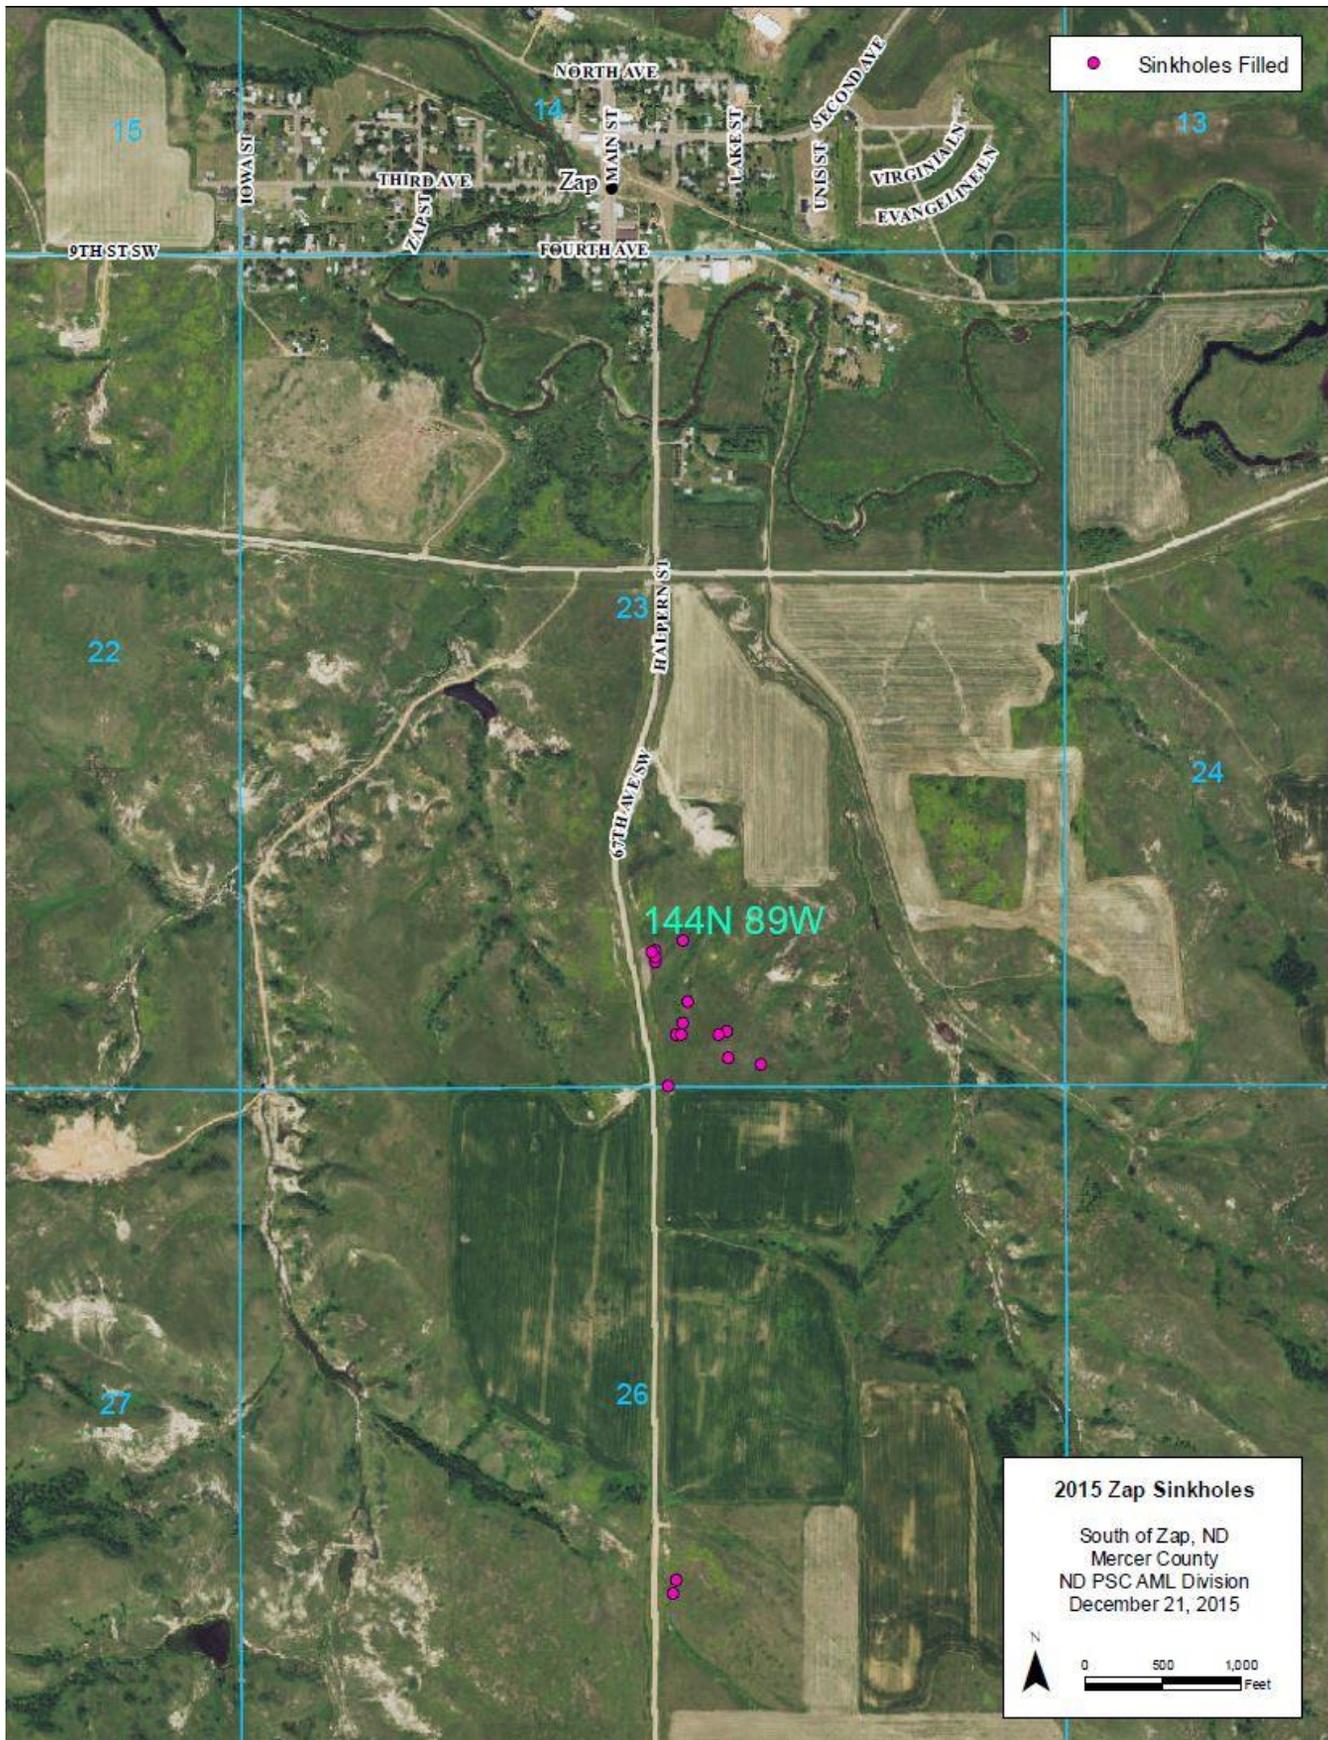
2015 Sinkhole Filling Approximate Locations of Sinkholes at Zap Sites

● Sinkholes Filled

2015 Zap Sinkholes
South of Zap, ND
Mercer County
ND PSC AML Division
December 21, 2015

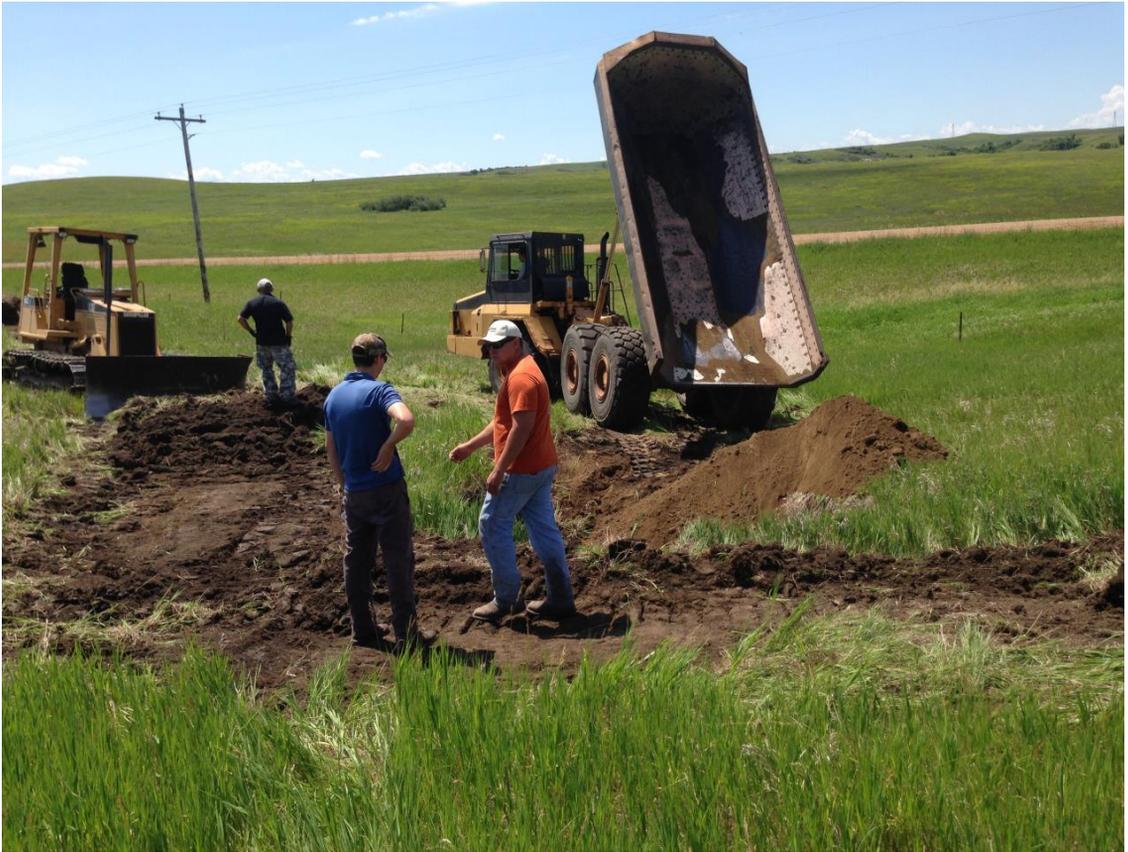
This shows the filling of a sinkhole on the east side of Mercer County Road 13, about 1½ miles south of Zap on June 26. Sixteen sinkholes were filled at the Zap sites and the approximate cost was \$3603.

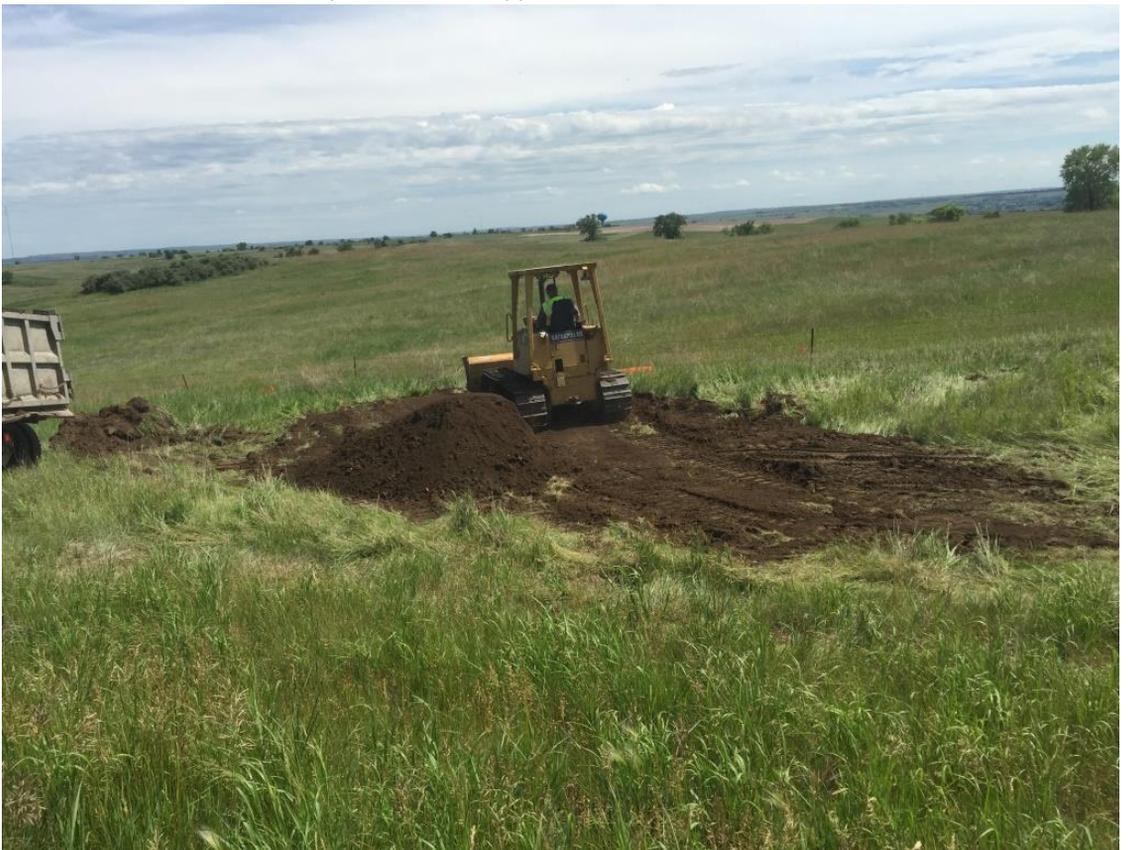
This shows a bulldozer respreading topsoil on a reclaimed sinkhole near Zap prior to seeding. All sinkholes at this site were tilled and seeded to a native grassland seed mix.

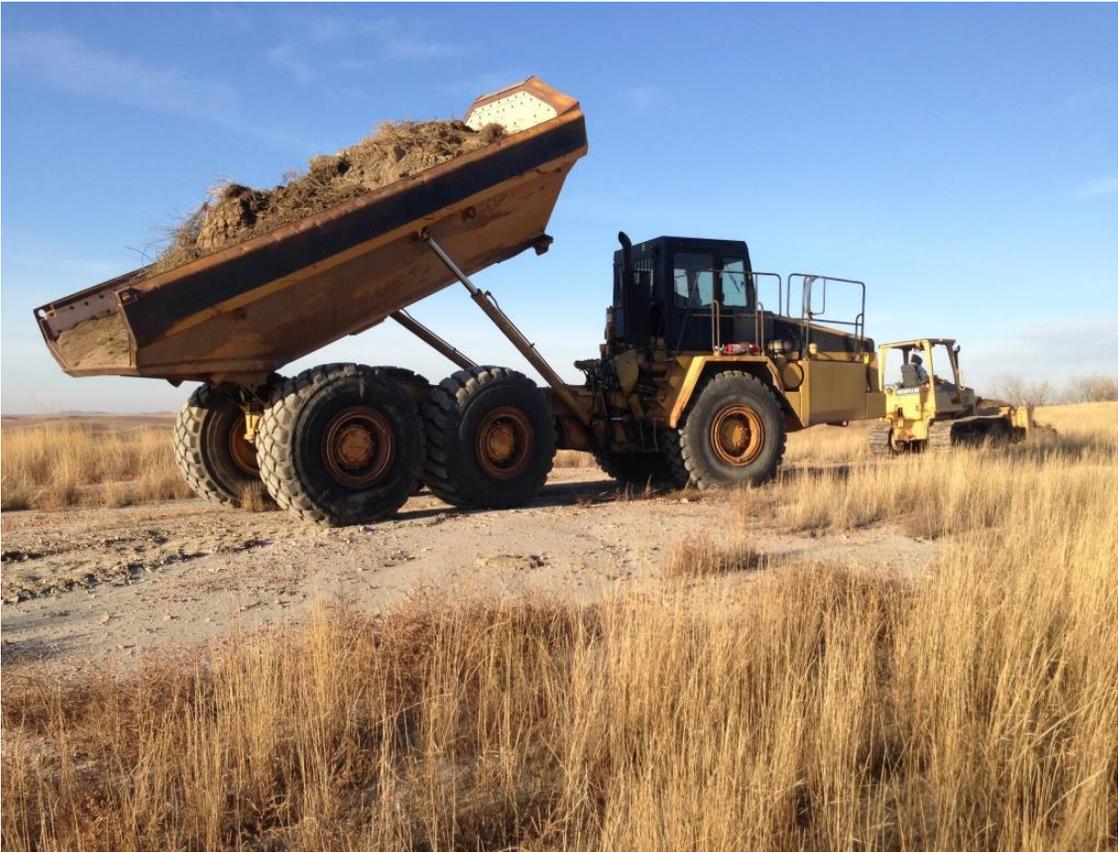
This shows a truck dumping topsoil on a barren spot at the Richter abandoned surface mine site, reclaimed in 2013. The site is located just south of I-94, exit 113, about 8 miles northeast of Glen Ullin. This maintenance work was done on October 19.

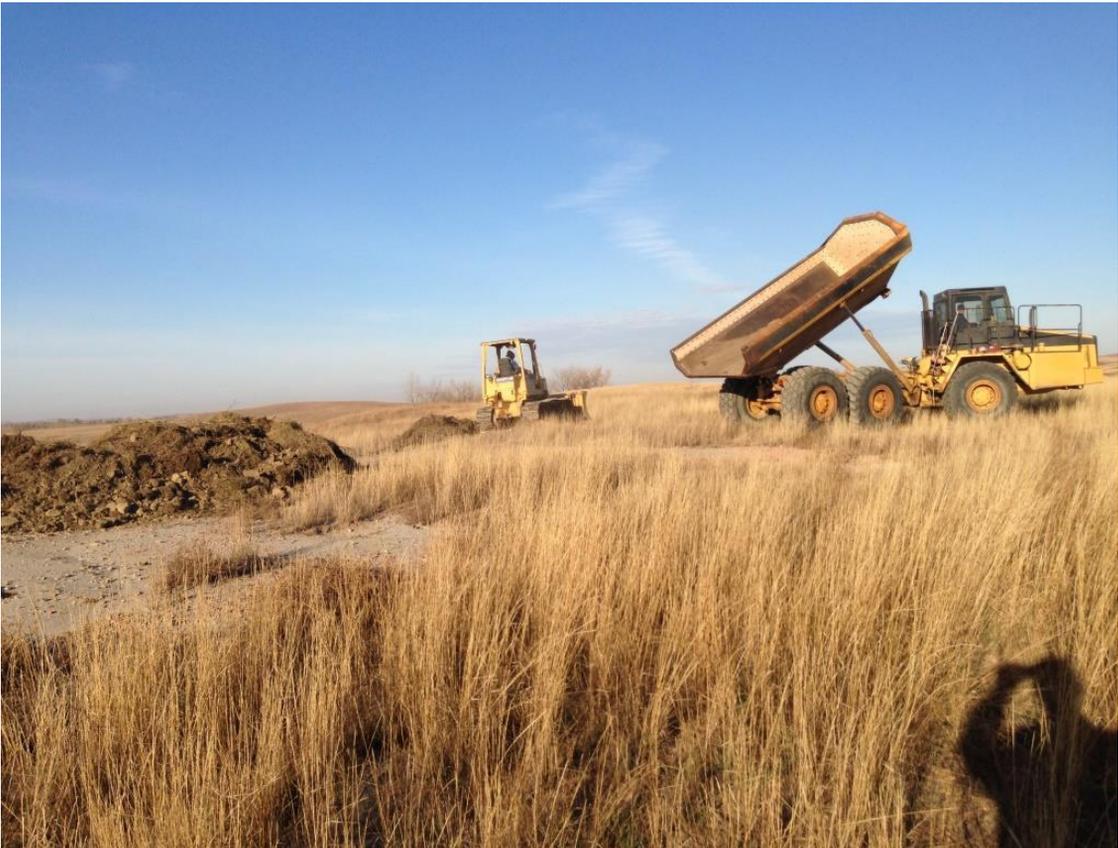
Approximately 222 cubic yards (about 20 truckloads) of topsoil and other suitable strata were respread on eight barren spots, comprising about one acre of this 55 acre site. All areas were tilled and seeded to native grasses. The cost was \$4000.

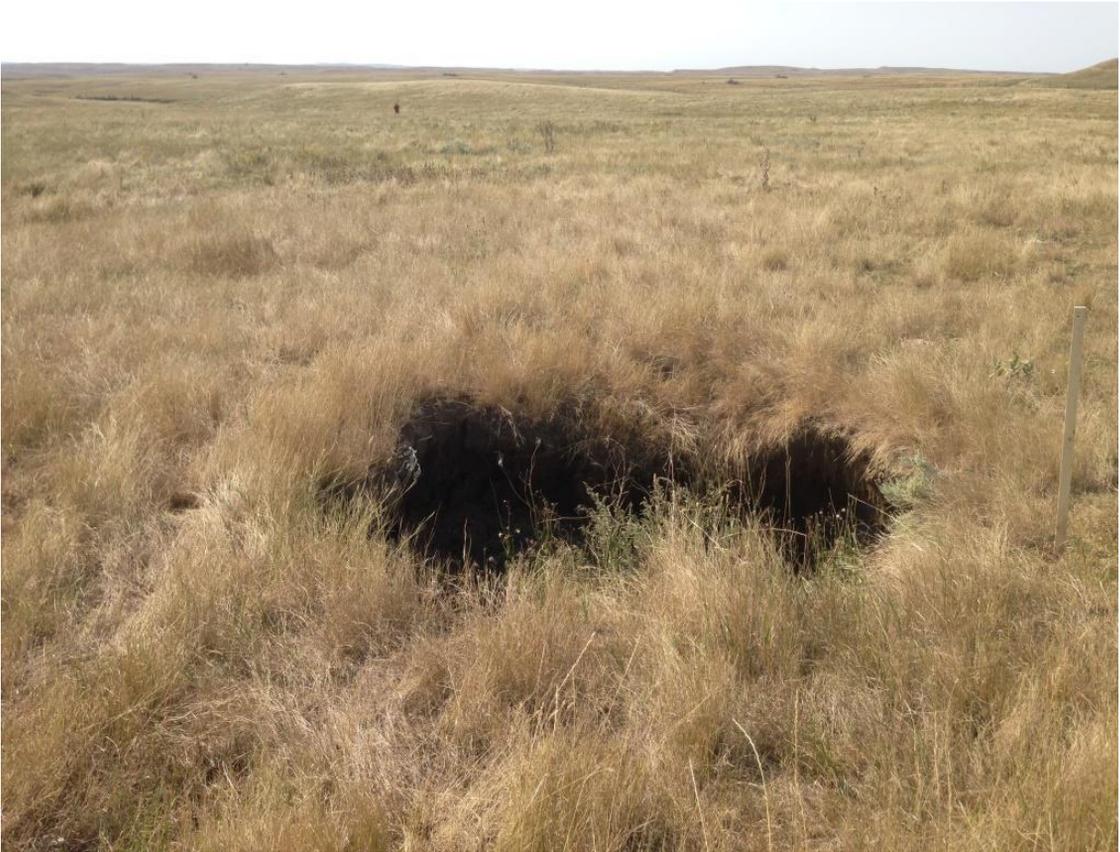
This shows one of the sinkholes at the New Leipzig site, approximately five miles northwest of the City of New Leipzig. This hole was about eleven feet in diameter and five feet deep. Tall grass made it difficult to see and very dangerous.

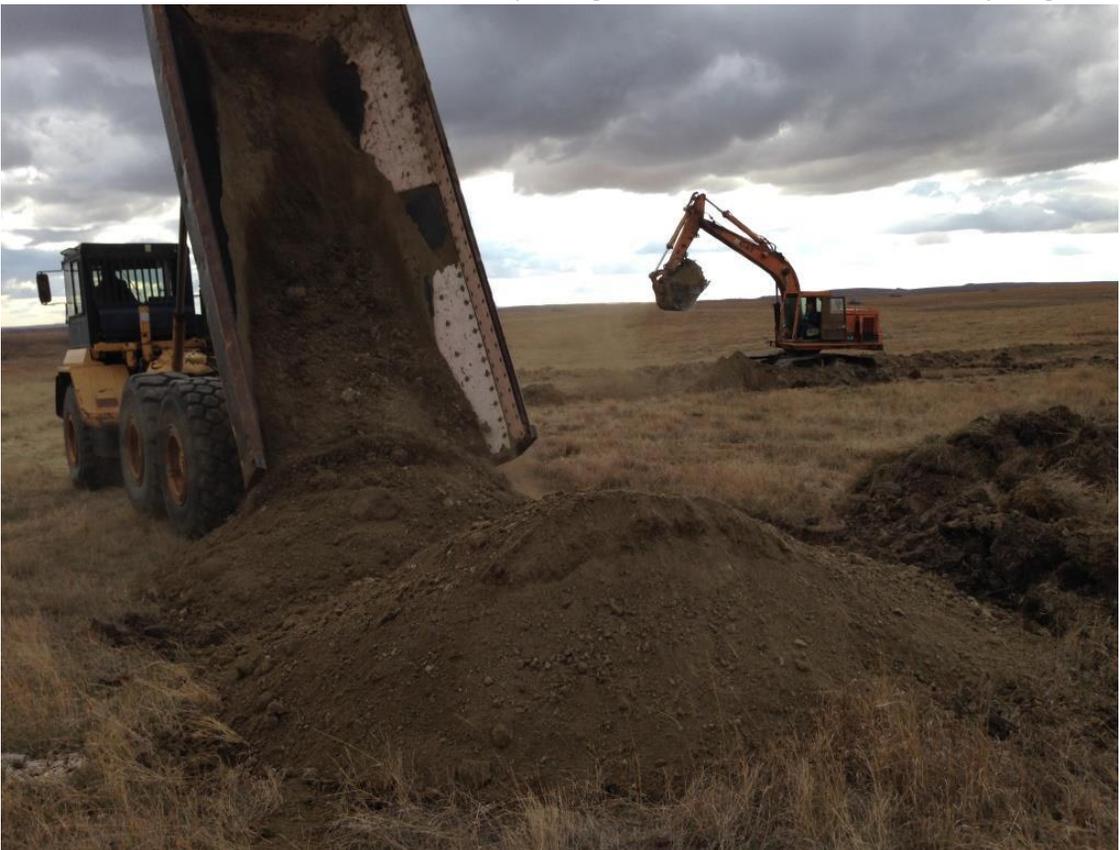
Sixteen sinkholes were filled at the New Leipzig site on October 20-21. Topsoil was saved and respread and all reclaimed areas were seeded to native grasses. The cost for this work was \$4065.

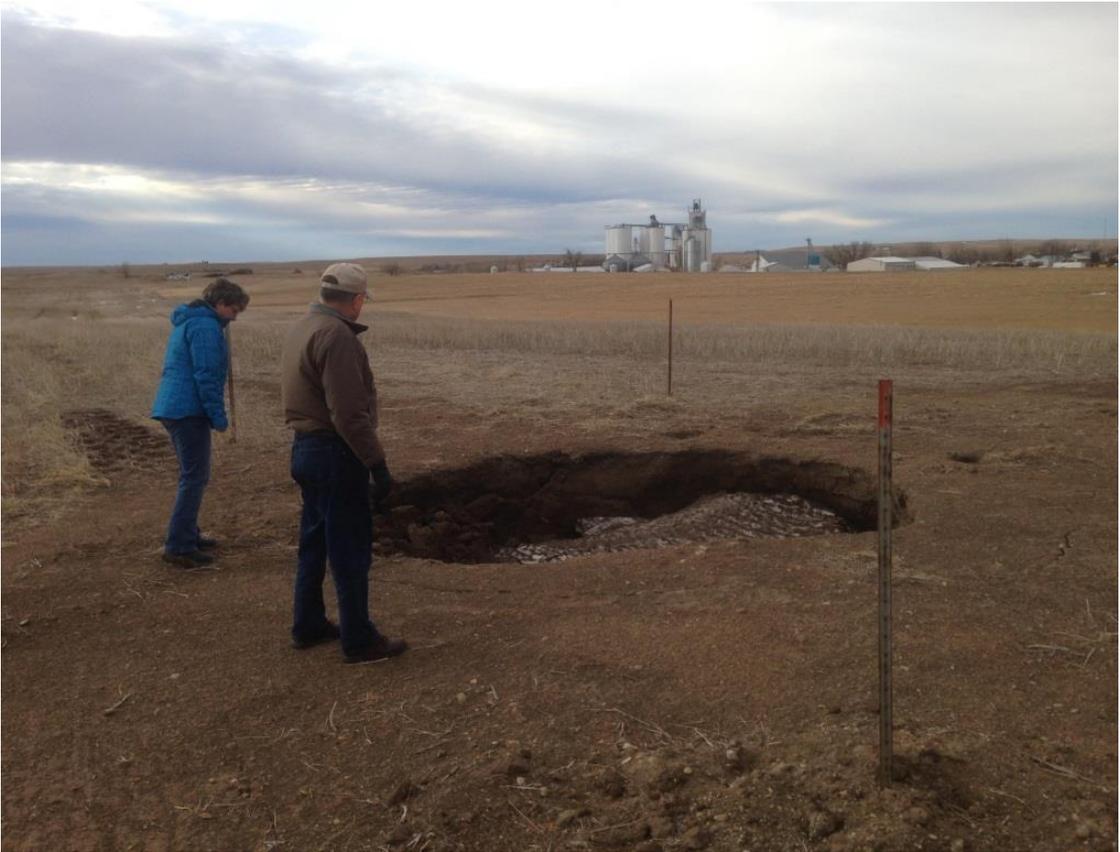
This photo was taken of a sinkhole on Tracy Schumacher's property, east of Scranton Equity Exchange, on January 28, 2015.

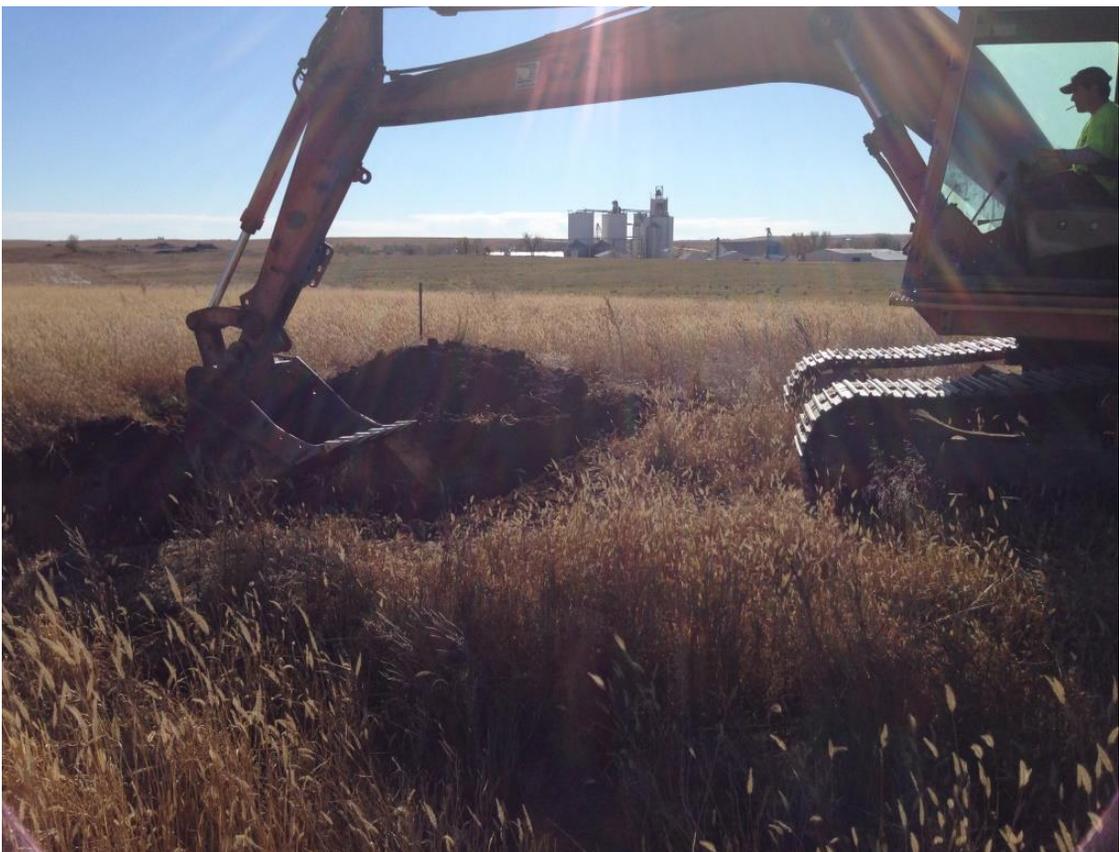
This shows the same sinkhole as it was being excavated and filled on October 21, 2015. Six sinkholes were filled on three properties near Scranton and the cost for this work was \$3130.

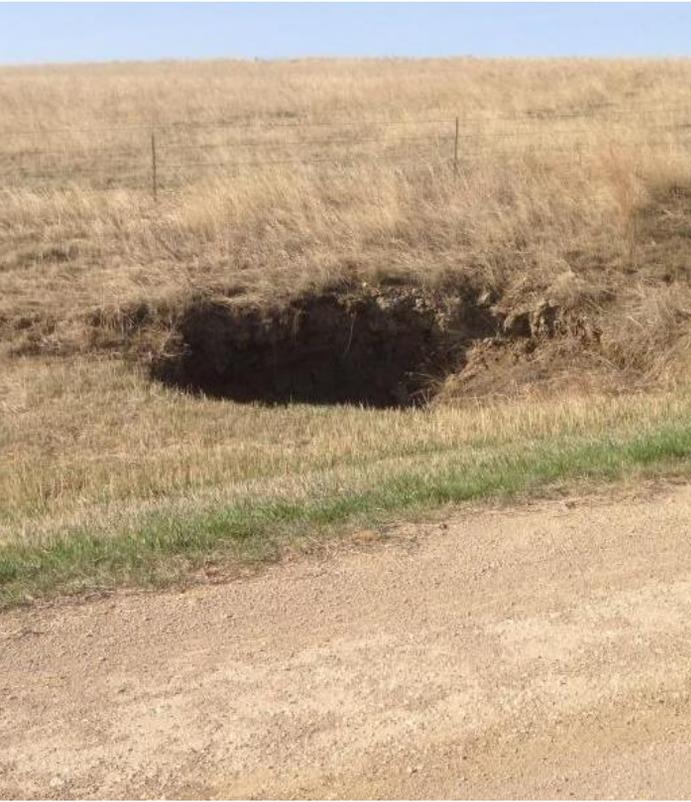
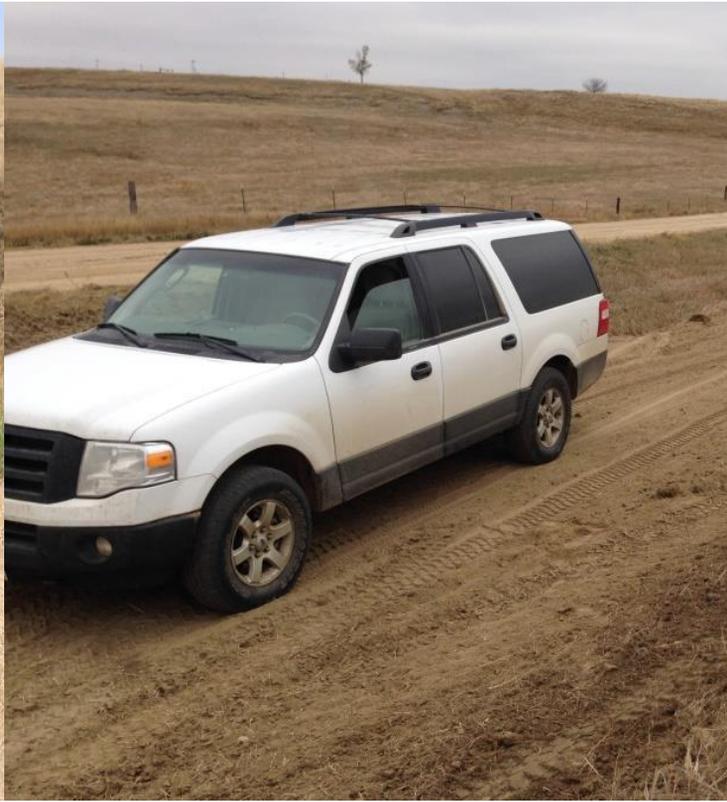
These are before/after photos of a sinkhole on the ditch of 38th Street Southwest, 3 miles southeast of Dickinson. Arnie Binek reported this sinkhole on March 17 and it was reclaimed October 29. It was about 18 feet long, 12 feet wide and 9 feet deep.

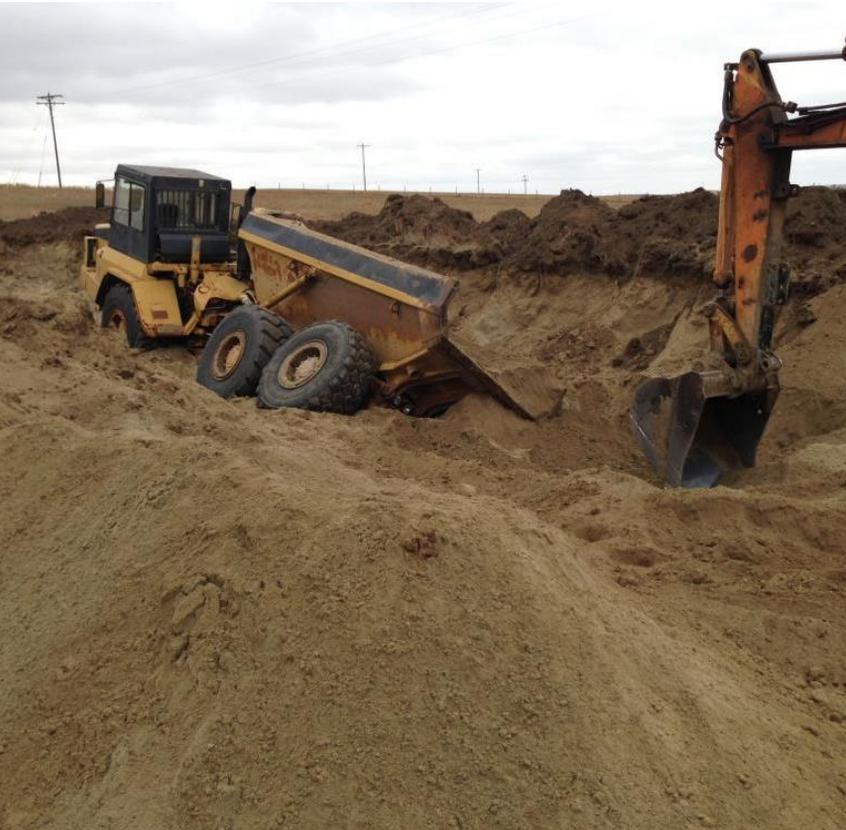
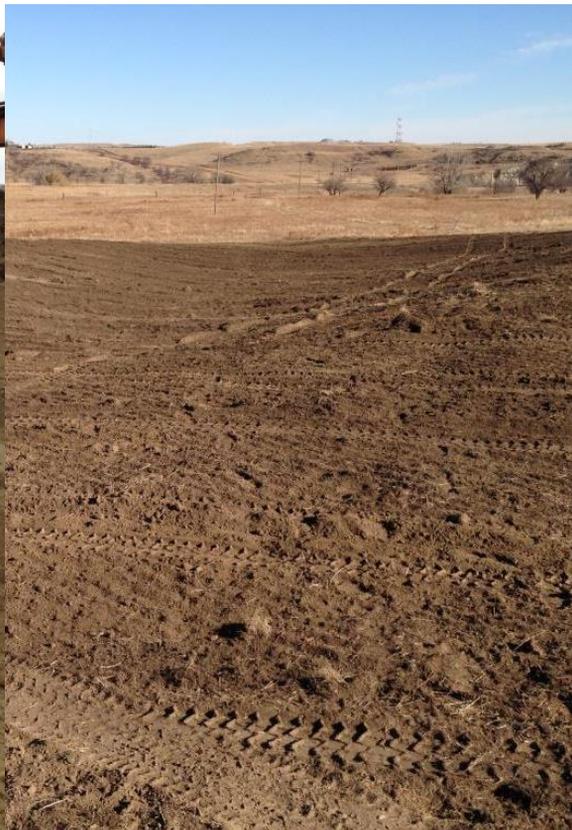
A truck dropped into this sinkhole while it was being excavated Oct. 28. The right side shows the area after it was topsoiled, reclaimed, tilled and seeded on Oct. 29. This large sinkhole was over-excavated and dirt was taken from it to fill all the other holes. Twenty nine sinkholes were filled at the Dickinson sites between Oct. 27 and 29 and the cost was \$11,329.

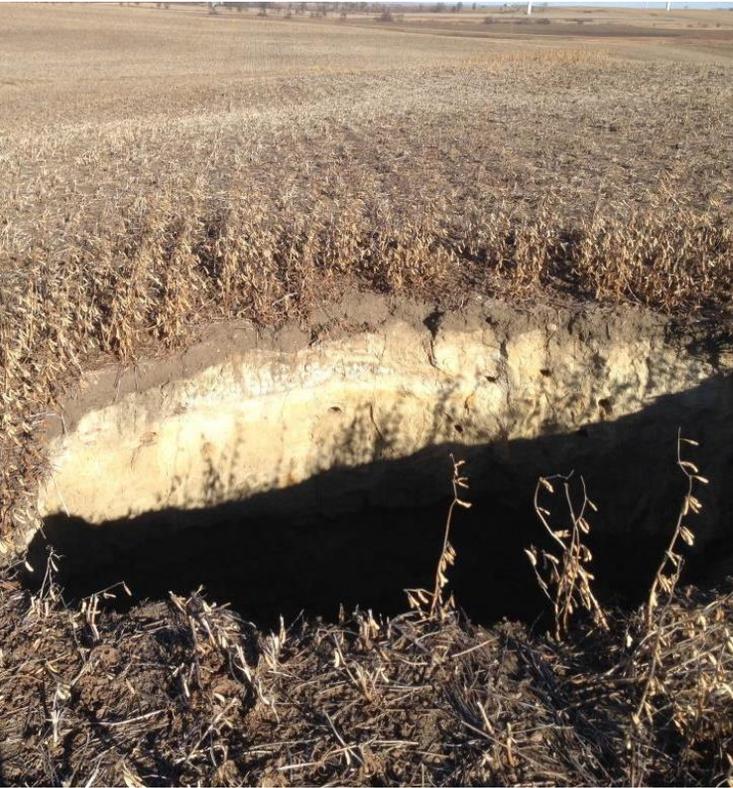
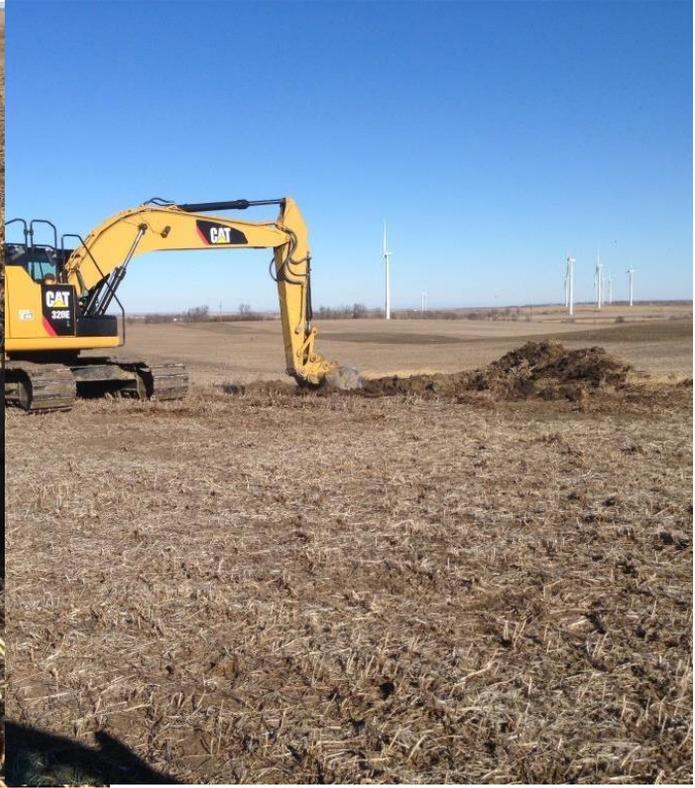
The picture on the left shows a sinkhole, about 8 feet in diameter and 17 feet deep, on a harvested soybean field near Wilton. The photo on the right shows reclamation work on the same field. Eight sinkholes were filled on this field on November 19.

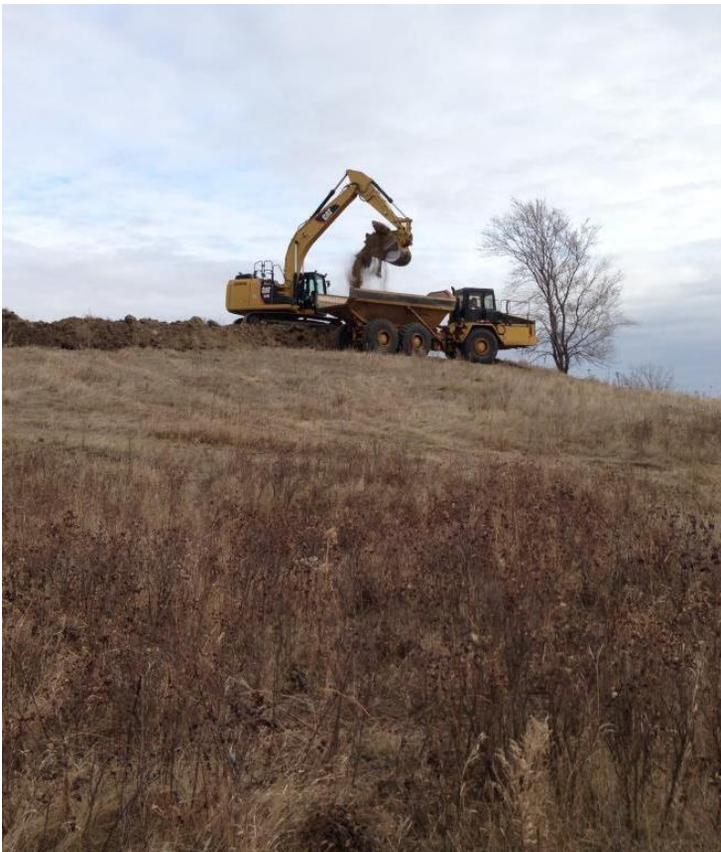
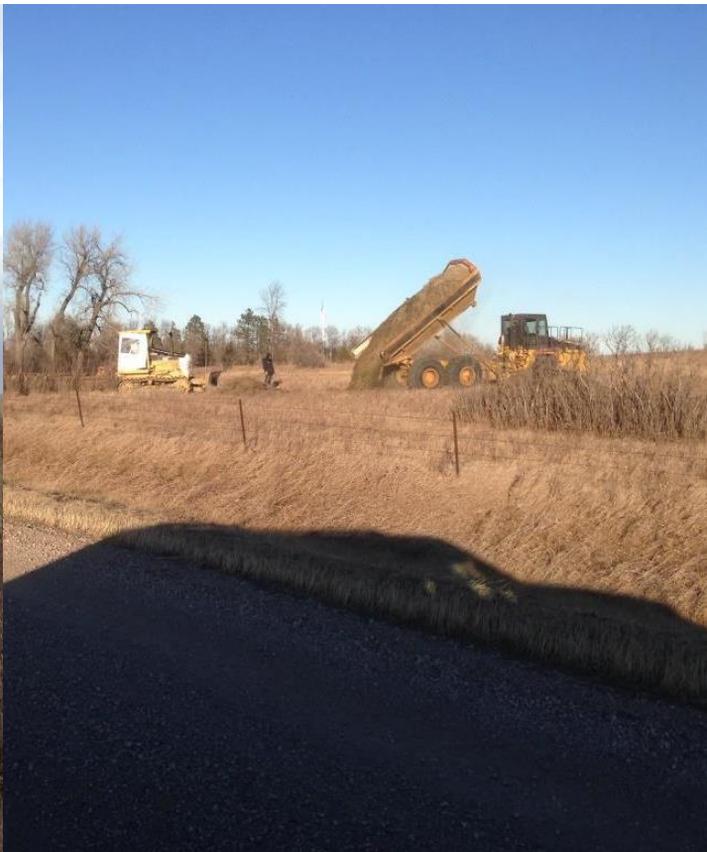
Approximately 114 sinkholes were filled at the Wilton sites between November 19 and December 4, 2015, and the cost was \$39,475. Dangerous sinkholes have been filled near Wilton almost every year since the mid-1980s. Drilling and grouting projects have been conducted to prevent AML subsidence under public roads in this area and another is planned for 2016.
