Project Summary 2016 Sinkhole Filling Contract AM-720-15

December 2016

**North Dakota Public Service Commission
2016 Sinkhole Filling AML Project Summary**

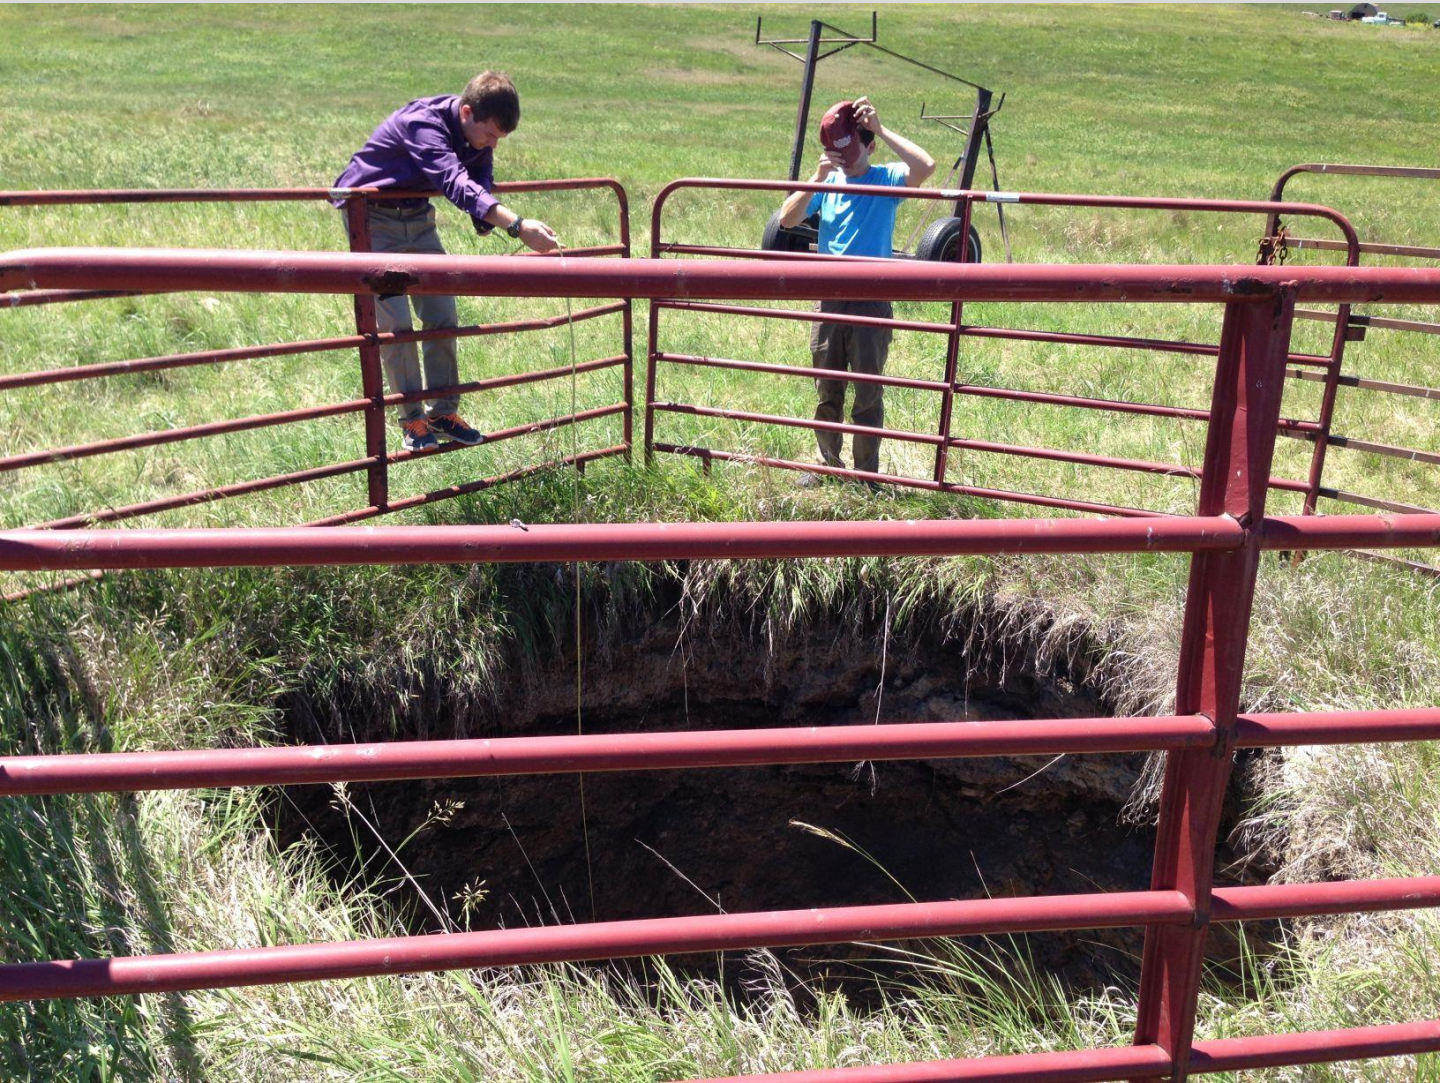
Cover Photo: *The cover photo shows AML Employees, Jordan Burns and Matt Fischer, inspecting and measuring a sinkhole on property owned by Mike Eslinger, about 1.5 miles north of Beulah. This sinkhole was located within 200 feet of 60th Avenue Southwest. It was about 13 feet in diameter and 11 feet deep. Mike barricaded the sinkhole with gate panels to keep people and livestock from falling into it. It was filled on November 24, 2016.*

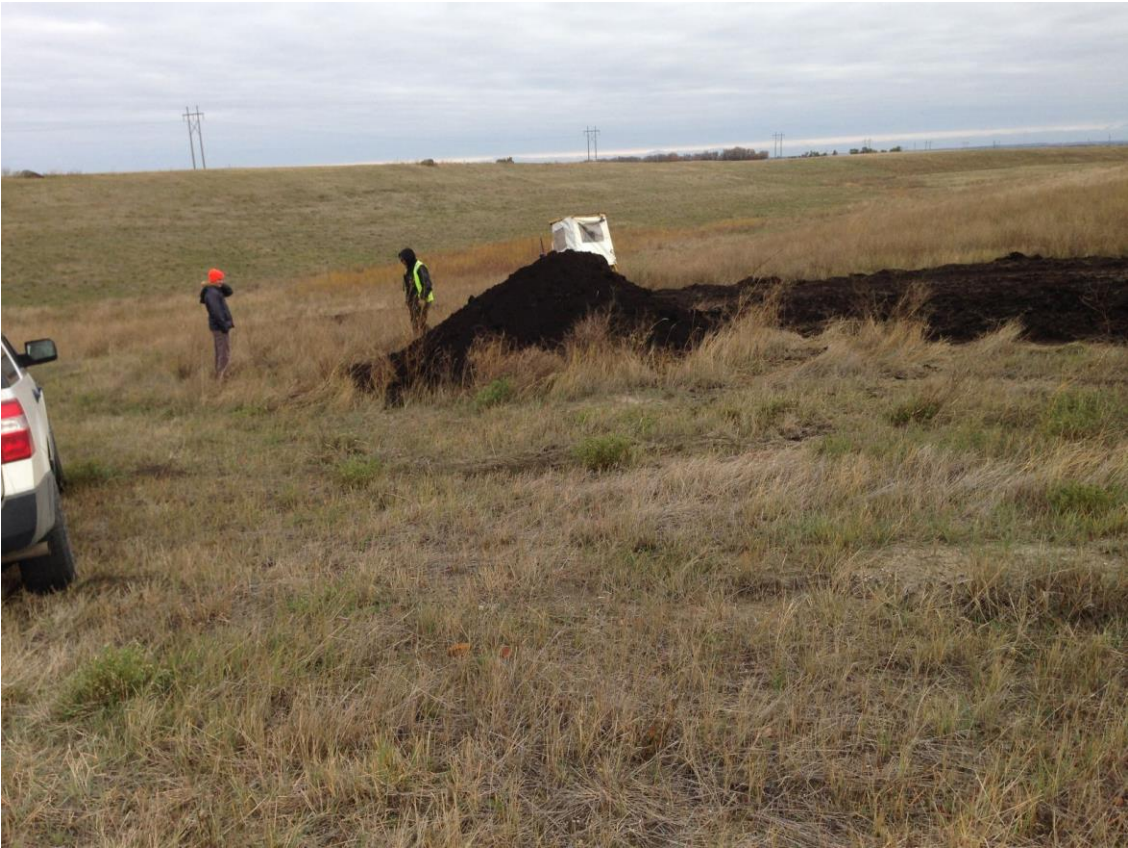
2016 Sinkhole Filling, Velva Maintenance

At the request of landowner, Albert Lindahl, work was conducted to fill erosion features at a reclaimed abandoned surface mine near Velva. This photo shows Matt Fischer supervising the respreading of topsoil to fill several erosion features.

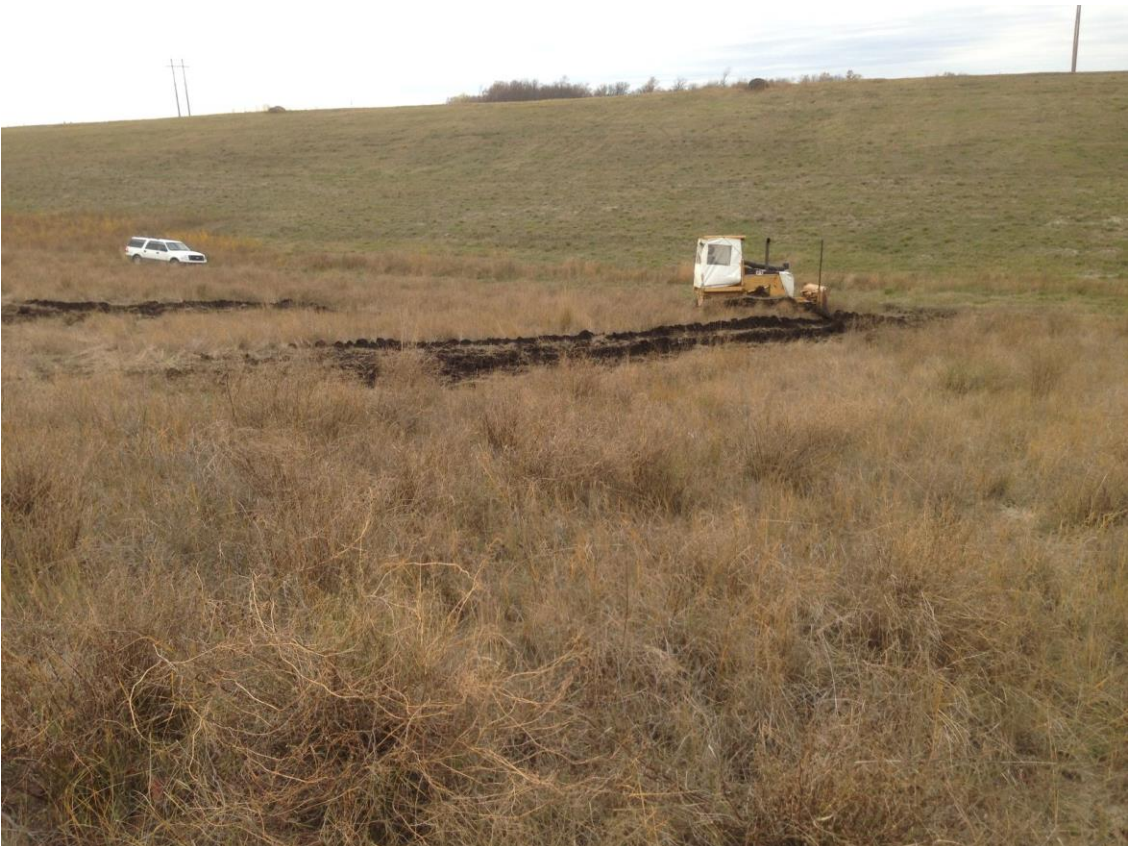
Approximately 60 erosion features were filled at this site on October 17-24. Albert Lindahl agreed to till and seed the repaired areas. Extra topsoil, seed and erosion control mats were left for him at the site. The cost for work at the Velva site was \$16,607.

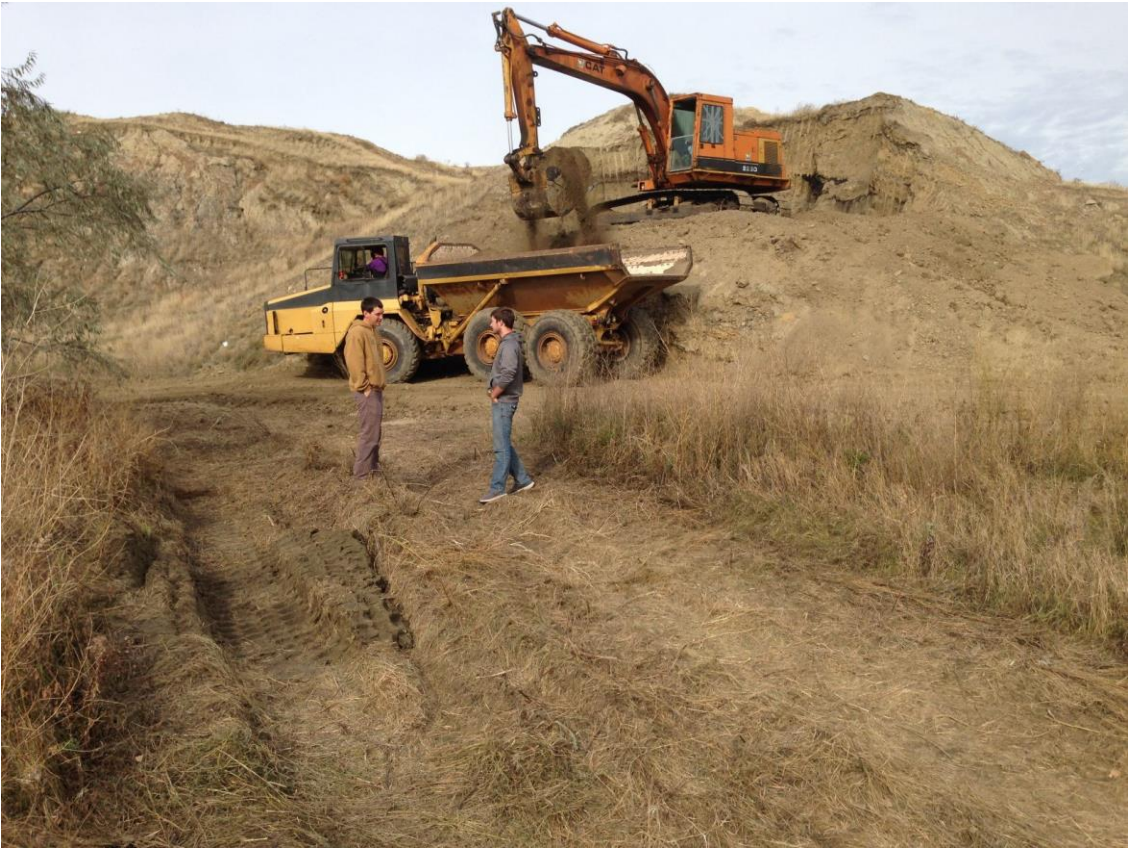
2016 Sinkhole Filling, Noonan Sites

Approximately 59 sinkholes were filled at two sites about a mile south of Noonan on October 26-29. This shows Matt Fisher and Jordan Burns supervising while a truck was being loaded with earthen materials from a nearby spoil pile to fill sinkholes.

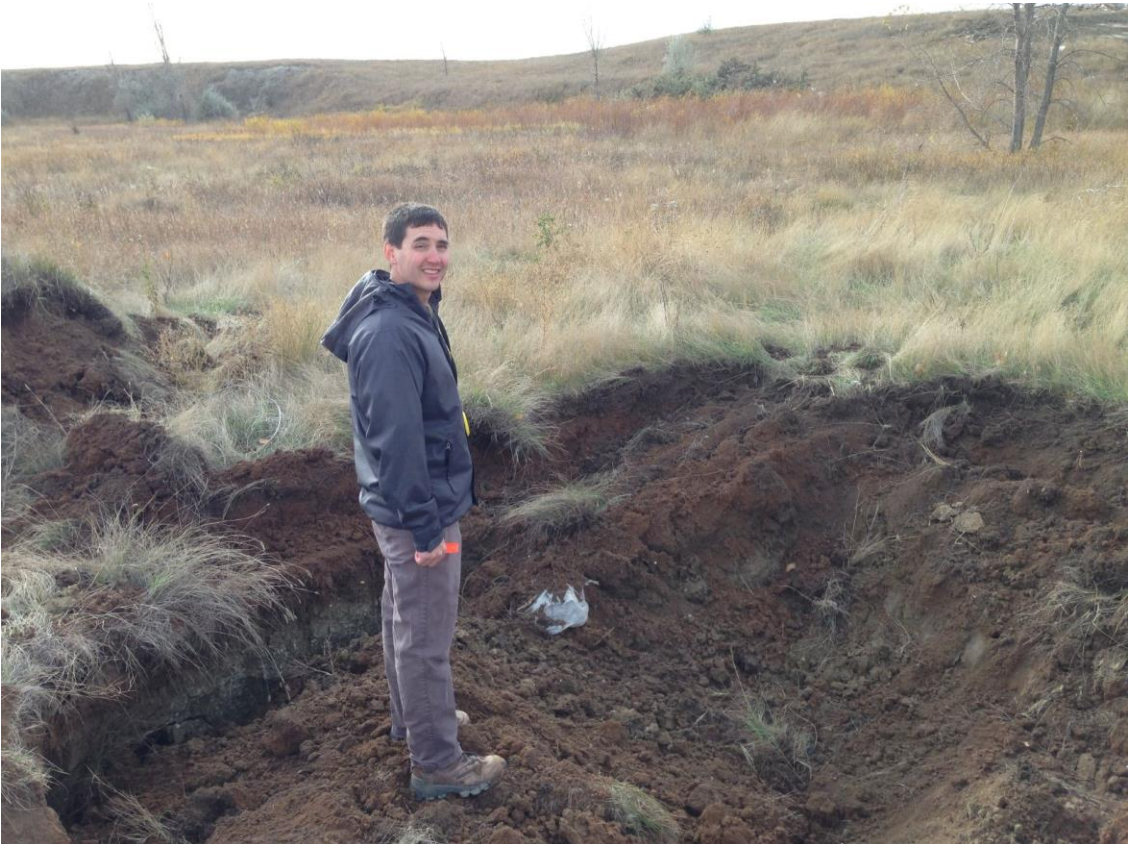
About 51 sinkholes were filled at this location, owned by Noonan Landfill, and eight on property owned by James Kimball. The cost for this work was \$14,832. Matt is standing on a partially filled sinkhole.

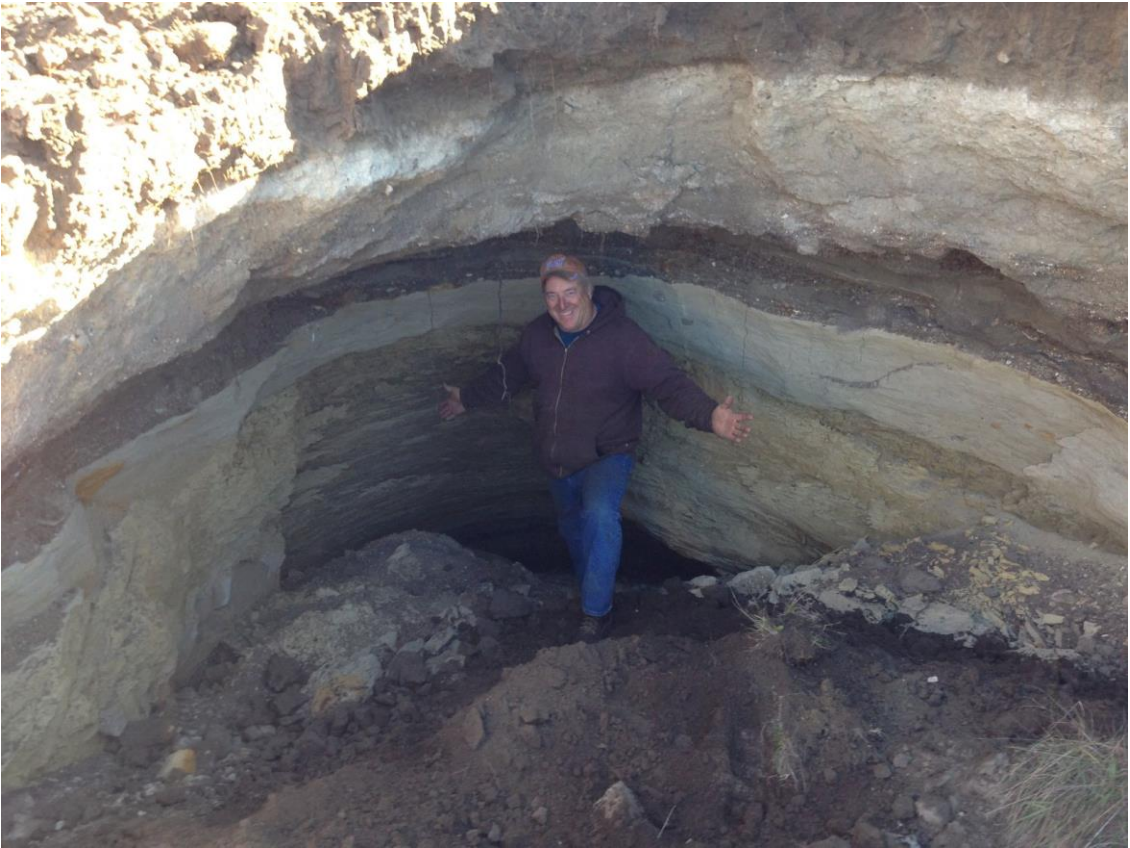
2016 Sinkhole Filling, Dickinson Sites

This shows contractor, Ross Smith, standing in a sinkhole on a pasture rented by Lexi Sebastian about two miles east of Dickinson. This sinkhole was approximately 33 feet long, 12 feet wide and more than 7 feet deep.

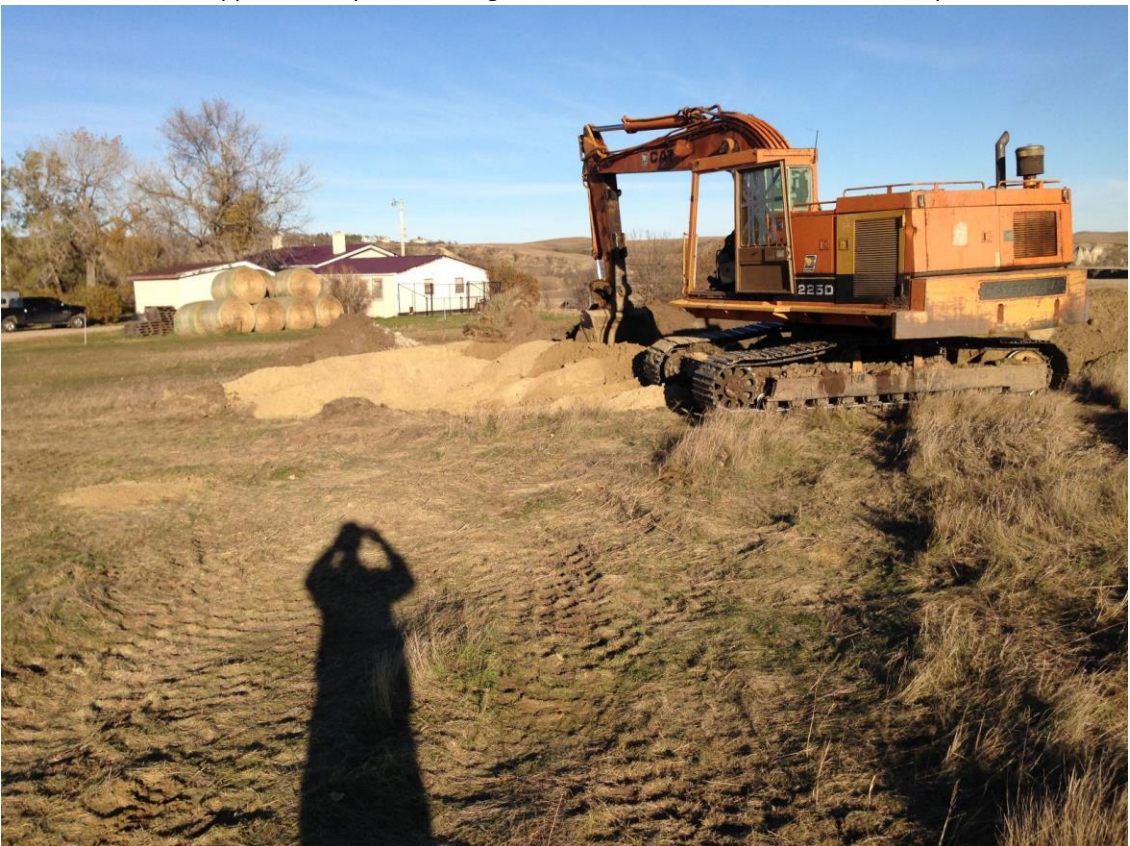
This shows the same hole when it was nearly full with 17 truckloads of dirt. Lexi's home is in the background. Eight sinkholes were filled at four properties near Dickinson on November 1–2. The cost for this work was \$3703.

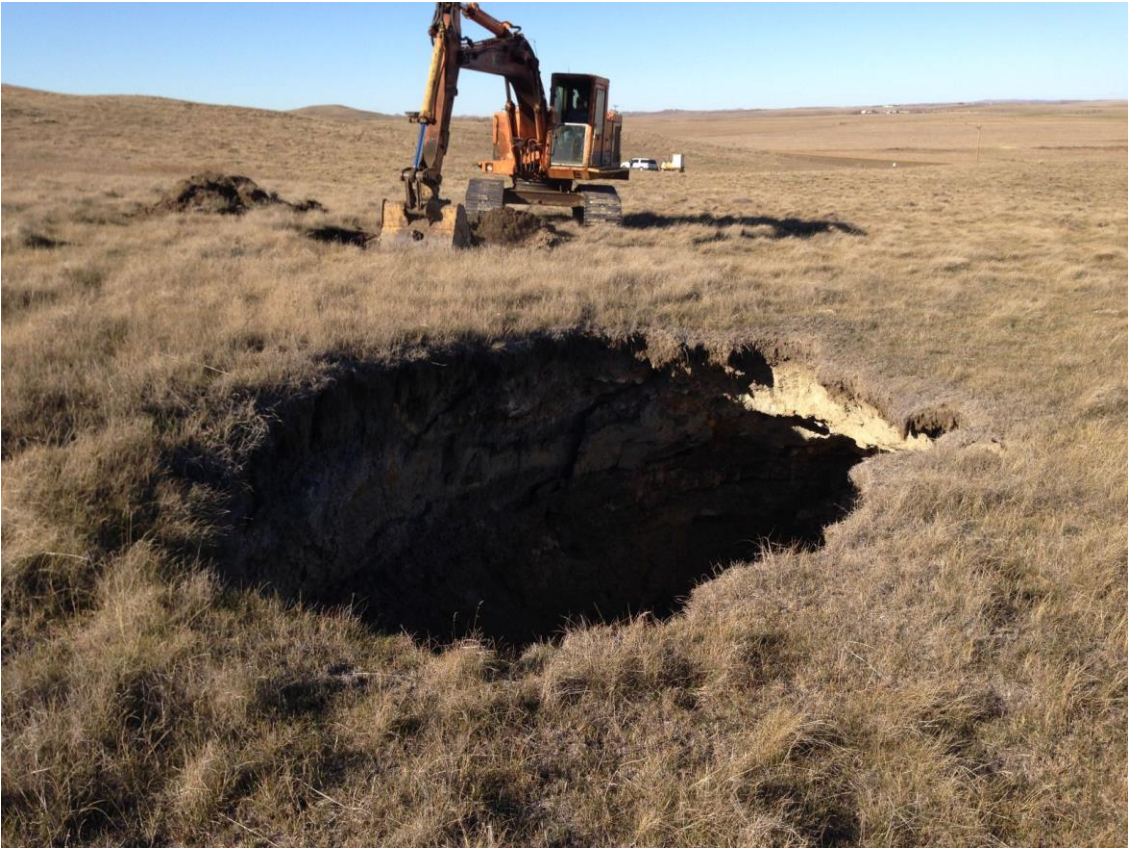
2016 Sinkhole Filling, Haynes Site

This shows two dangerous sinkholes at the Haynes site. The one in the foreground was 13' deep and the one in the background by the excavator was 15' deep. They were reported by the Hettinger Fire Protection District.

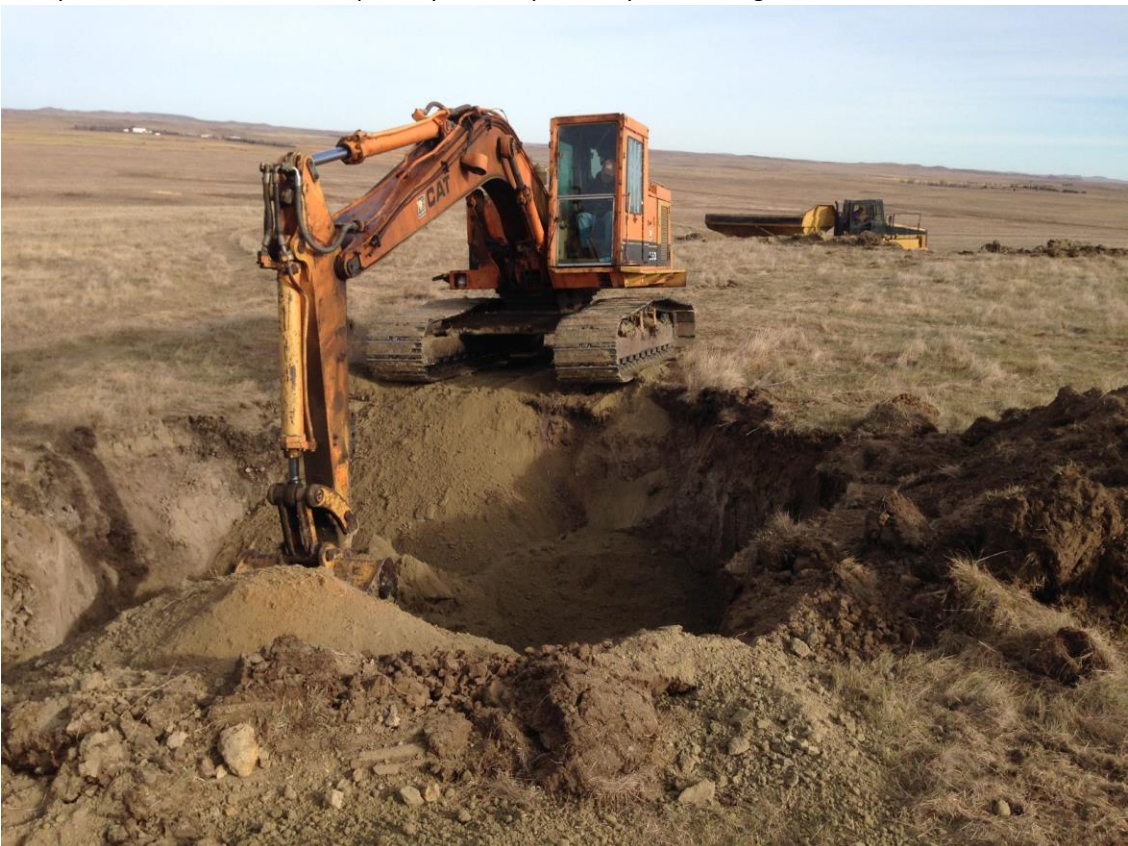
Eight sinkholes were filled at the Haynes site on November 7-8 and the cost was \$5375. This shows a sinkhole which was found when the haul truck dropped a wheel into it. It was 25' in diameter, 15' deep and took 15 truckloads of dirt.

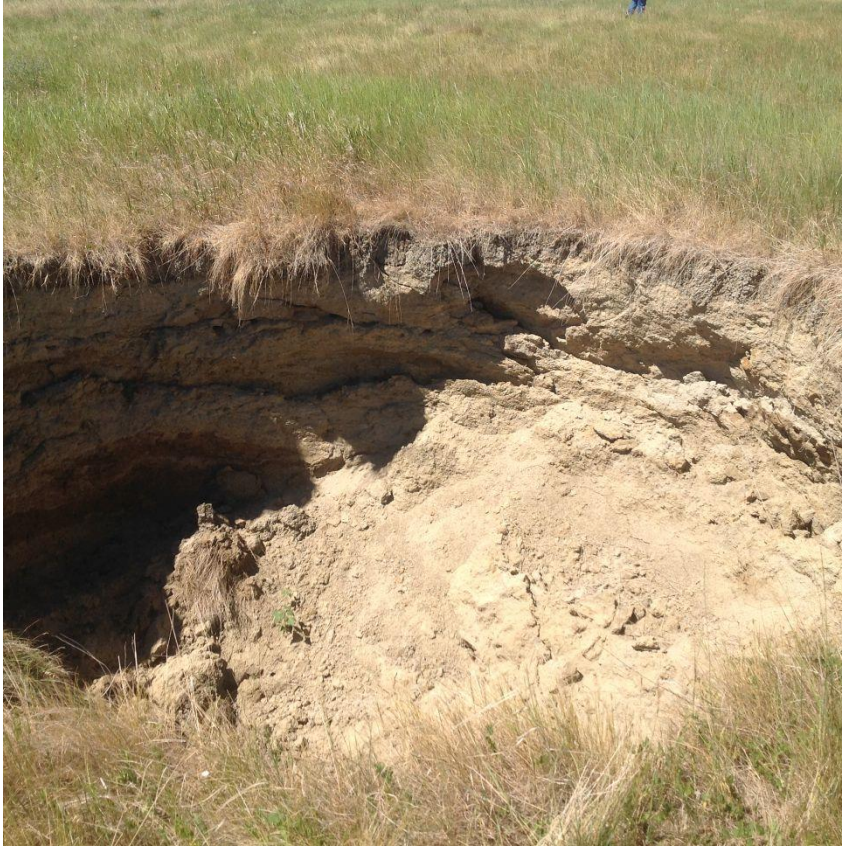
2016 Sinkhole Filling, Bowman Site

This sinkhole occurred on property owned by the City of Bowman, near the City Landfill. It was about 21 feet in diameter and 12 feet deep. It was located about 200 feet from a public road.

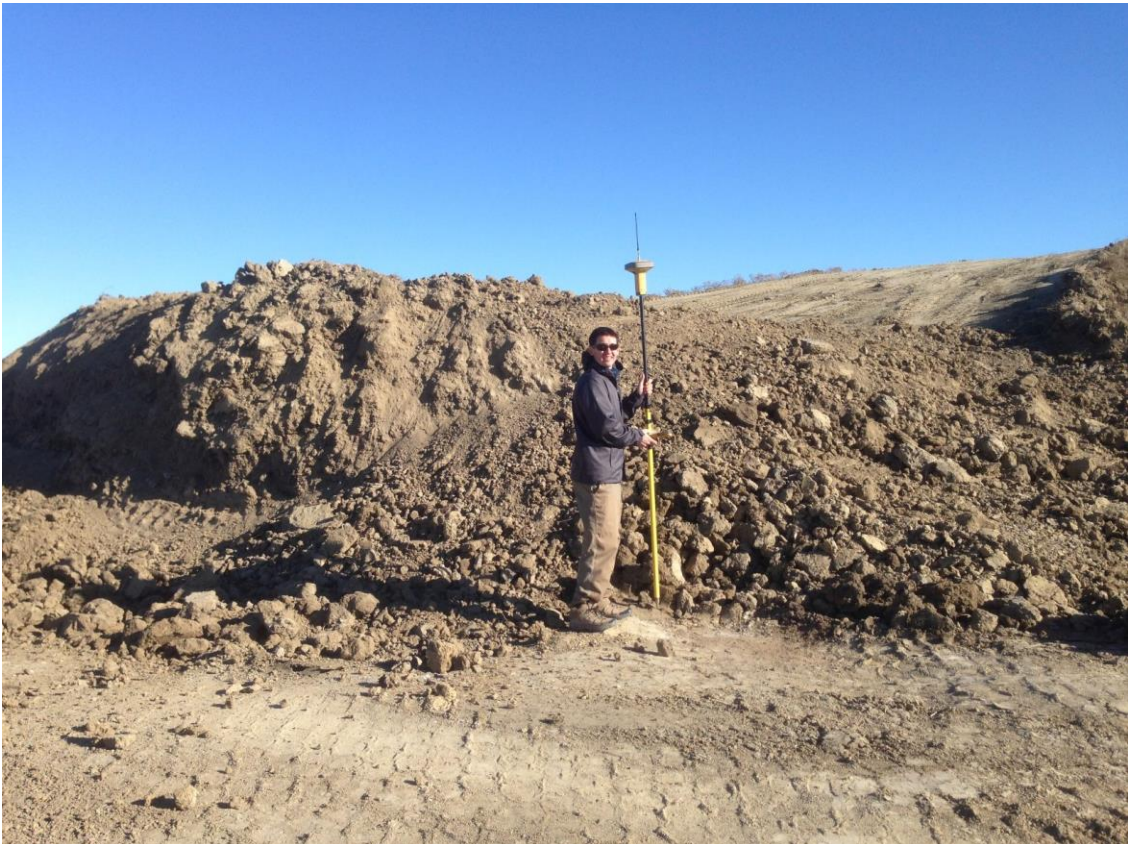
This shows Matt surveying a clay stockpile at the Bowman Landfill. Approximately 120 cubic yards of soil from this pile was used to fill the sinkhole. Work was completed November 9 and the cost was \$2100.

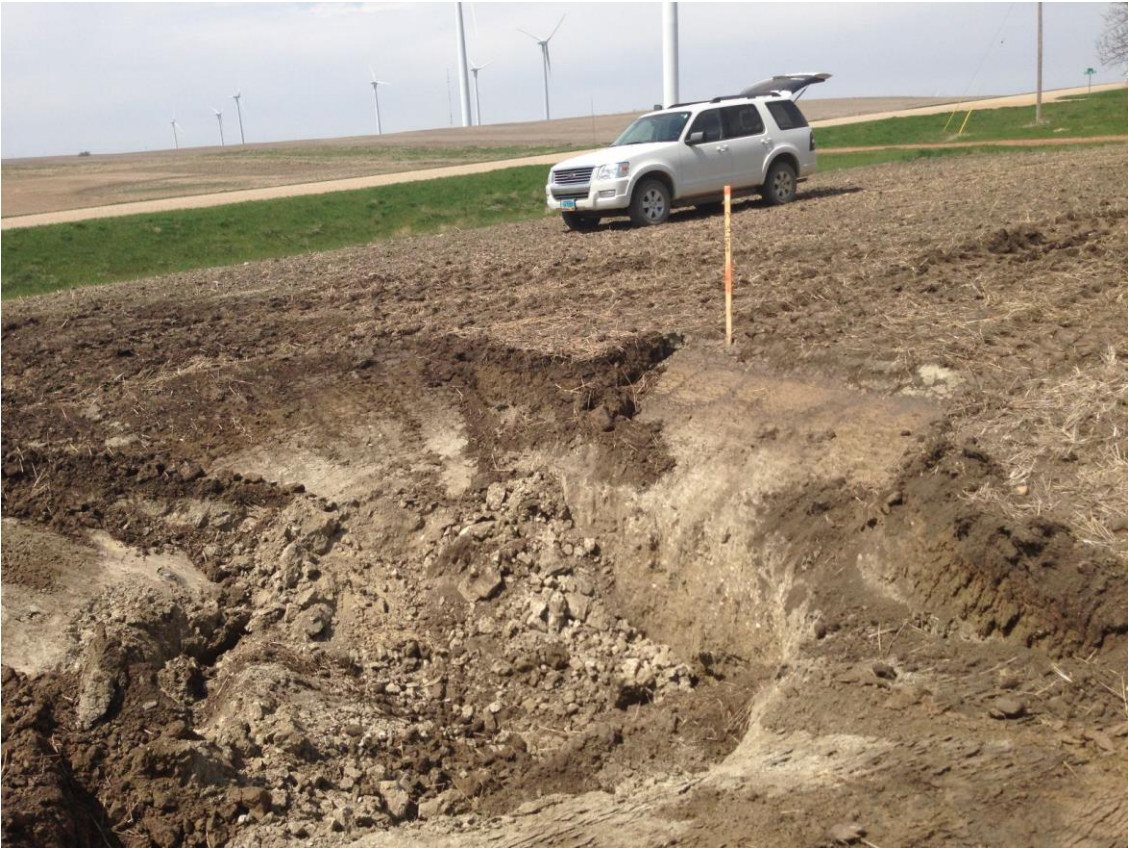
2016 Sinkhole Filling, Wilton Sites

This is a sinkhole that occurred on cropland owned by Donald Sorch, about 5 miles southeast of Wilton. Donald pushed dirt in, it but it was still dangerous. The Wilton Windfarm and 66th Street are in the background.

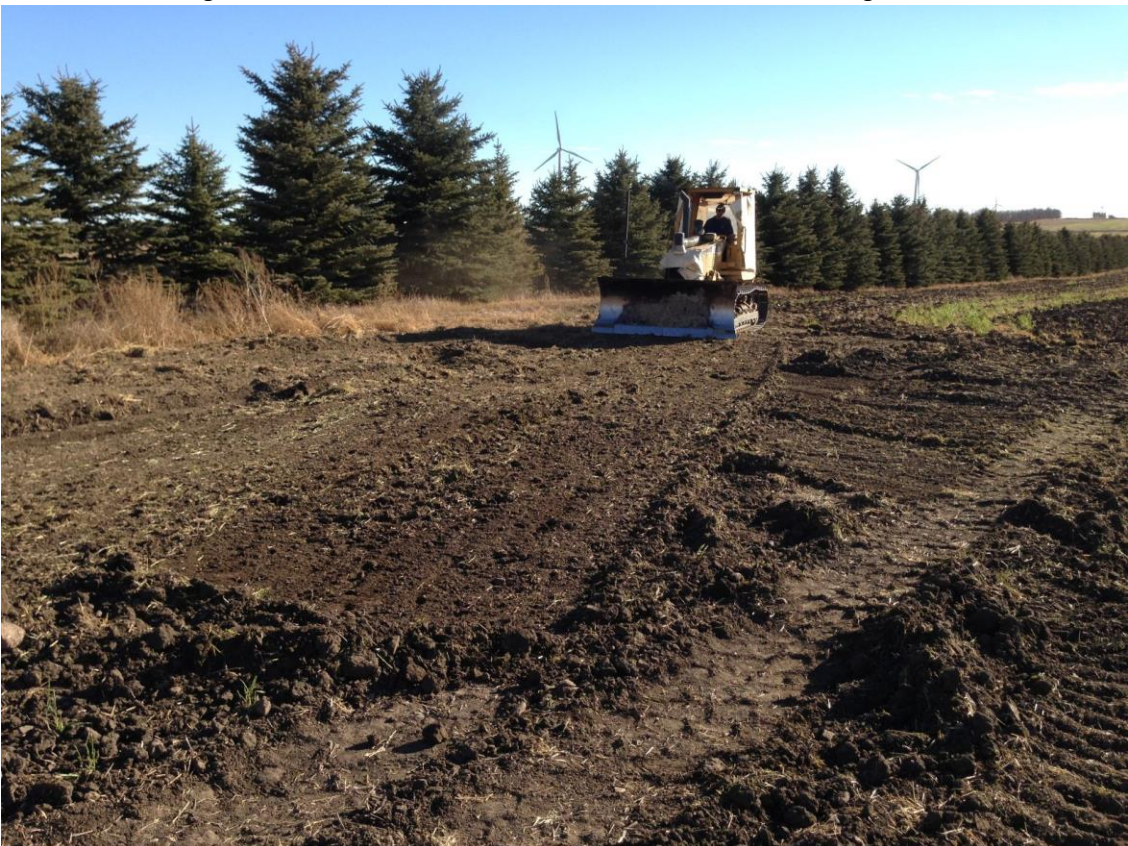
This photo was taken November 15 after the sinkhole was filled and topsoil was respread. Approximately 22 sinkholes were filled at five properties near Wilton on November 14-16 and the cost was \$4330.

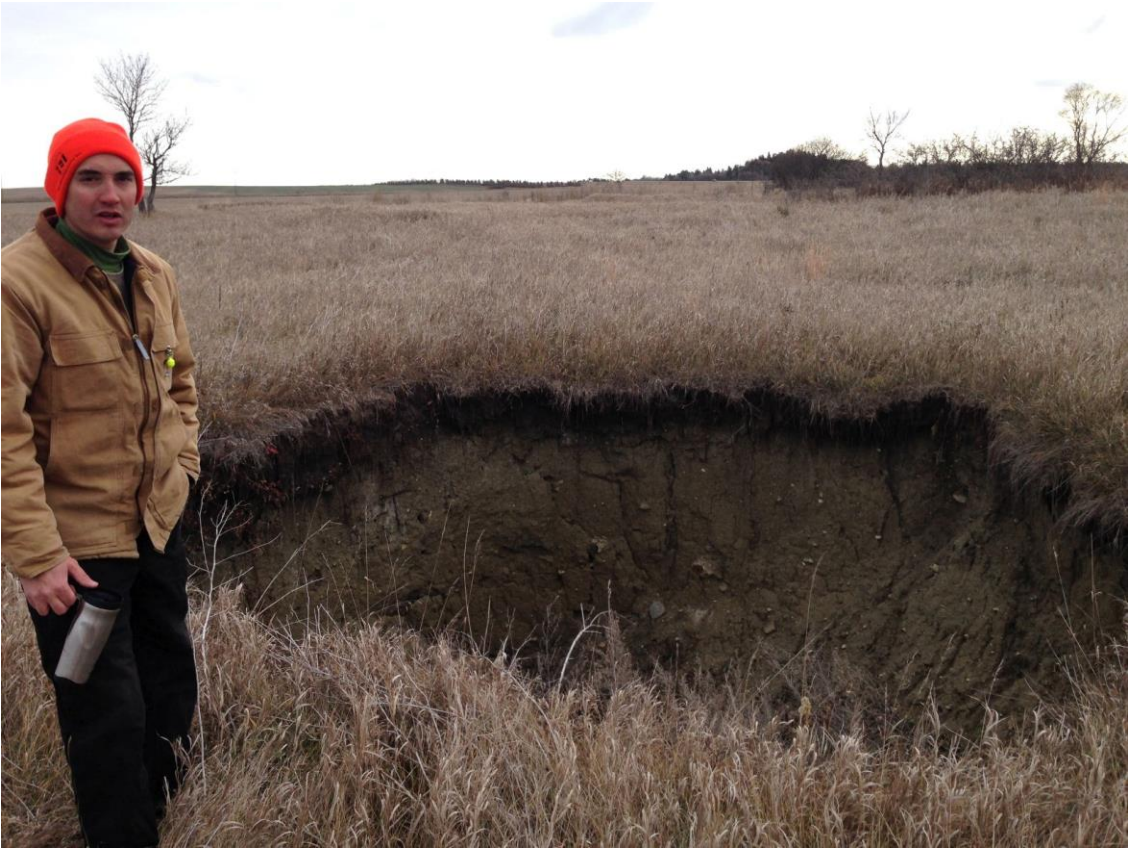
2016 Sinkhole Filling, Beulah Sites

This shows Matt standing by a sinkhole on Garner Sailer's property north of Beulah. It was about 15 feet in diameter and 8 feet deep. Four sinkholes were filled on Garner's property, two on Mike Eslinger's property and 34 on ND Game & Fish property.

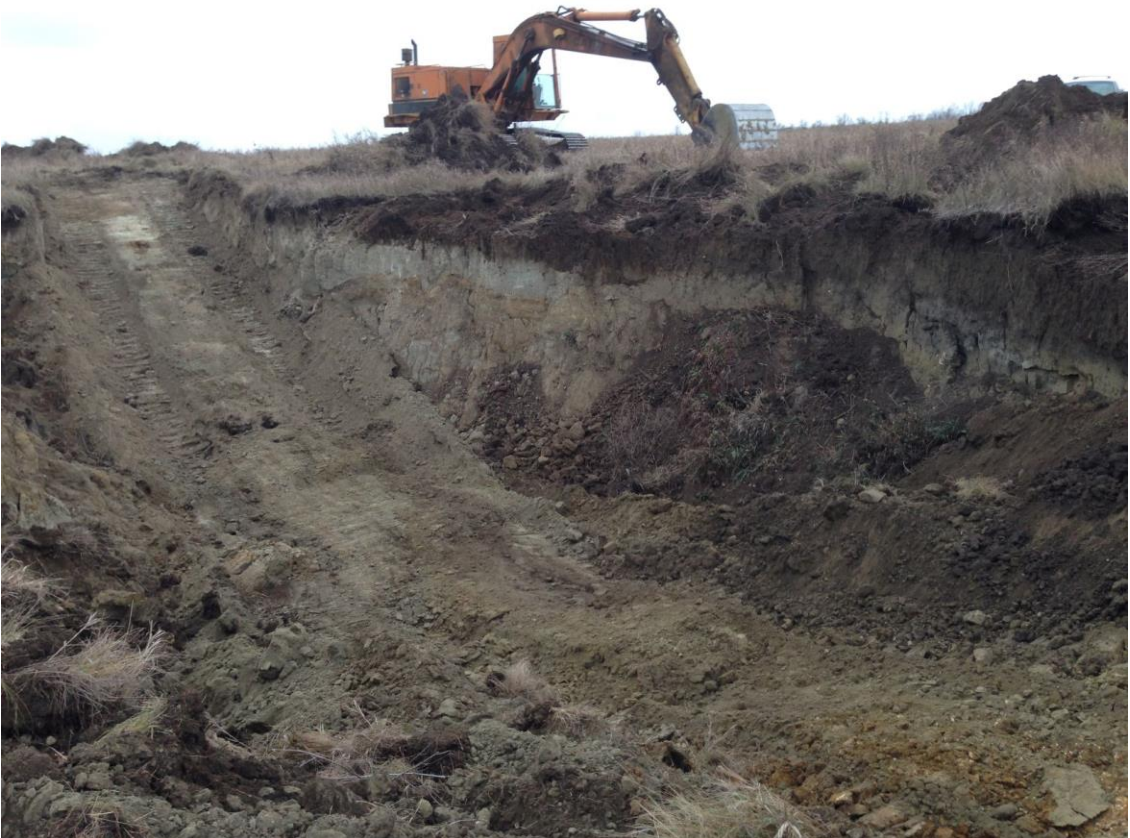
This sinkhole on ND Game & Fish property was 45' long, 18' wide and 16' deep. Ramps were constructed on two sides and it was filled by scrapers. Many dangerous sinkholes remain on this property, and they will need to be filled in the future.
