# 2018 Morton County AML Project Summary

## **North Dakota Public Service Commission, Abandoned Mine Lands Division November 2018**

This 36-acre project was conducted to reclaim about 2500 feet of dangerous highwalls at two abandoned surface coal mines in Morton County. These highwalls were about 15-40 feet high, with water-filled pits at the bottom. Reclamation involved backsloping and backfilling the highwalls with earthen material from adjacent spoil piles.

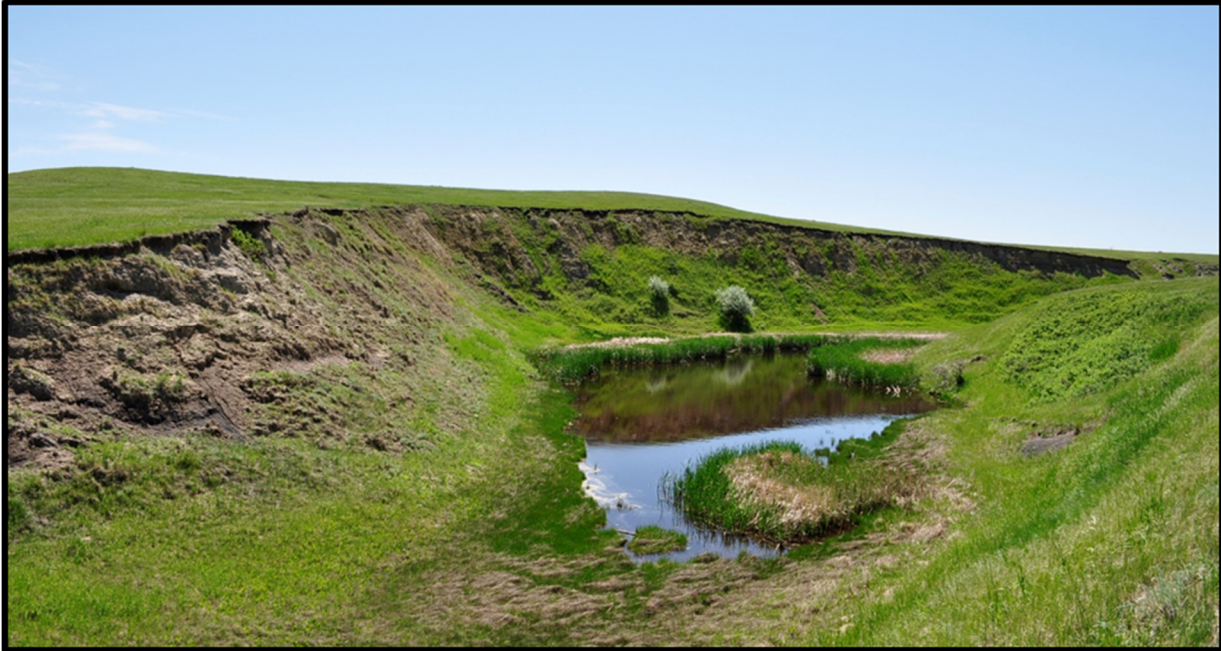
### Carrick Site

This shows part of the unstable highwall at the 24-acre Carrick site. It was up to 40 feet high and quite steep. There was stagnant, poor quality water in the pit. Spoil piles are at the right of this photo.

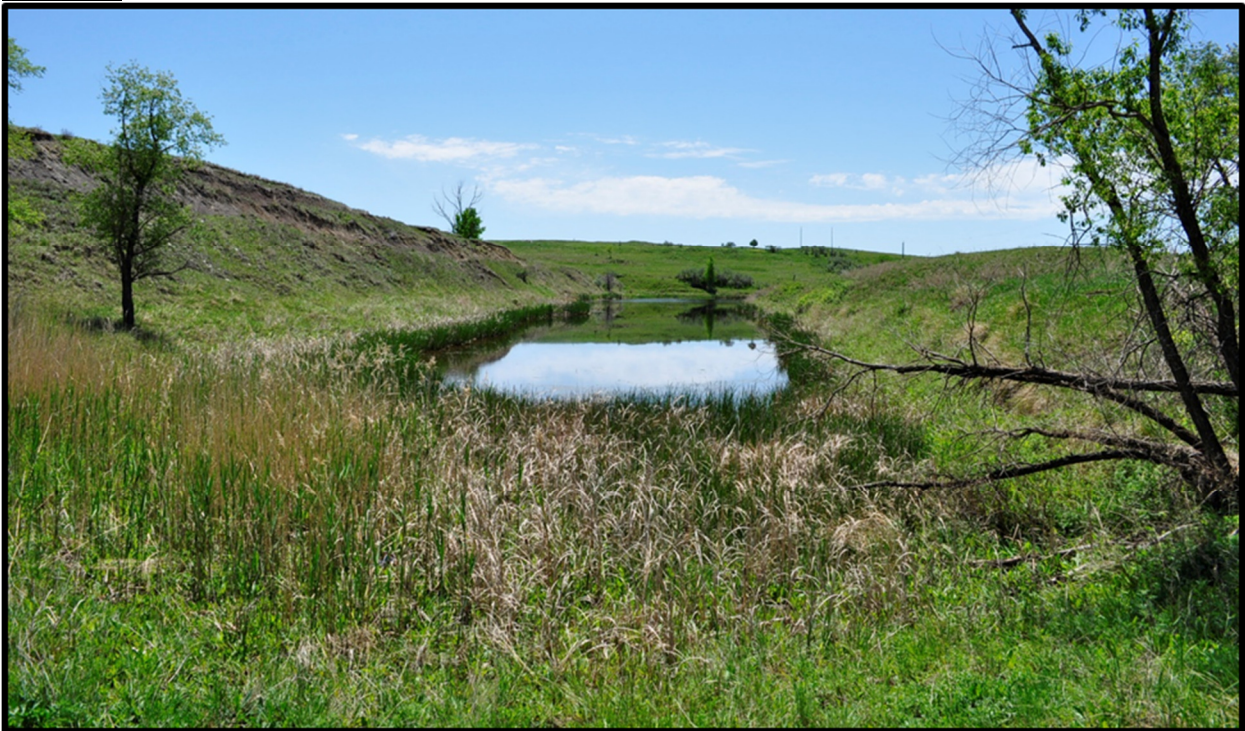
### Nilles Site

This shows a portion of the 12-acre Nilles Site. The highwall was up to 25 feet high and quite steep with water in the final pit. Spoil materials used for reclamation are on the right of this photo.

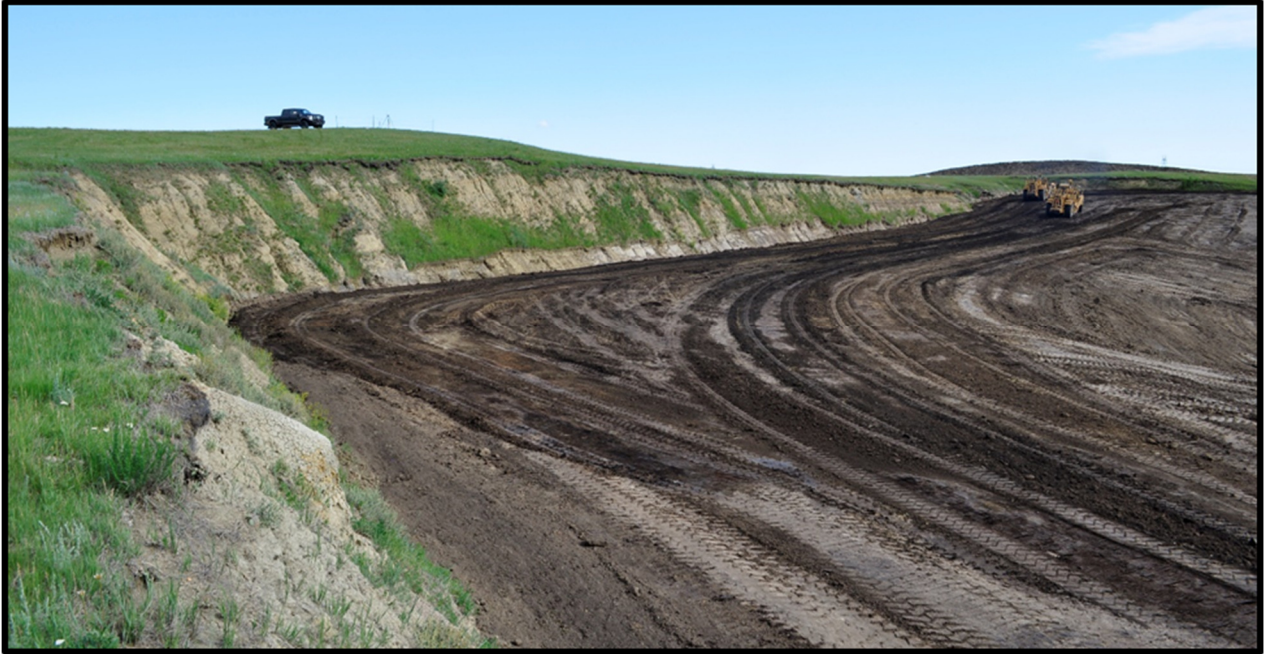
### Carrick Site During Construction

This shows a scraper hauling spoils to fill the final pit along the highwall. A perforated pipe “toe drain” was installed to collect water from seeps at the base of the highwall and discharge it into a reclaimed pond.

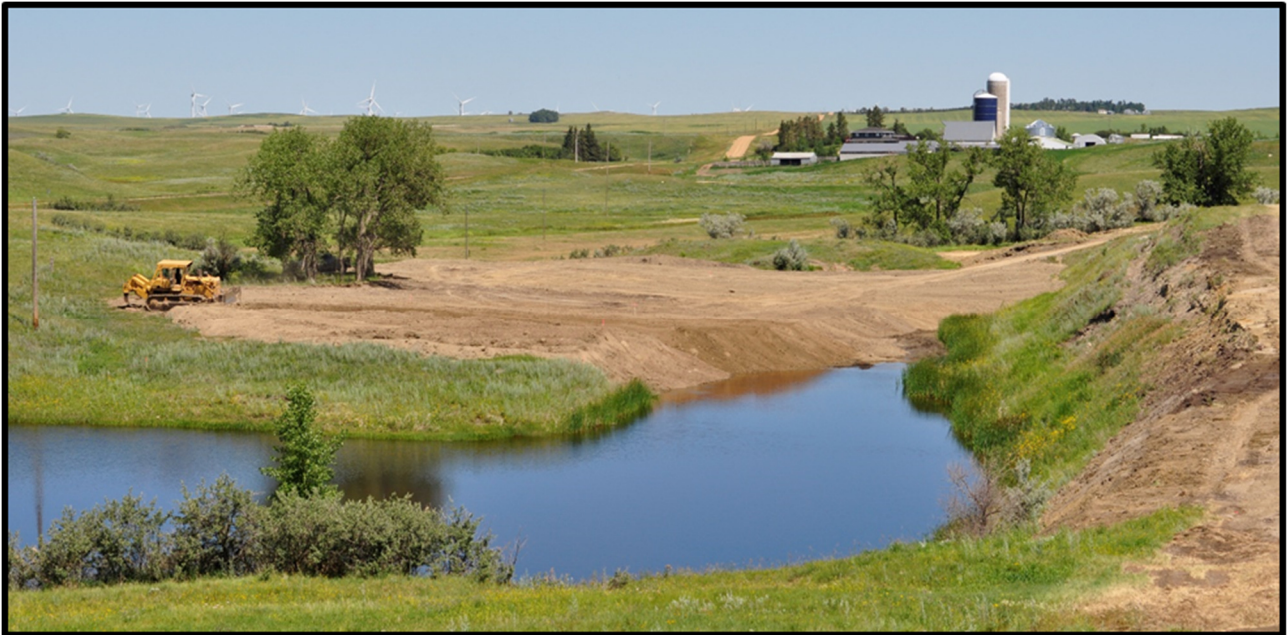
### Nilles Site During Construction

This shows a bulldozer pushing spoil to fill part of the pond and the final pit highwall. This highwall was reclaimed by backfilling with spoil and backsloping the top of the highwall.

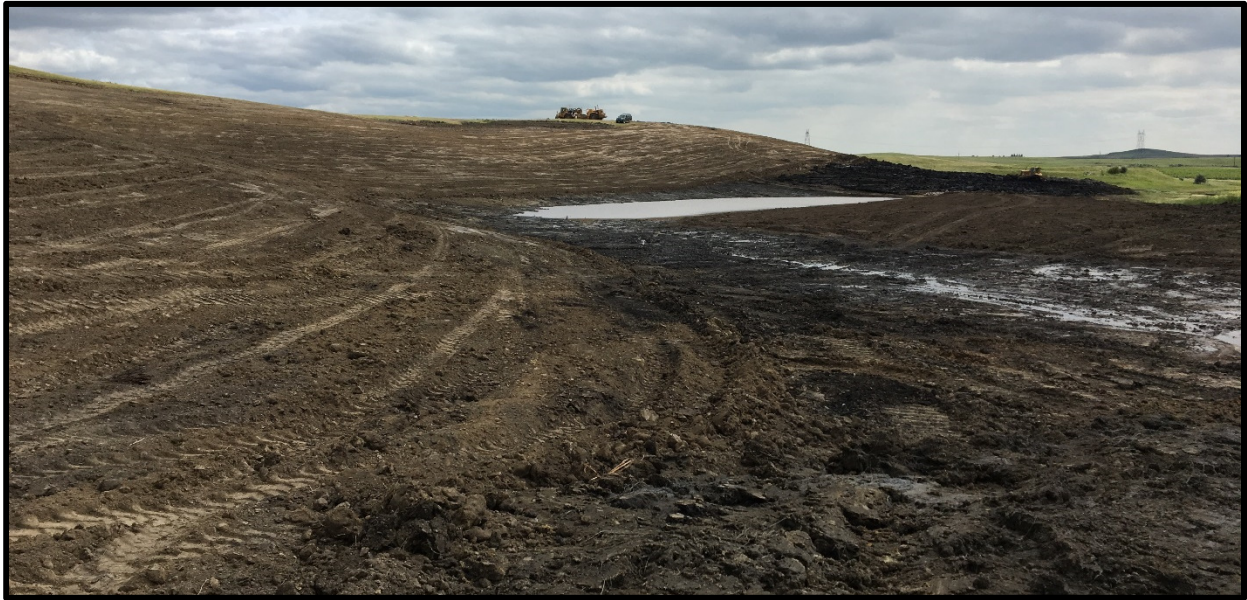
### Carrick Site Final Grade

This shows the Carrick Site after the highwall was completely reclaimed but before seeding and mulching. A waterway and two ponds were constructed on this site. Two areas near the pond in this photo were fenced and trees will be planted there in 2019 by Morton County Soil Conservation District.

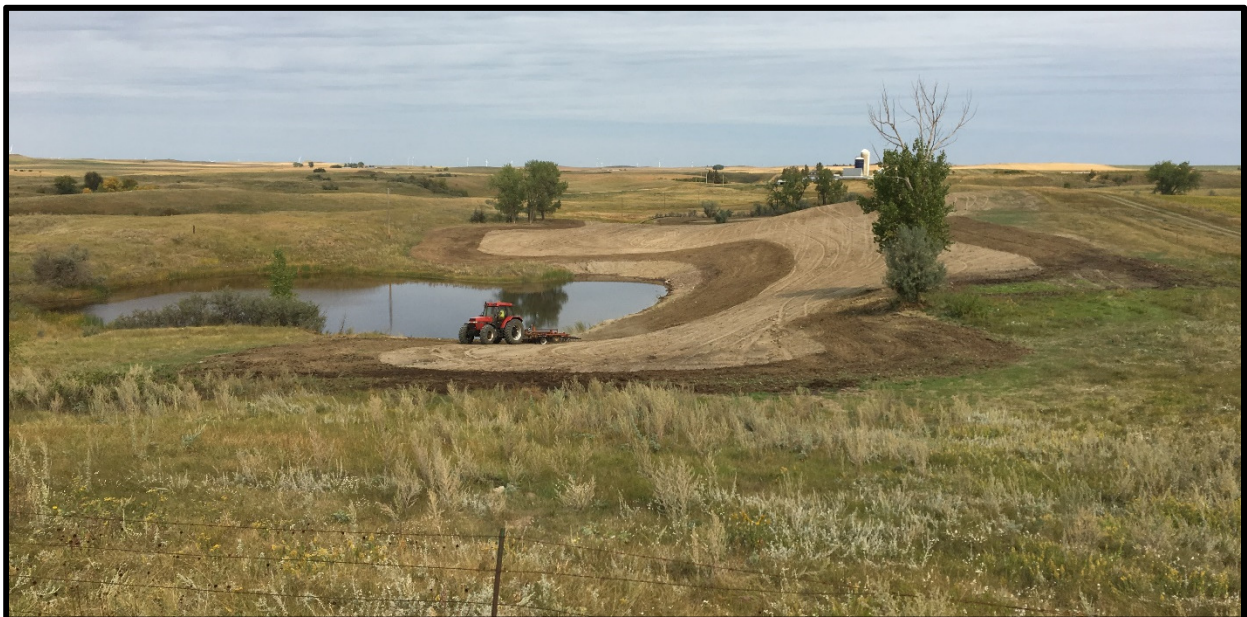
### Nilles Site Final Grade

This shows the reclaimed highwall at the Nilles site while it was being seeded and mulched. Part of the water filled pit was eliminated to make a smaller pond. Inert wastes including wood, metal and concrete were cleaned up and buried away from the pond.
