2021 Buechler/Velva Phase 2 Project Summary

Contractor: Martin Construction, Inc. of Dickinson ND

Contract Number: AM-848-21

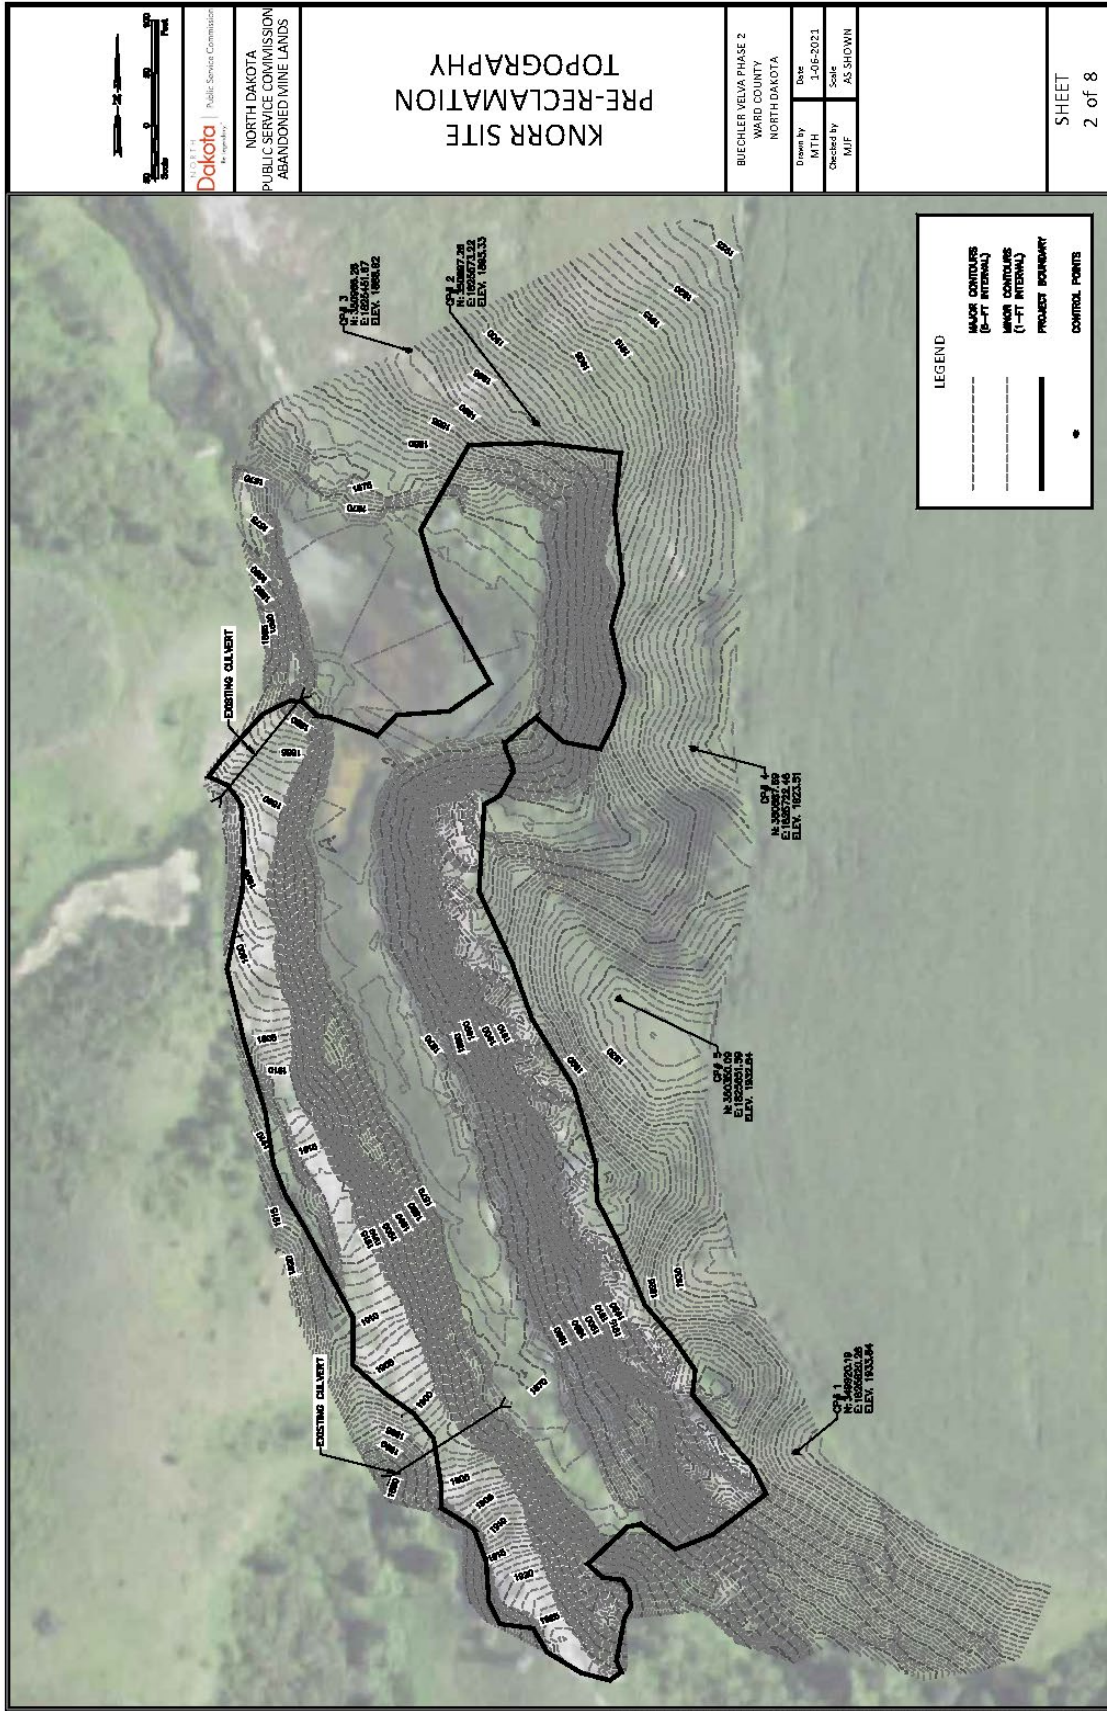
Figure 1: Knorr Site Pre-Reclamation Topography Map

The Knorr Site was the most difficult of the three project areas. This site contained 1,600 feet of dangerous highwall that averaged 50 feet in high with no topsoil available for salvage. Erosional piping created dangerous holes and instability along the highwall. Cropland and several wooded draws surround the site. Two small ponds upstream of the highwall contained surface water from the large watershed. The design included back-sloping the southern highwalls and using the excess spoil material to backfill the highwall adjacent to the southern pond (**Figure 1**). A floating turbidity curtain was installed prior to construction in the southern pond to prevent sedimentation.

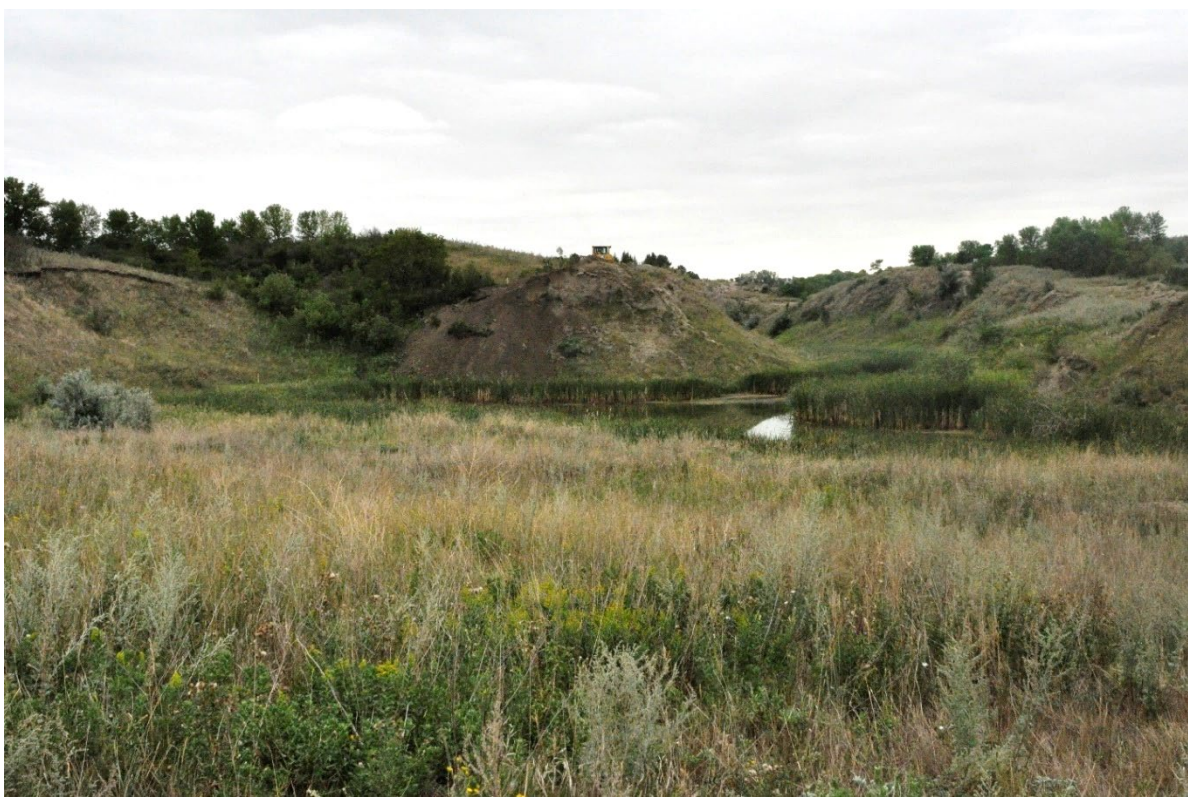
Figure 2: Starting Reclamation of the Knorr Site.

The reclamation of the Knorr Site began with the construction of ramps by a Cat D8 dozer to gain access to the highwalls on both sides of the drainage (**Figure 2**). Reclamation of the site was conducted exclusively with dozers due to the steepness and instability of the highwalls. A D8 was initially used and a smaller D6 dozer was brought in later to do the more precise grading (**Figure 3**). Reclamation of this site involved moving approximately 28,350 cubic yards of spoil material and replacing a 36-inch corrugated metal pipe that had been compromised by water erosion.

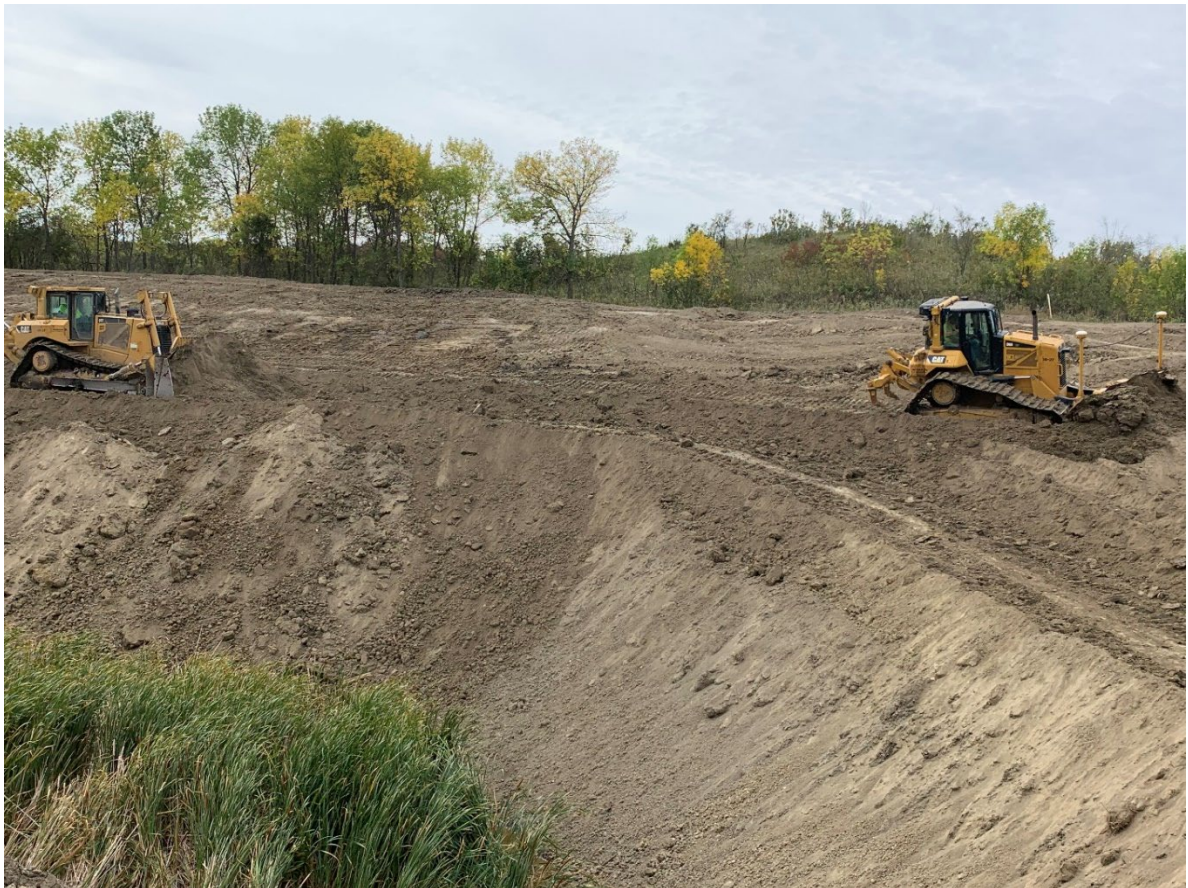
Figure 3: Dozers Moving Spoil Material at the Knorr Site.

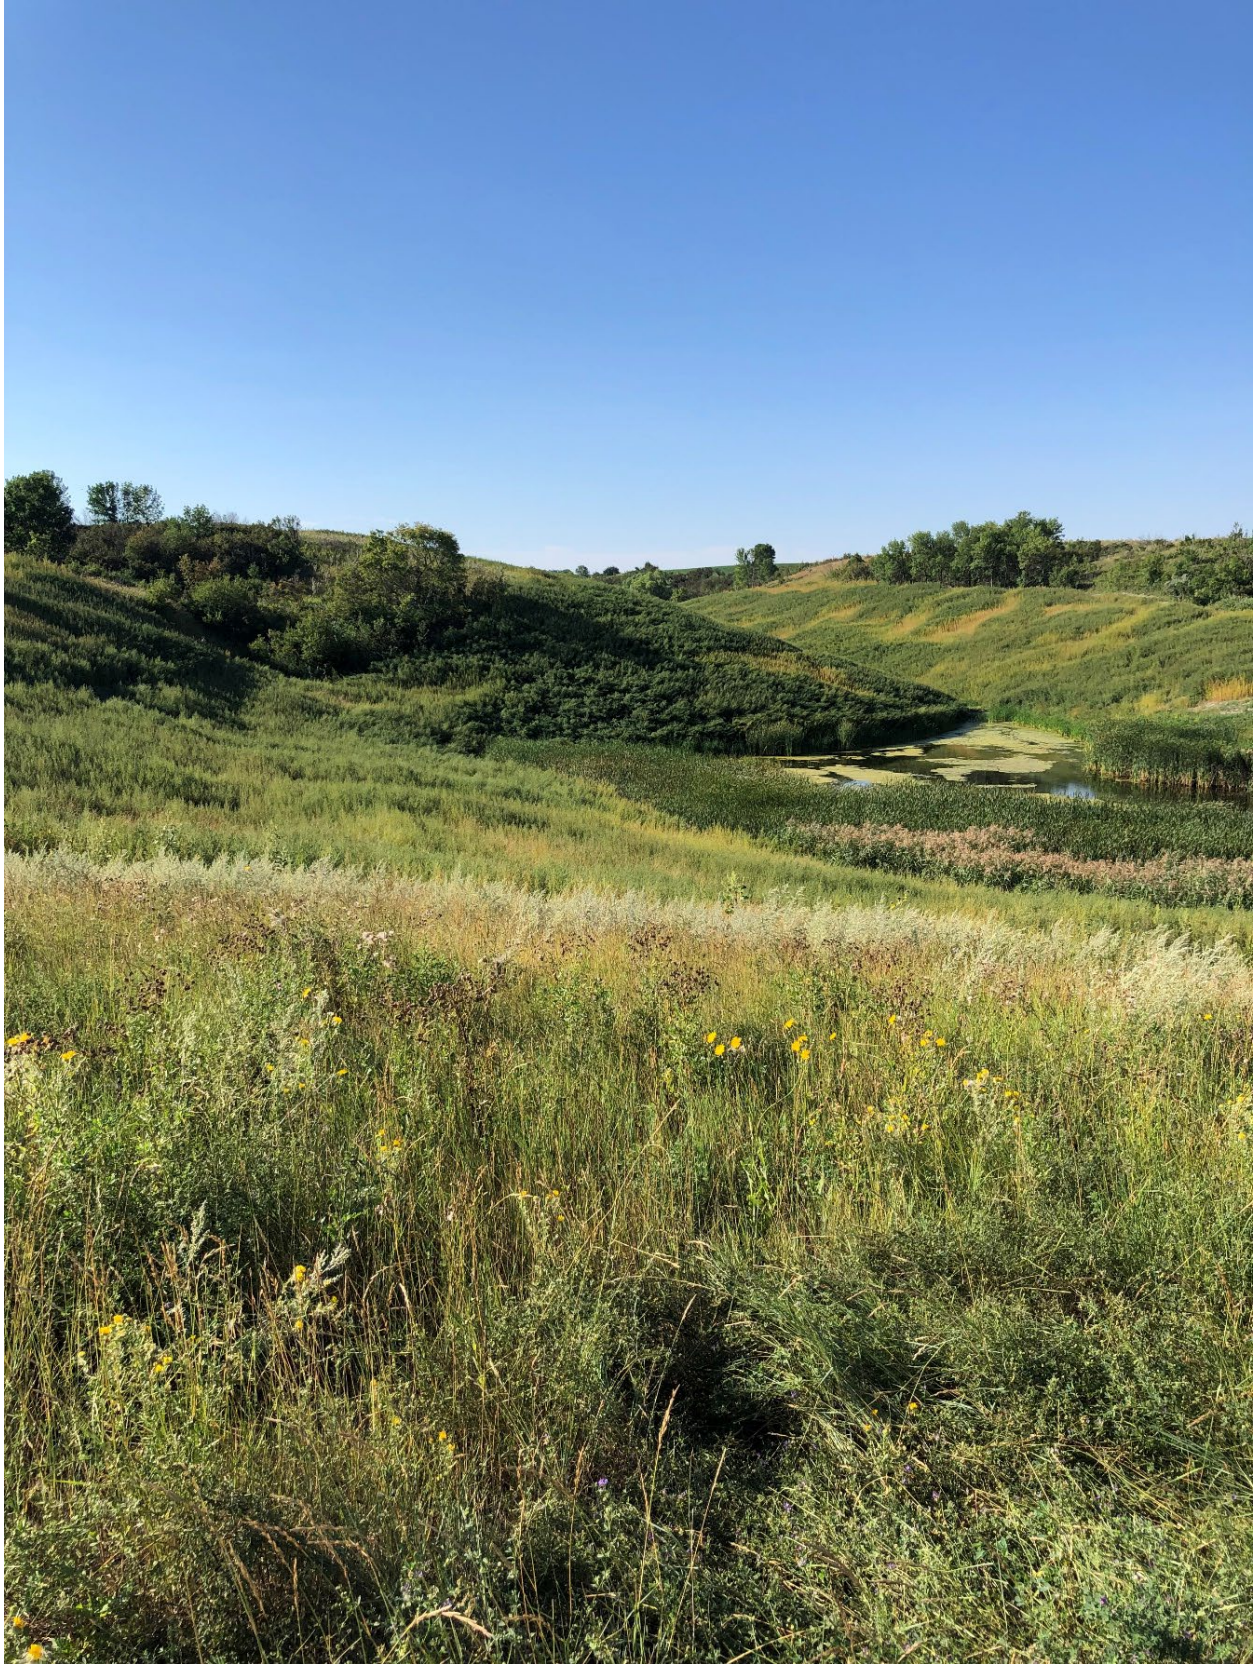
Figure 4: Completed reclamation at the Knorr Site on August 22, 2022.

After grading was complete, Martin Construction hauled 2,350 cubic yards of manure to the site and spread it evenly. The area was then tilled to four inches and seeded. Finally, 1,360 feet of erosion control blanket was placed to stabilize steep slopes. Construction at this site was completed by October 1, 2021 (34 Days). A small slope failure on the steep, southern highwall occurred during construction and repair attempts failed. This area continues to settle and will be addressed once it has stabilized. The vegetative growth promoted by the incorporation of manure is clearly evident in an August 22, 2022 photo (**Figure 4**).

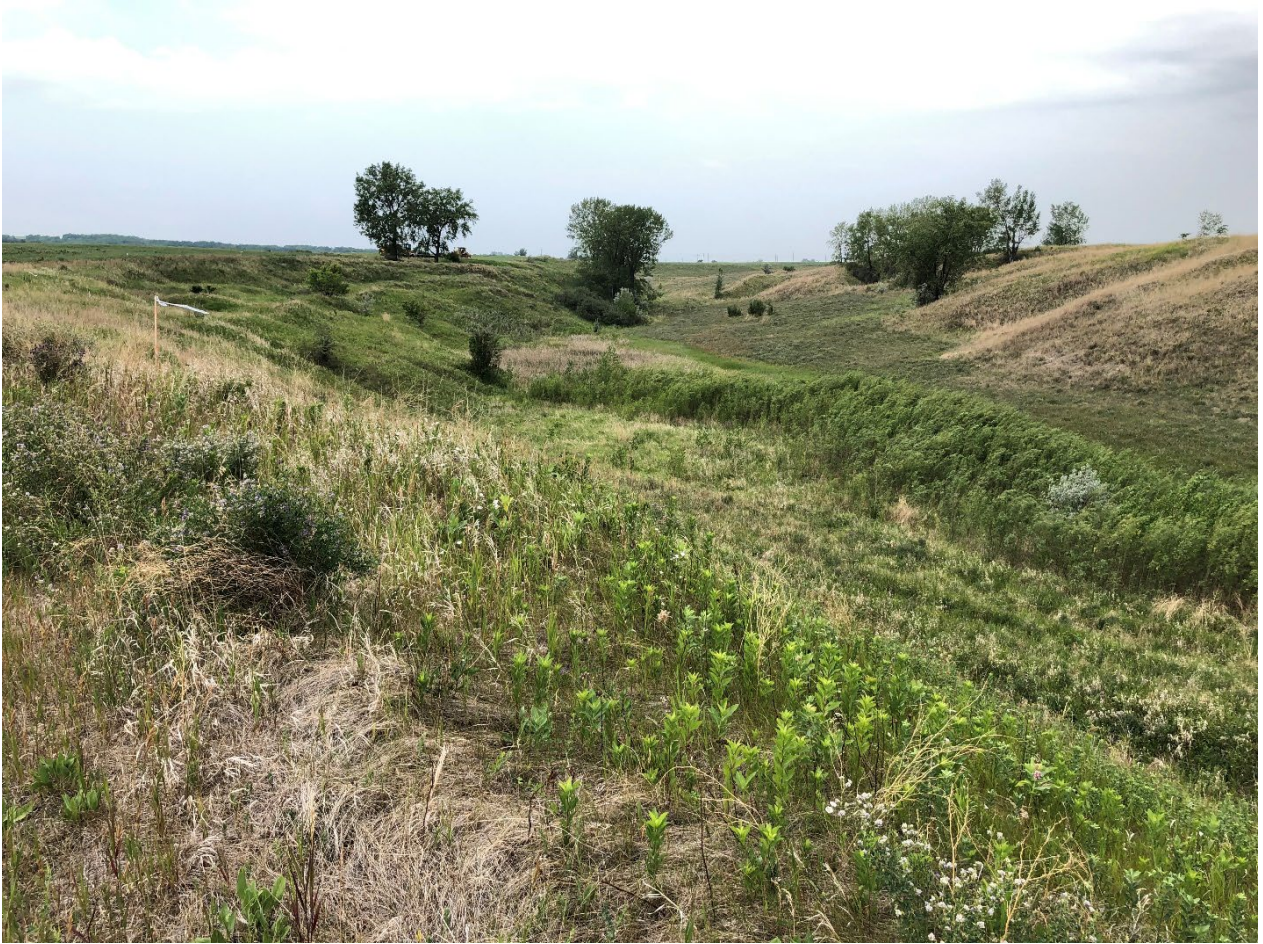
The Lindahl Site (**Figure 5**) is located approximately 2 miles southeast of the Knorr Site and at 14.5 acres was the largest of the un-reclaimed abandoned mines (**Figure 6**). The site contained 1,200 feet of dangerous highwall that was up to 40 feet in height. Erosion features 3 to 4 feet deep had developed in the main drainage along portions of the highwall. The site was partially reclaimed in 2010 and 2011.

Figure 5: *Lindahl site before reclamation.*

The reclamation design for the site involved back-sloping the south highwall and filling it in with spoil material reclaimed from the northern spoil piles. Silt fences were installed before any construction activity to prevent any sediment from leaving the site. Several large trees were removed with a tree shredder (**Figure 7**) which reduced the standing trees to wood chips. Smaller wood chips were salvaged and incorporated into the topsoil.

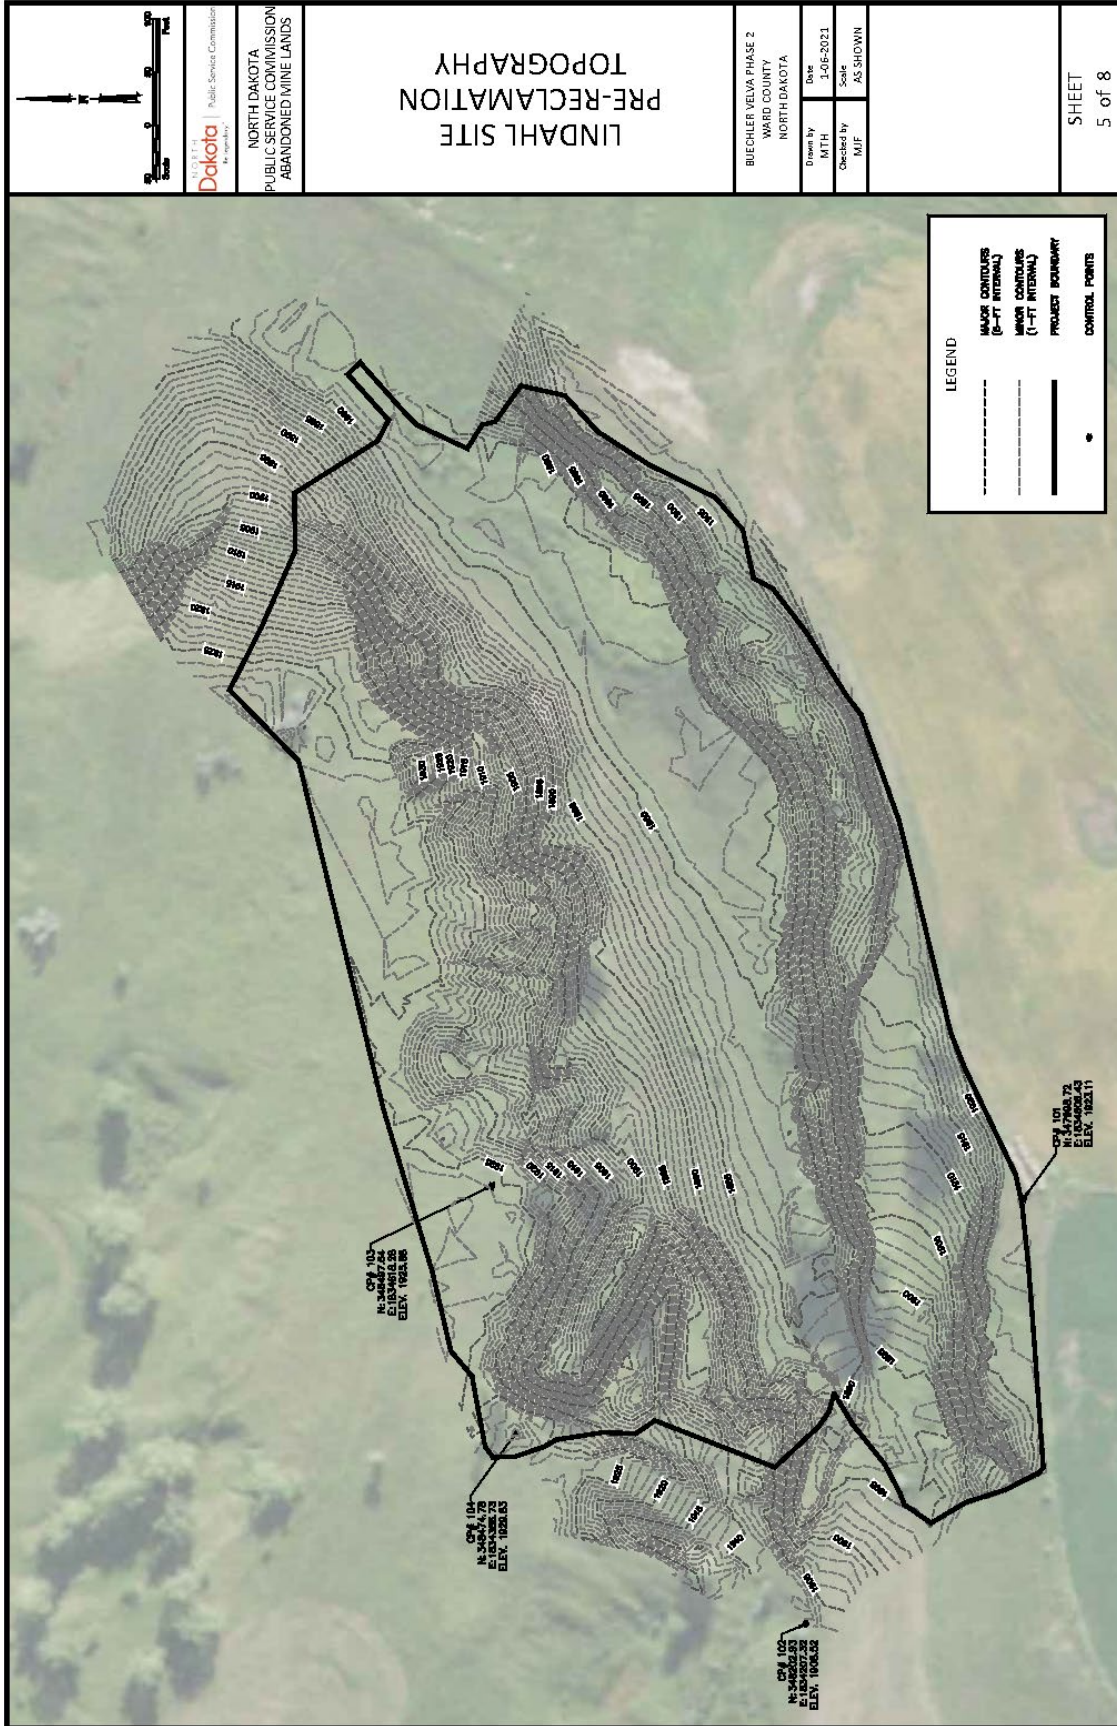
Figure 6: Lindahl Site - Pre-reclamation topography map.

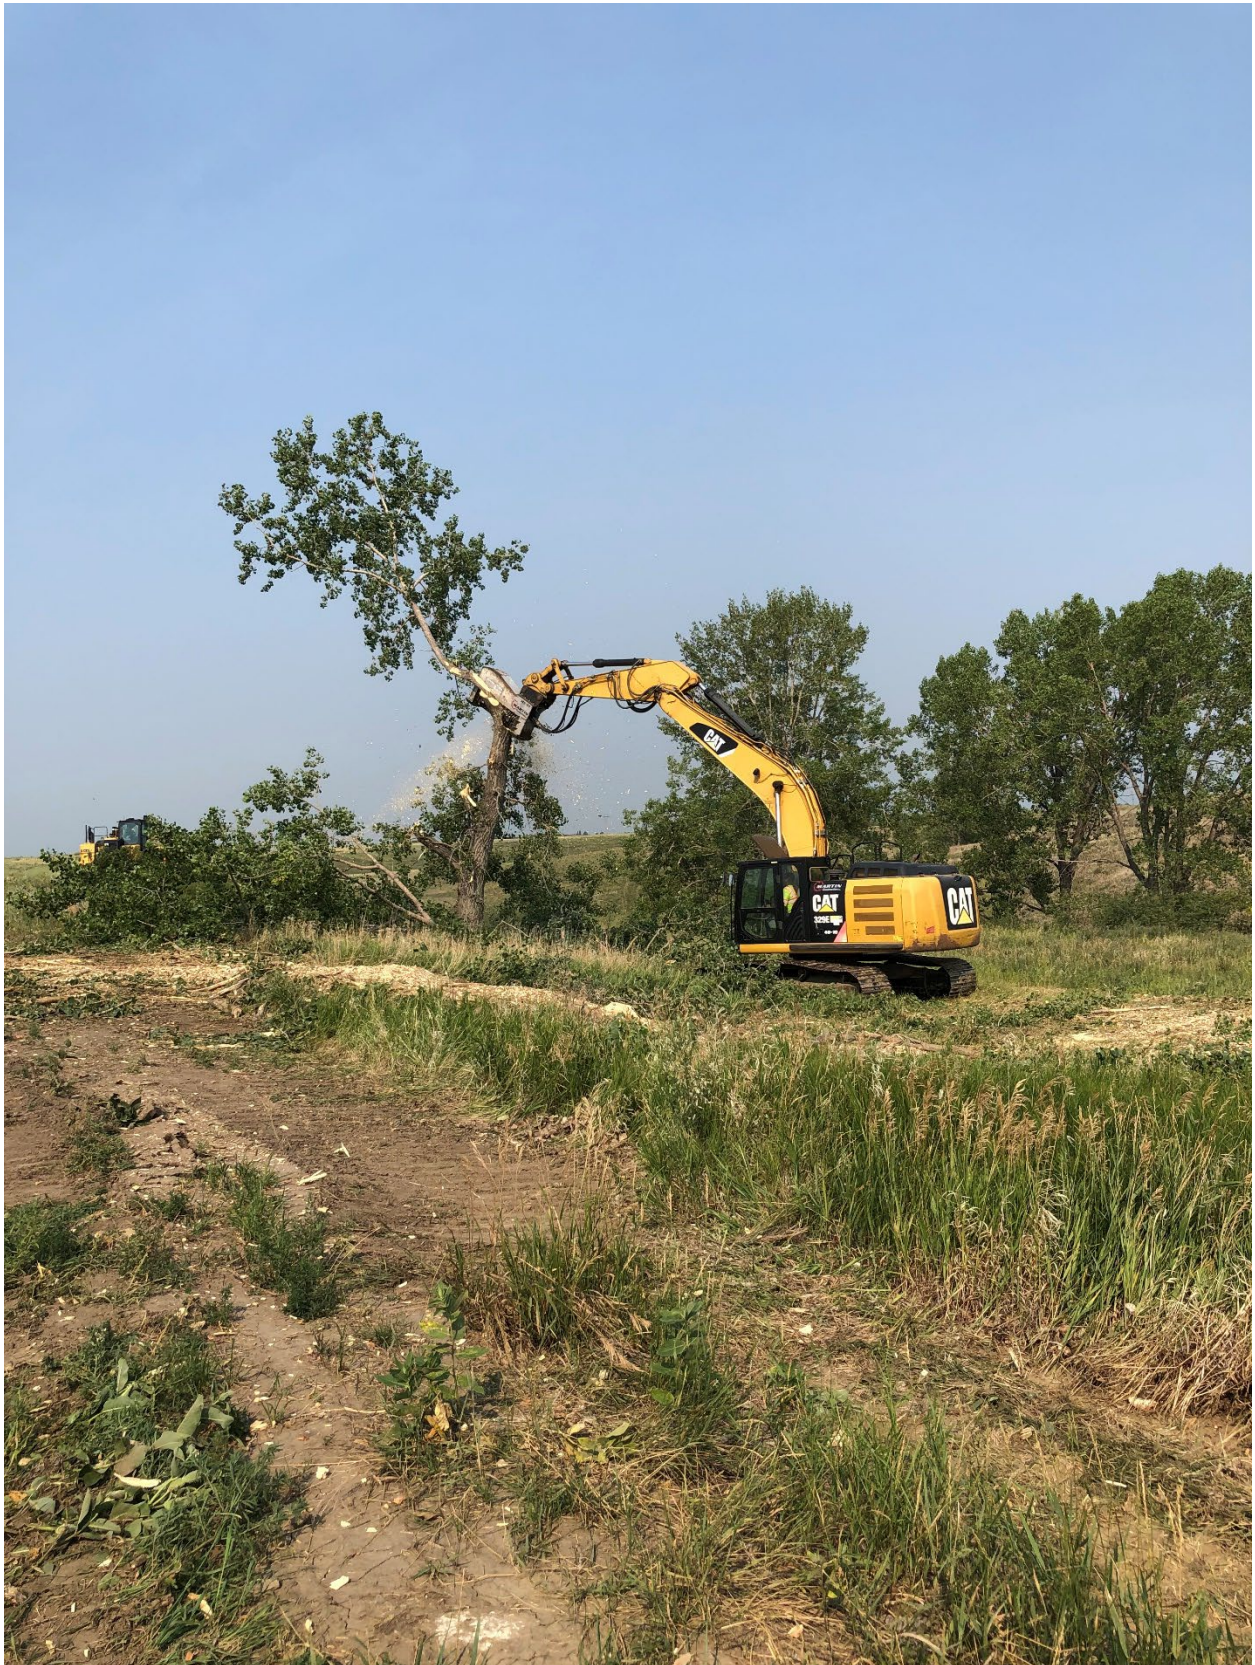
Figure 7: Trees being shredded at the Lindahl Site.

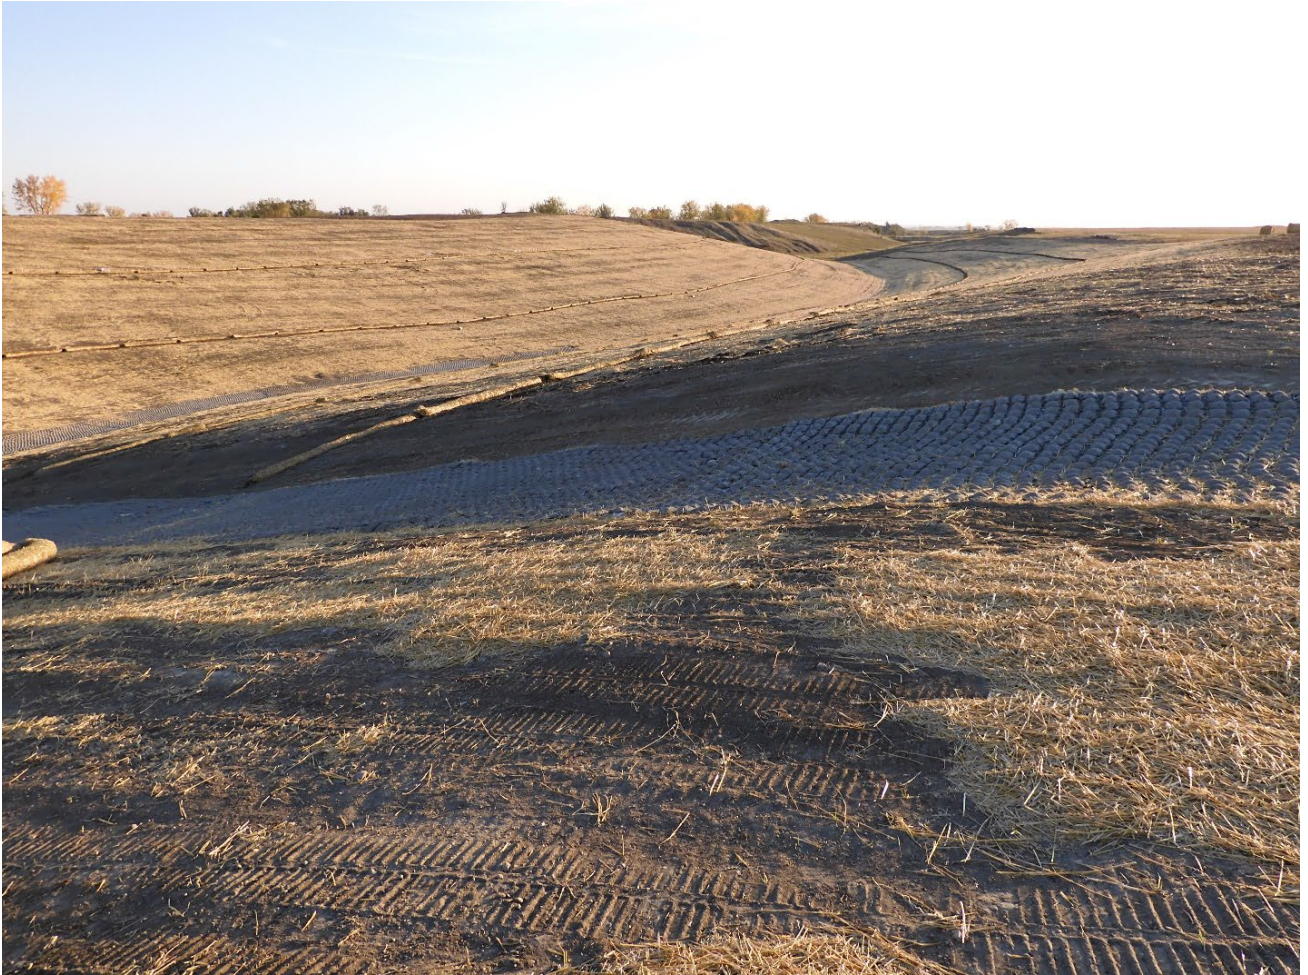
Figure 8: *Lindahli Site after reclamation.*

Reclamation began on July 7 and was complete by September 27, 2021 (58 Days). A total of 44,215 cubic yards of spoil material was used to fill the highwall. Over 7,600 cubic yards of topsoil was salvaged and respread. Once topsoil was respread, 1,325 cubic yards of manure were hauled to the site and spread over the area. The manure was tilled to a depth of 4 inches. The area was then fertilized and seeded with a native grass mix and oats cover crop (**Figure 8**).

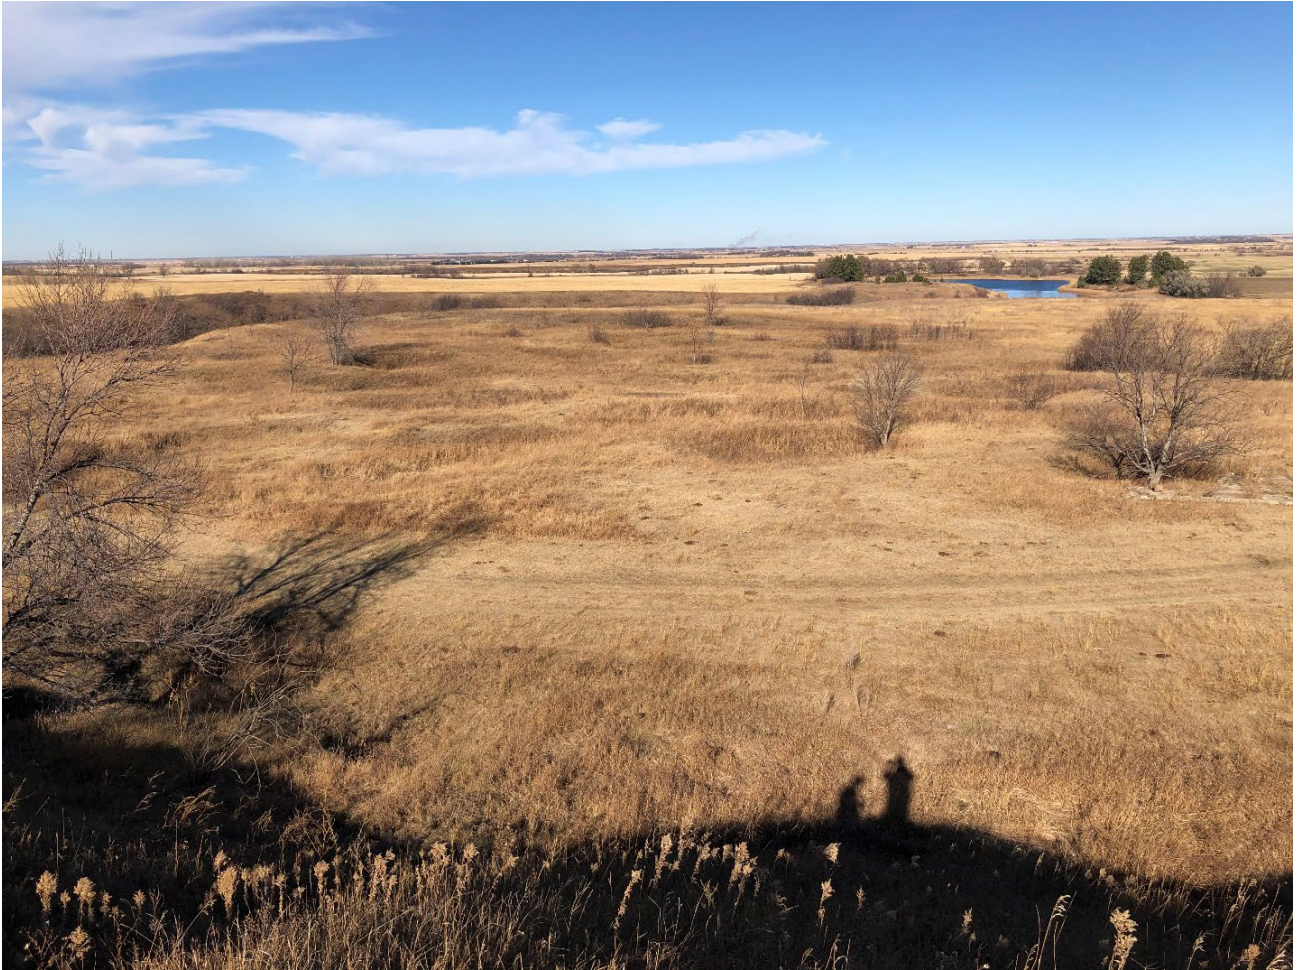
The Quist Site (**Figure 9**) involved reclaiming approximately 90 sinkholes on a 4.7 acre tract (**Figure 10**). The sinkholes varied between 5 to 15 feet in depth and were up to 35 feet long and 20 feet wide.

Figure 9: *Quist Site before reclamation.*

The reclamation of the site involved stripping topsoil from the bottom of the sinkholes and then filling the excavated area to the approximate original contour with fill material taken from an adjacent spoil pile (**Figure 11**). Once the fill material was placed and compacted in the sinkholes the salvaged topsoil was respread. The area was seeded in late September with the native grass seed mix and then mulched and crimped. Construction on the Quist Site began on August 16, 2021, and was completed by September 1, 2021 (13 Days). A total of 4,890 cubic yards of soil was used to fill the sinkholes (**Figure 12**).

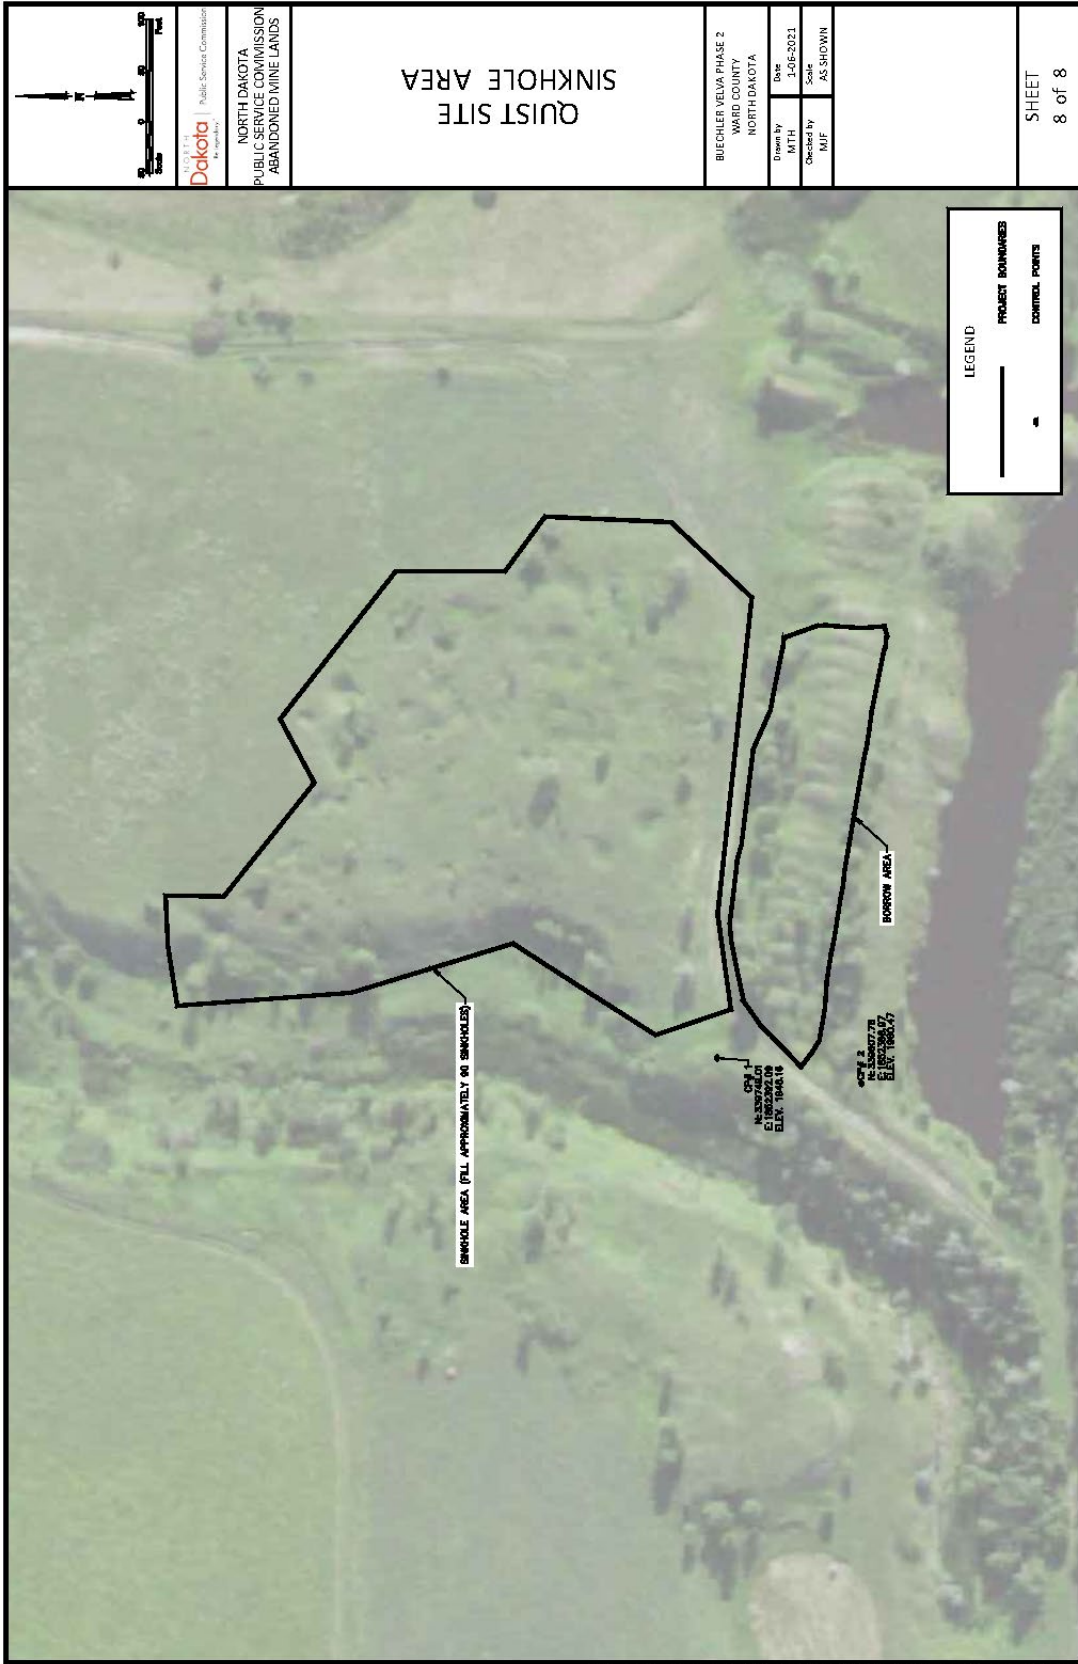
Figure 10: Quist Site - Pre-reclamation map

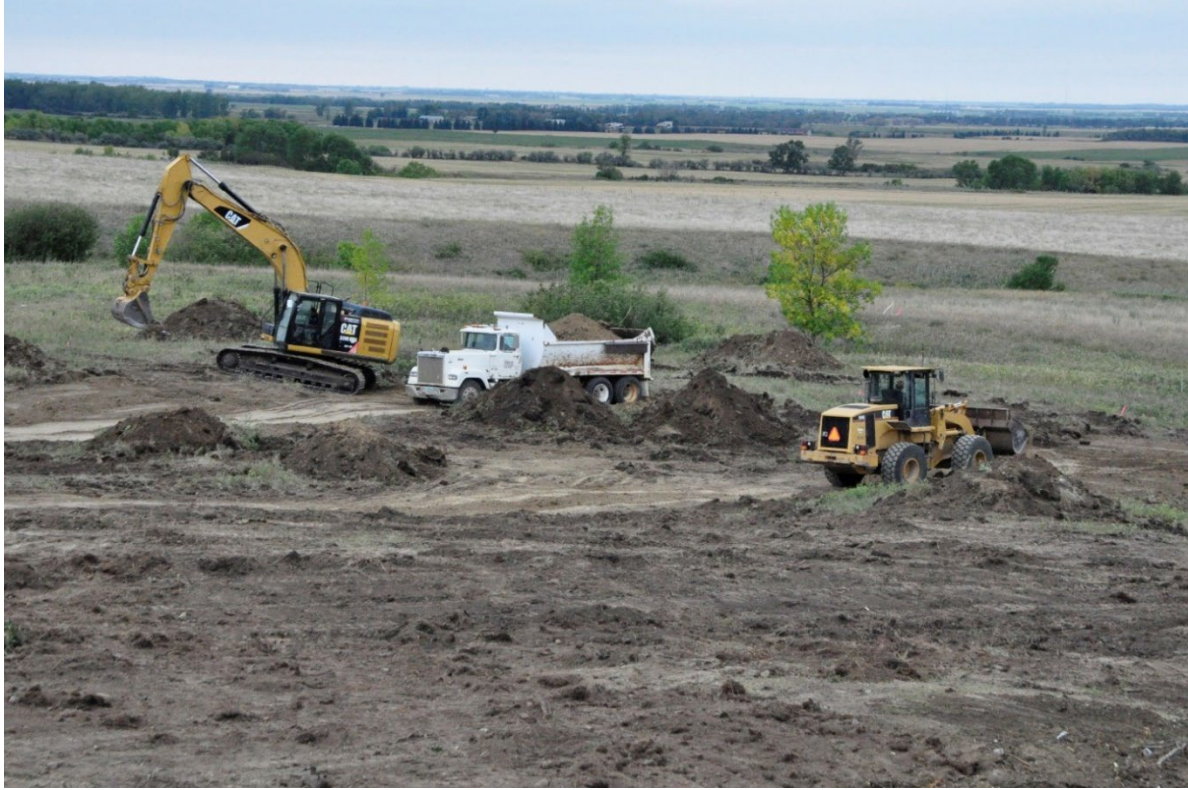
Figure 11: Sinkhole filling at the Quist Site.

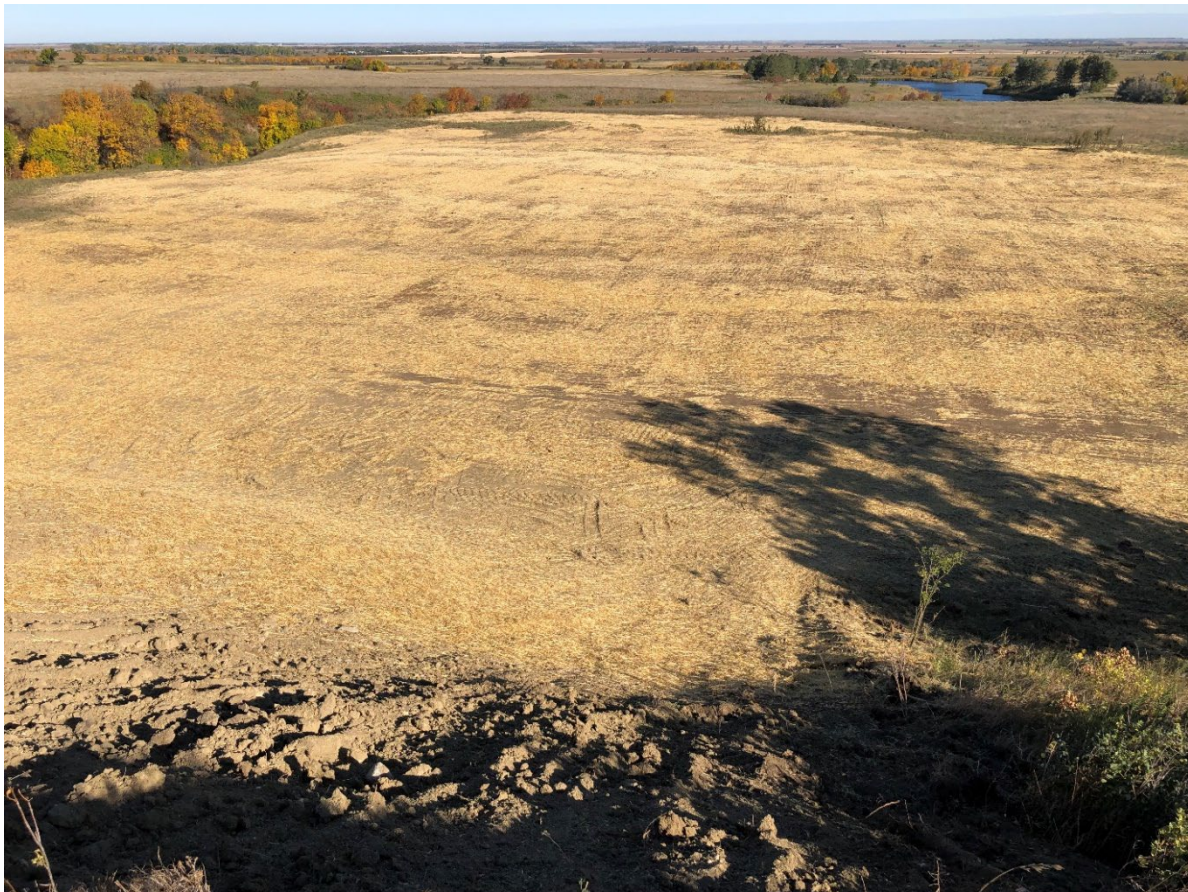
Figure 12: Completed reclamation at the Quist Site.
