2021 Exploratory Drilling AML Project Summary

Project Type: Exploratory Drilling

Drilling to locate and characterize abandoned underground mines.

Belfield, Beulah and Garrison

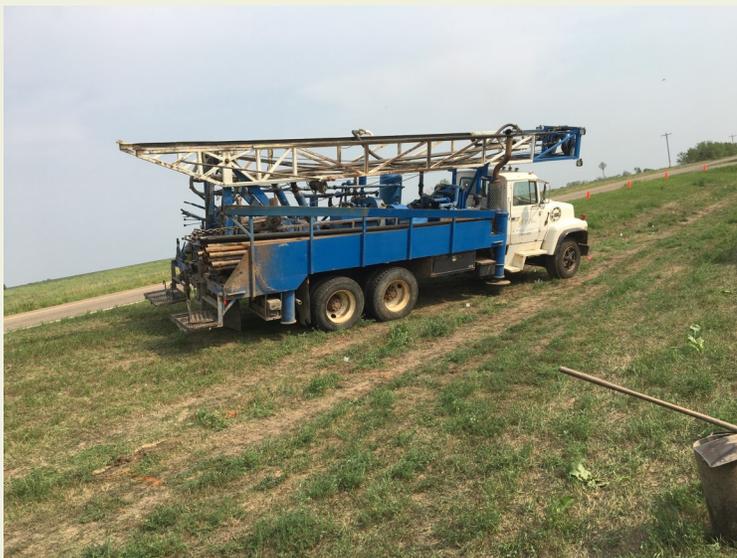
Earth, Energy and Water Systems, Inc. drill rig in the ditch of McLean County Highway 15.

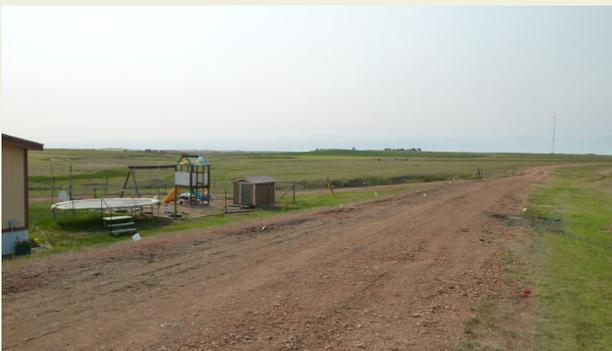
Above is the Belfield site in 2012. The site has not changed much in those 9 years.

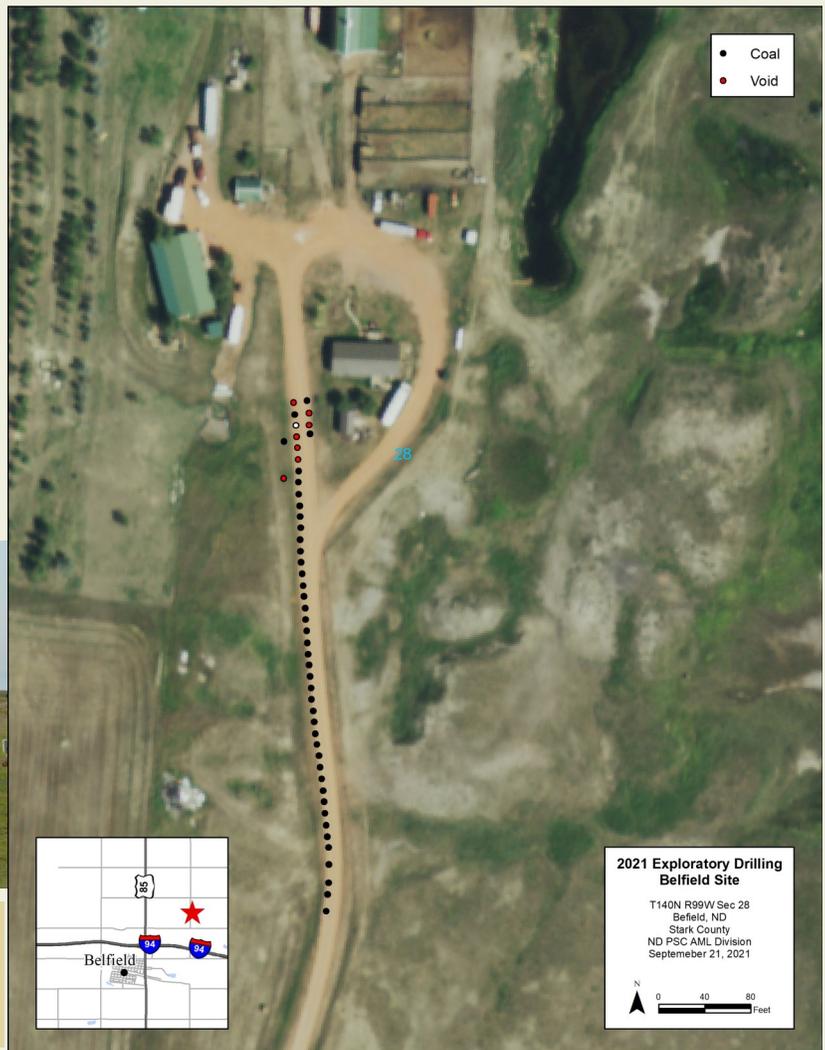
The total drilling depth varied from 26 feet to 40 feet below the surface. The rubble was encountered from 25 feet to 35 feet below surface. The map on the right shows black dots which encountered coal while the red dots encountered mine workings. The single white dot encountered neither coal nor mine workings. A backfilling project is currently being planned to fill the voids.

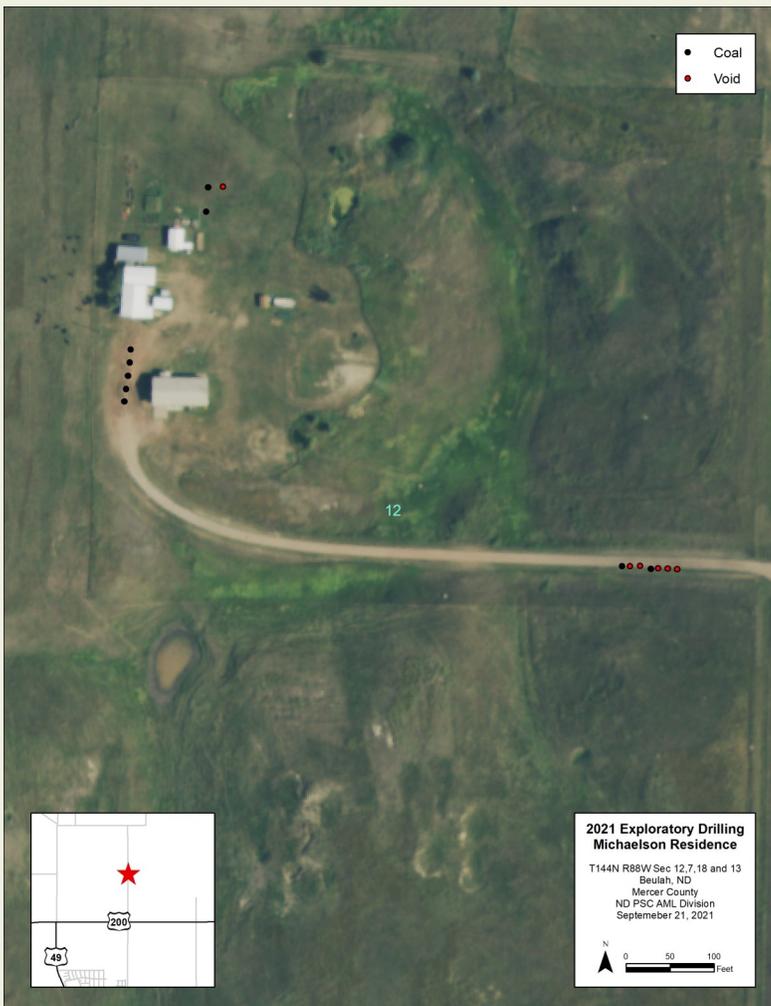
Drilling began on the Michaelson farmstead just north of the town of Beulah, see the map below. There were cased holes here were from a project in 1998 (not shown on map). The landowner wanted the PSC to fin-

ish the drilling and was very cooperative with AML staff and the contractor. Drilling in 2021 found one void in the yard. Holes were also drilled just west of the house and all encountered coal.

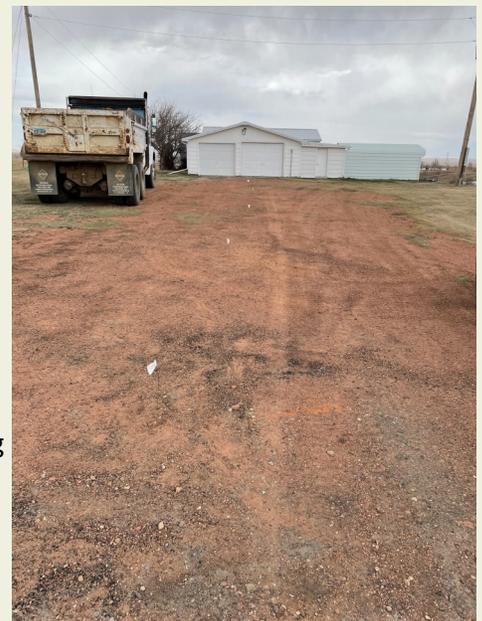
Pinflags mark coal holes just west of the Michaelson residence.

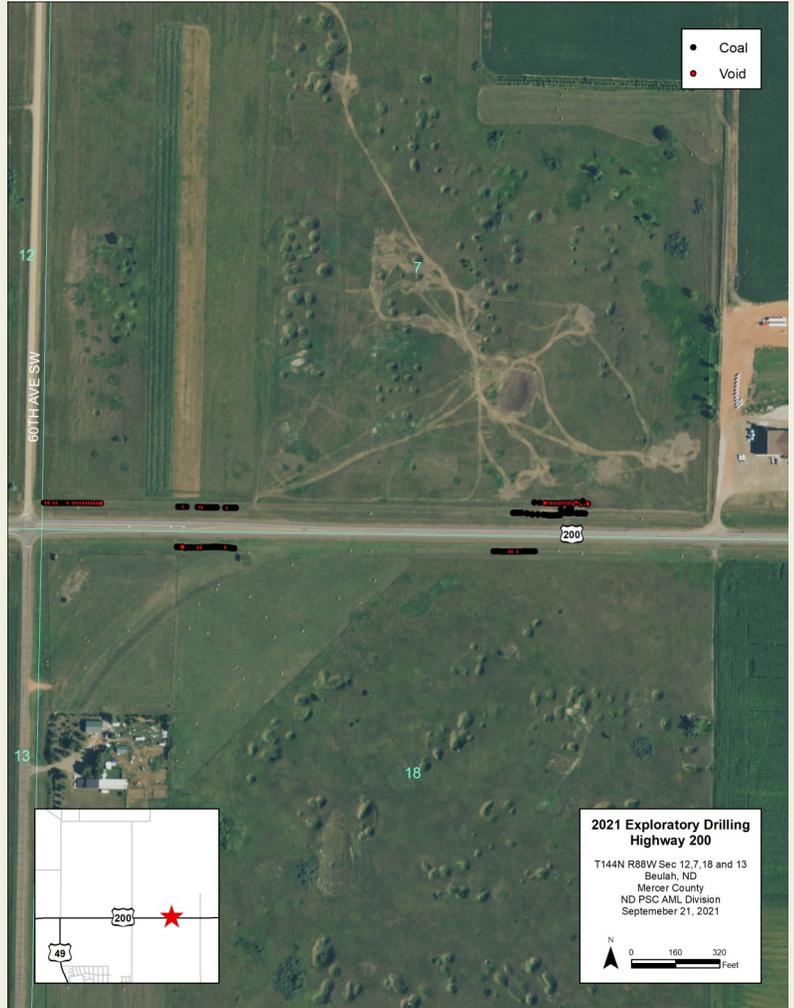
Recently formed sinkholes are good indicators of where to drill. Voids were found near a sinkhole we filled in 2019 and 2020 in the ditch of U.S. Highway 200. Map on the upper right. This ditch was drilled and grouted in past projects. The holes in the ditch ranged from 104 to 126 feet below surface. We encountered 6 holes filled with grout and one partially filled with sand from previous AML projects. We also encountered areas of both open voids at around 110 feet to 120 feet from the surface and upward migration of voids ranging from 30 feet to 90 feet.

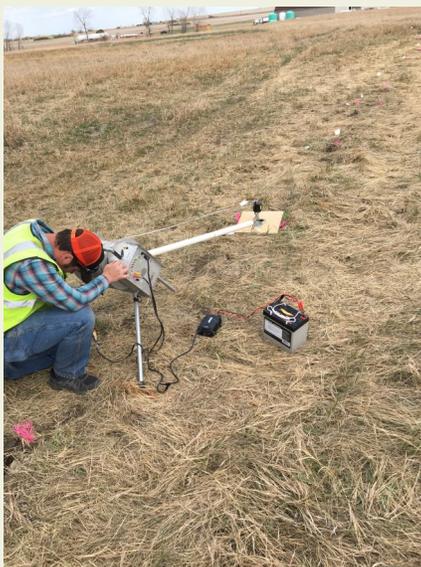
Environmental scientist Ross Edisson operating the borehole camera.

One useful tool we used to confirm the drilling logs was a borehole camera provided by the Office of Surface Mining Reclamation and Enforcement. The camera was designed to fit into the casing and be lowered down to the mine voids. The camera is equipped with lights to illuminate the dark mine. Images and videos were recorded to be viewed later. We use the camera to help estimate how much material we need to fill the voids.

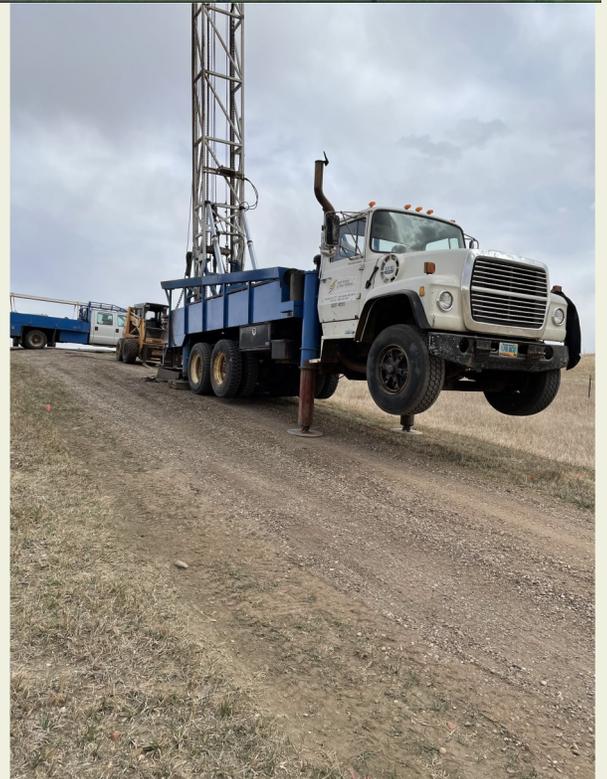
Drilling the driveway presented a challenge because of the steep 18% grade. The drill rig was equipped with jacks that made it safe to drill by lifting the front end while keeping the back end at ground level. Of the 7 holes drilled on the drive-

Drill rig on Curt Michaelson's Driveway at 18% grade.

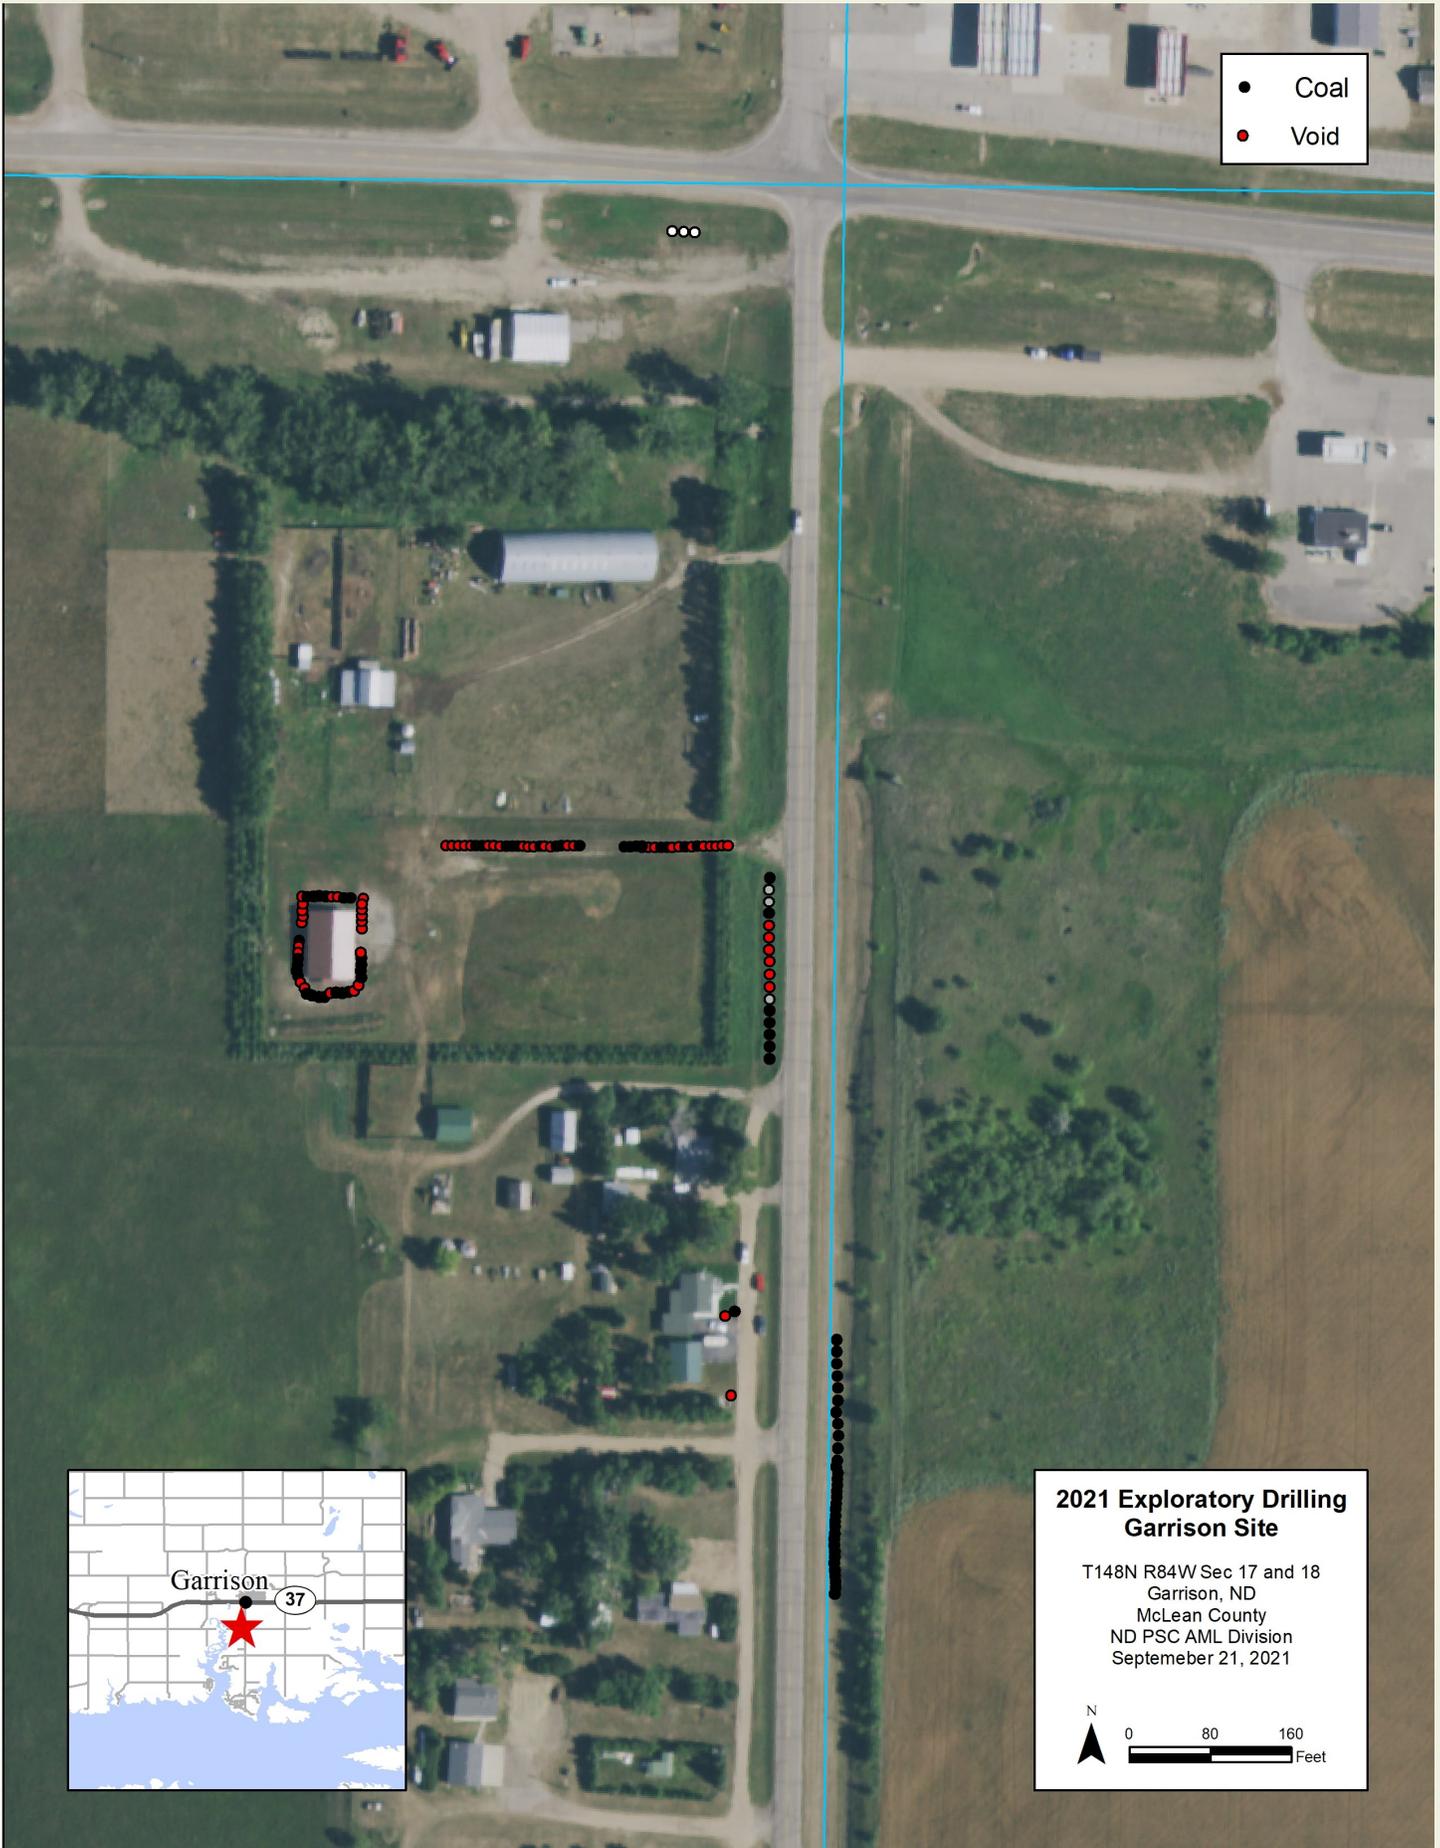
**2021 Exploratory Drilling
Garrison Site**

- Coal
- Void

The map on page 6 shows the 2021 drill holes. Several voids encountered around the house suggest that Dean

Folden's house is undermined. Additional drilling inside the unfinished house is scheduled for 2022. Two of three drill holes near another home encountered rubble. There were also some voids as well as hardened grout from previous projects

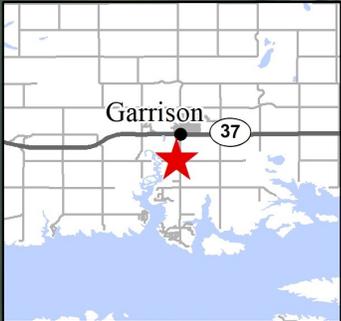
T148N R84W Sec 17 and 18
Garrison, ND
McLean County
ND PSC AML Division
Septemeber 21, 2021

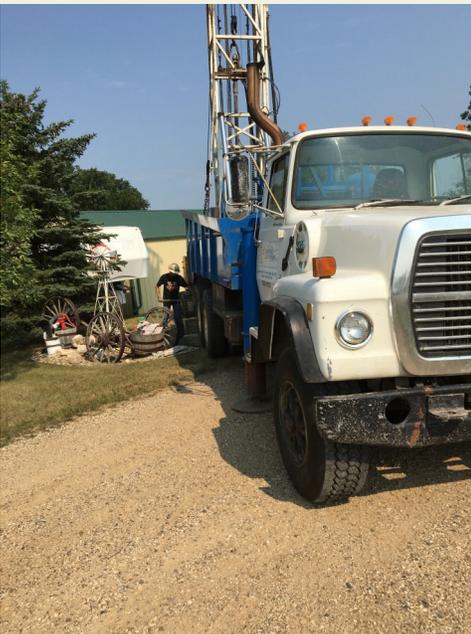
Above: Drilling being done near the Brunsell residence.

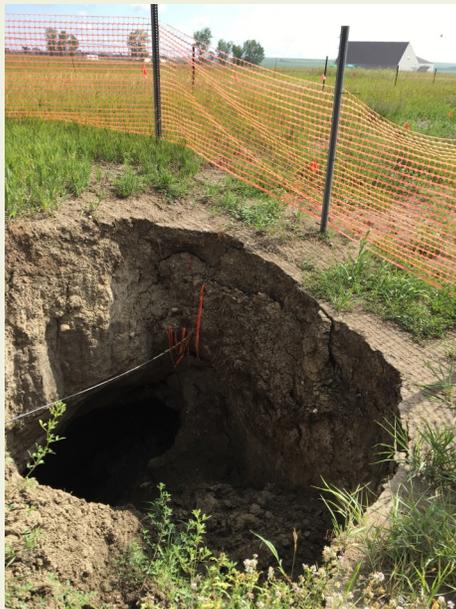
The sinkhole on the right opened in spring 2020 in the ditch of U.S. Highway 200 near Beulah. The sinkhole opened up within a few feet of a sinkhole filled in 2019. Reoccurring sinkholes are a hazard and often it remote backfilling may be needed.
