Abandoned Mine Land Problems and Solutions in North Dakota

William E. Dodd
North Dakota Public Service Commission
May 2002

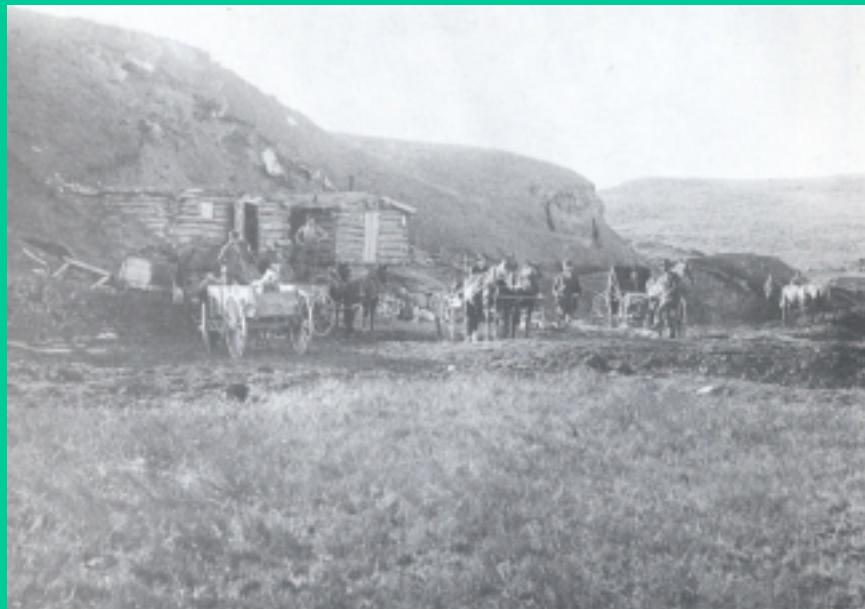
Coal Mining in North Dakota: Historic Mining

The first commercial mine in North Dakota opened in 1873, about 30 miles west of Bismarck. Since then, over 600 lignite mines have operated in North Dakota. This is a picture of the Satterlund Black Diamond Mine, near Washburn, circa 1895.

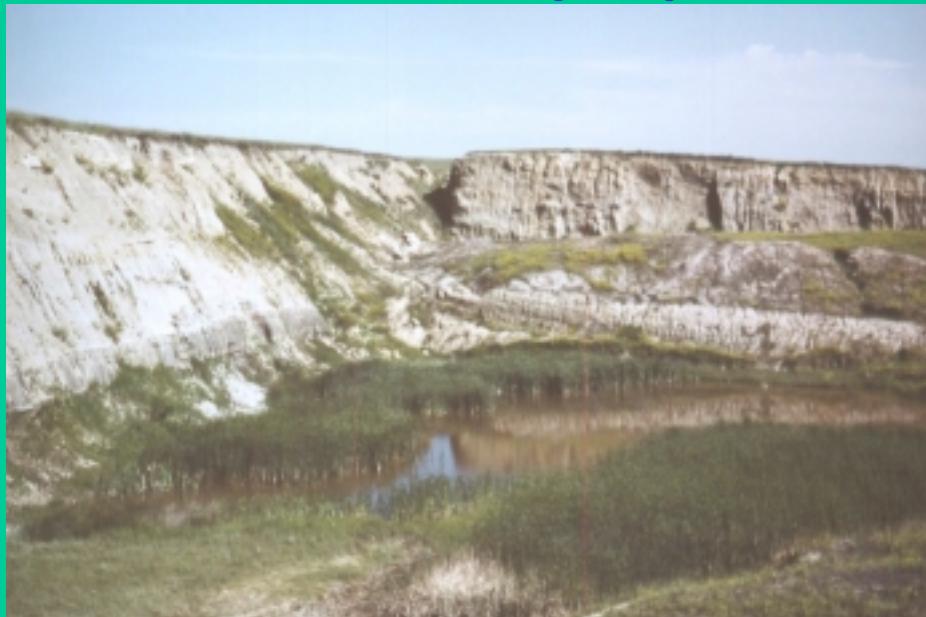
North Dakota AML Problems: Dangerous Highwalls

This hazardous abandoned surface mine with steeply sloping highwalls was located near Center, ND. It was reclaimed in a 1989 AML Project.

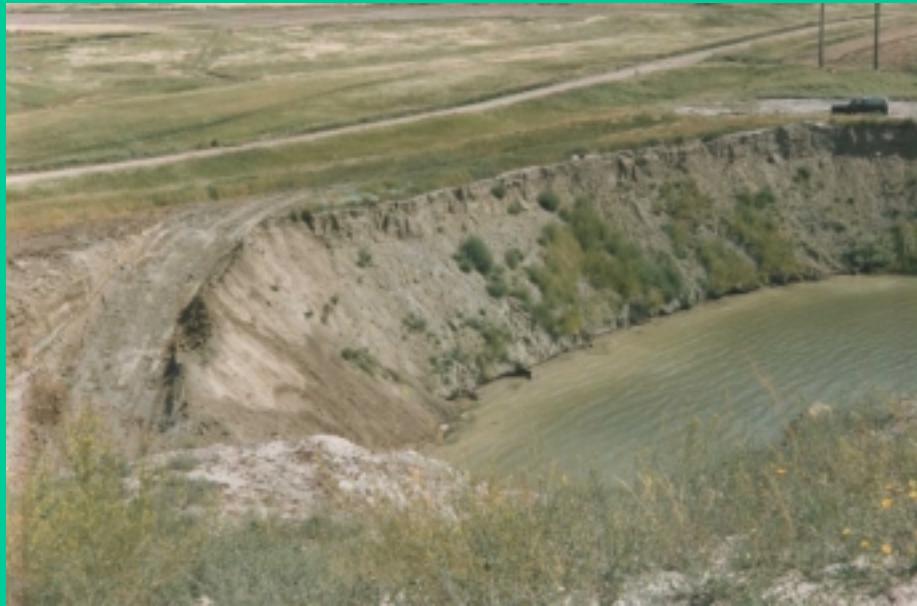
North Dakota AML Problems: Dangerous Highwalls/Hazardous Water Bodies

This is the edge of a surface mine highwall near Noonan, ND, that extended approximately 3 1/2 miles in length. The highwall dropped about 60 feet to a hazardous water body that was up to 30 feet deep. It took several years and millions of dollars to reclaim this site.

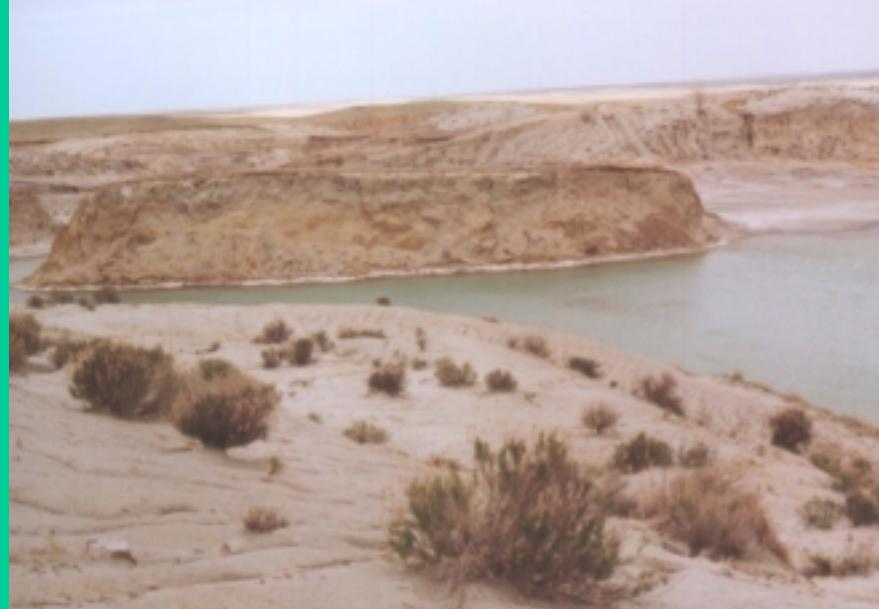
North Dakota AML Problems: Dangerous Piles & Embankments/Polluted Water

Uraniferous, or uranium bearing, coal was mined from this site near Amidon, ND, in the early 1960s under contract to the Atomic Energy Commission. Coal was burned in the pit and the ash was shipped to processing plants. When the mine was abandoned, uranium-rich ash polluted the water and the soil. This site was reclaimed in 1992.

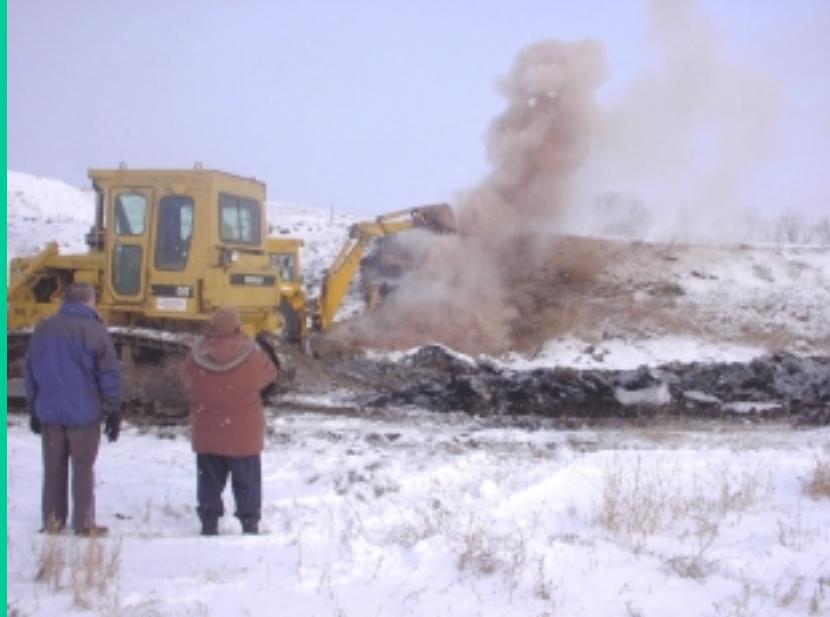
North Dakota AML Problems: Coal Fires

Coal refuse fires, like this one burning in Beulah, ND, January 2002, are difficult to extinguish. Coal screenings had been deposited at this site, near the former location of a power plant, for many years and were several feet deep. Emergency reclamation included excavating the burning materials, dousing with water and burying them in a pit.

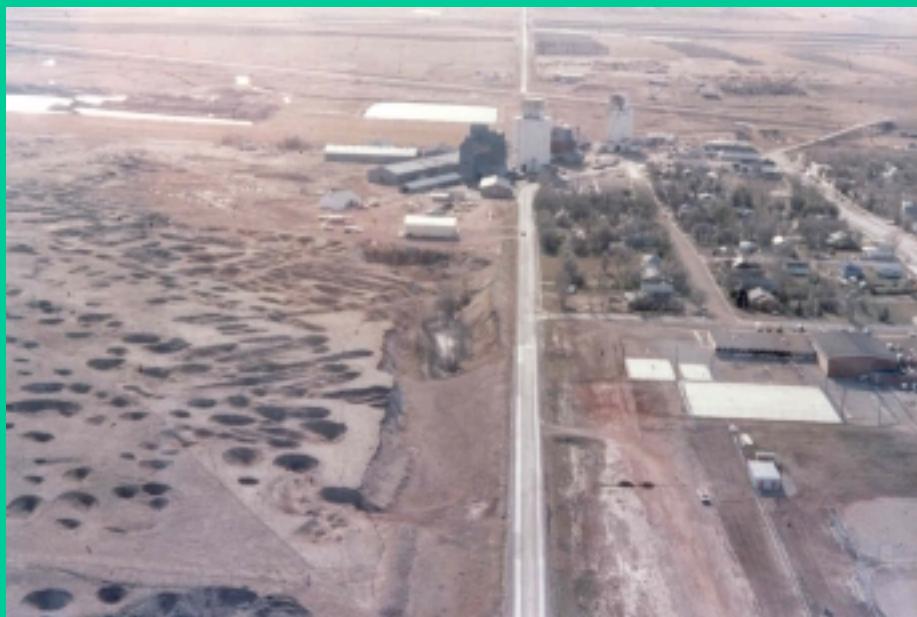
North Dakota AML Problems: Subsidence

This picture, taken near Scranton, ND, in the early 1980s, provides an example of the hazards associated with abandoned underground mines. A portion of this site was "daylighted" or completely excavated and reclaimed in the mid-1980s.

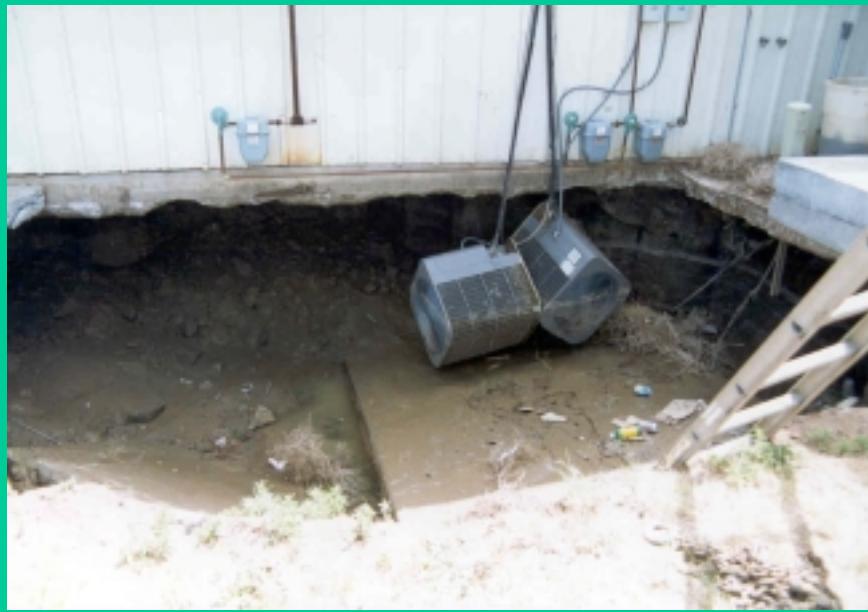
North Dakota AML Problems: Subsidence

Underground mine subsidence can be especially dangerous when near residential/commercial areas or public roads. This sinkhole collapsed suddenly beneath the Black Diamond Lounge in Beulah in 1993. It damaged the foundation, severed water lines and ruined air conditioning units. Luckily no one was injured and the sinkhole was repaired.

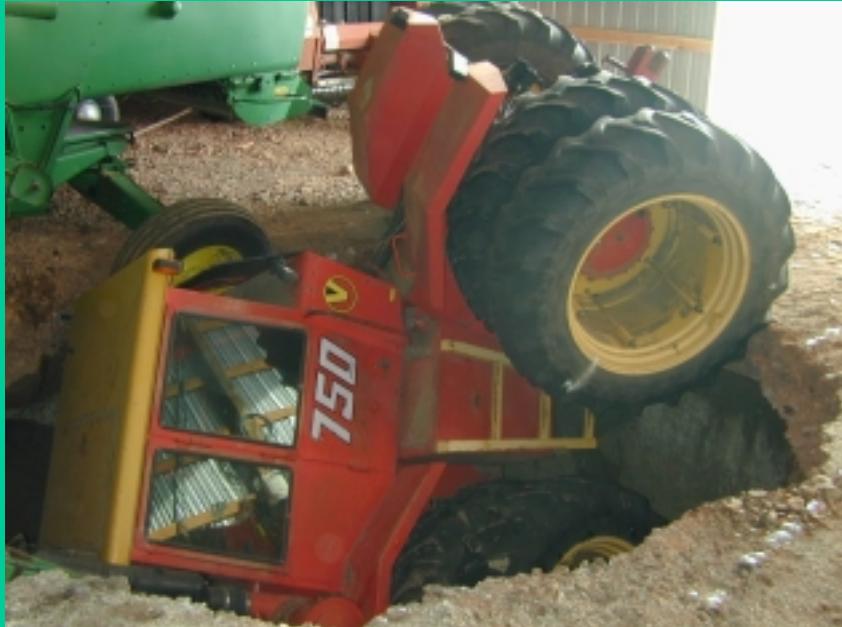
North Dakota AML Problems: Subsidence

This sinkhole collapsed suddenly in a machine shed near Beulah "swallowing" a tractor. It was repaired in an emergency project conducted in 2001.

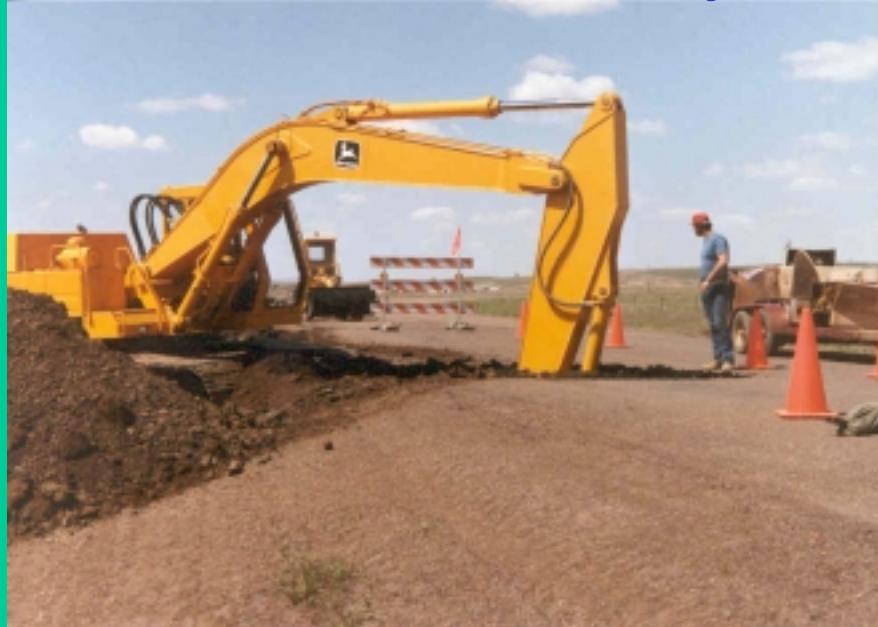
North Dakota AML Reclamation: Sinkhole Filling

The easiest and cheapest way to remedy underground subsidence is to excavate and fill the sinkholes with dirt. However, these sinkholes can be extremely hazardous to the public. This 10 foot deep sinkhole appeared suddenly on the driving surface of Lehigh Road near Dickinson, ND, in the mid 1980s.

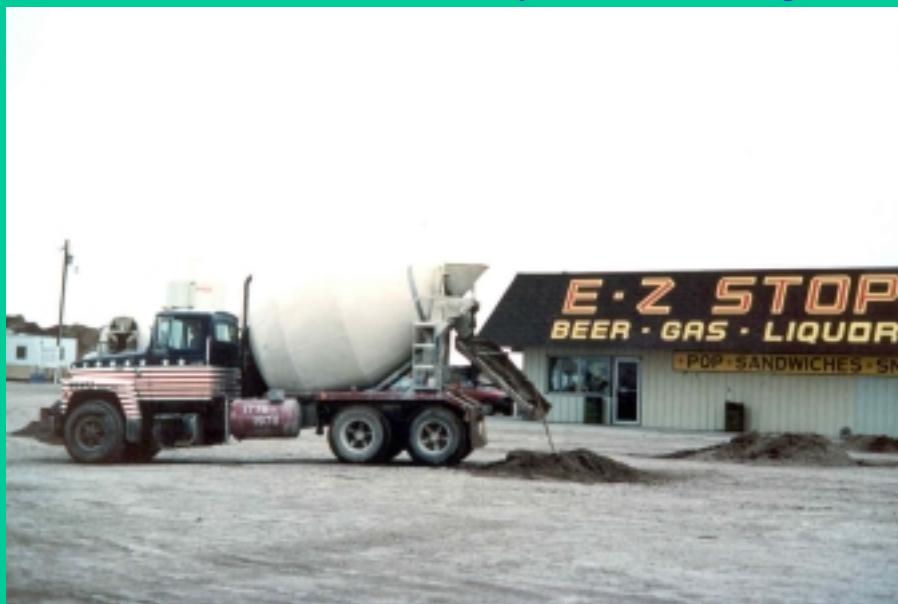
North Dakota AML Reclamation: Slurry Fill Remote Backfilling

Subsidence control projects have been conducted in North Dakota since 1982. In this 1983 project near Beulah, a slurry of sand and water was "poured" into the mine workings through large diameter drill holes. This method was adequate when the mine was intact and open but was less effective when the mine had already begun to collapse.

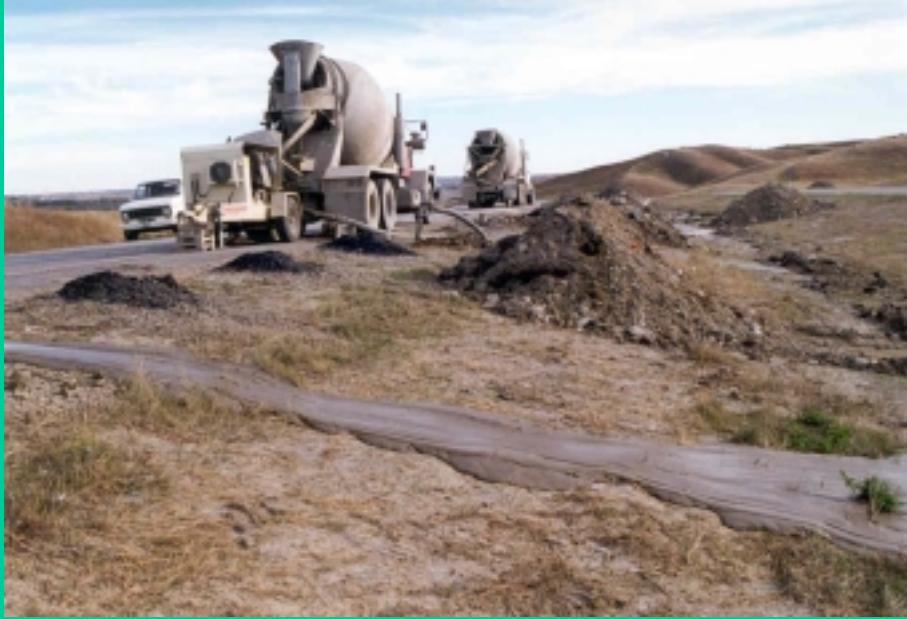
North Dakota AML Reclamation: Pressurized Grout Remote Backfilling

Since 1991, pressurized grout remote backfilling has been used for subsidence control in "high use" areas. Pumping pressure enables the cementitious grout to penetrate partially collapsed mine workings. In this 1994-95 project, grout was pumped under a 3000 foot long segment of a four-lane highway near Burlington, North Dakota.

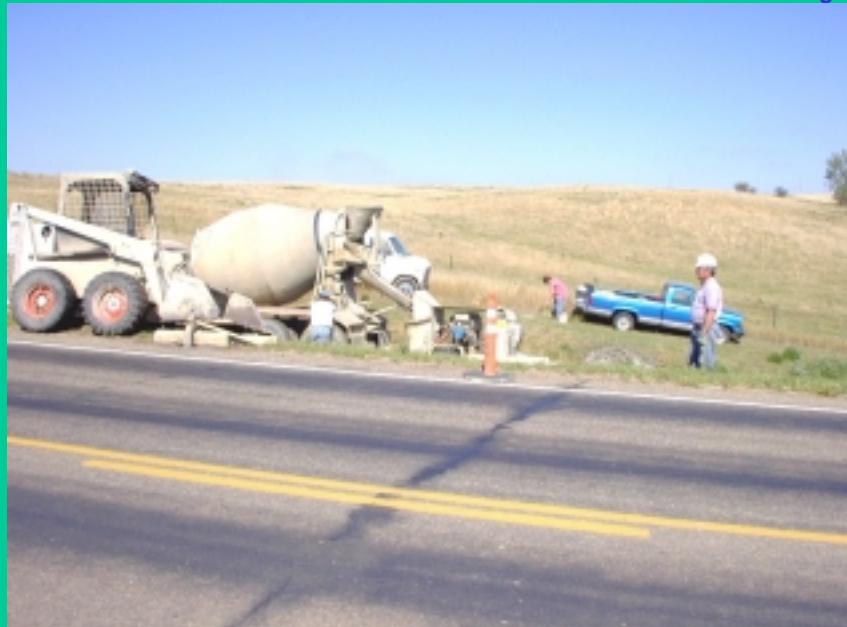
North Dakota AML Reclamation: Pressurized Grout Remote Backfilling

Grout Injection along US Highway 200 near Beulah in 2001. Grout was composed of cement, flyash, aggregate, superplasticizer and water. The material tester in the background is testing the slump of the grout. Grout used at this location was about 10-inch slump. The grout must achieve unconfined compressive strength of 150 PSI at 28 days.

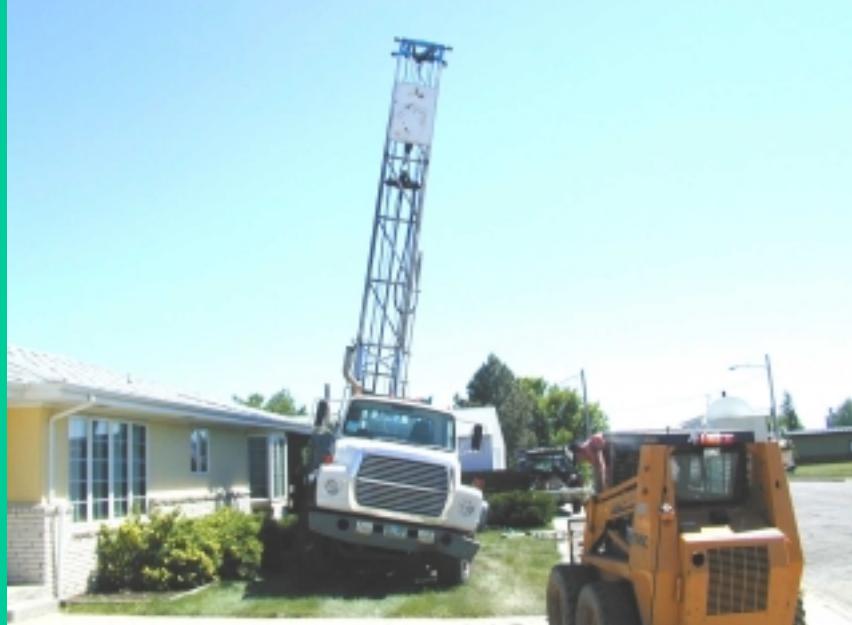
North Dakota AML Reclamation: Pressurized Grout Remote Backfilling

Angled drilling was used during the 2000 Beulah project in order to intercept mine workings directly underneath homes and other structures.

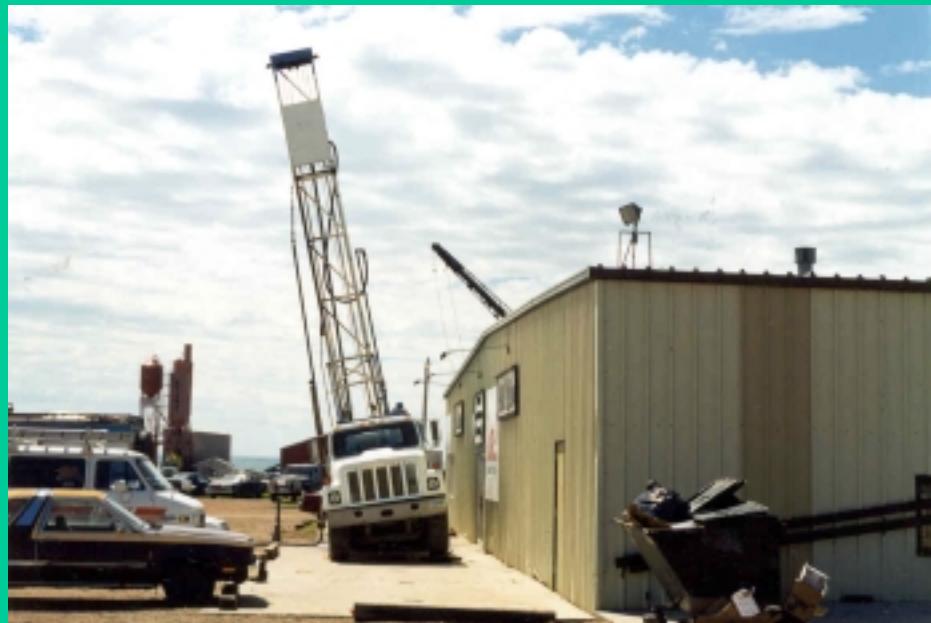
North Dakota AML Reclamation: Pressurized Grout Remote Backfilling

This angled drilling was conducted during a 1997 project to stabilize a bar, restaurant, and gas station near Beulah.

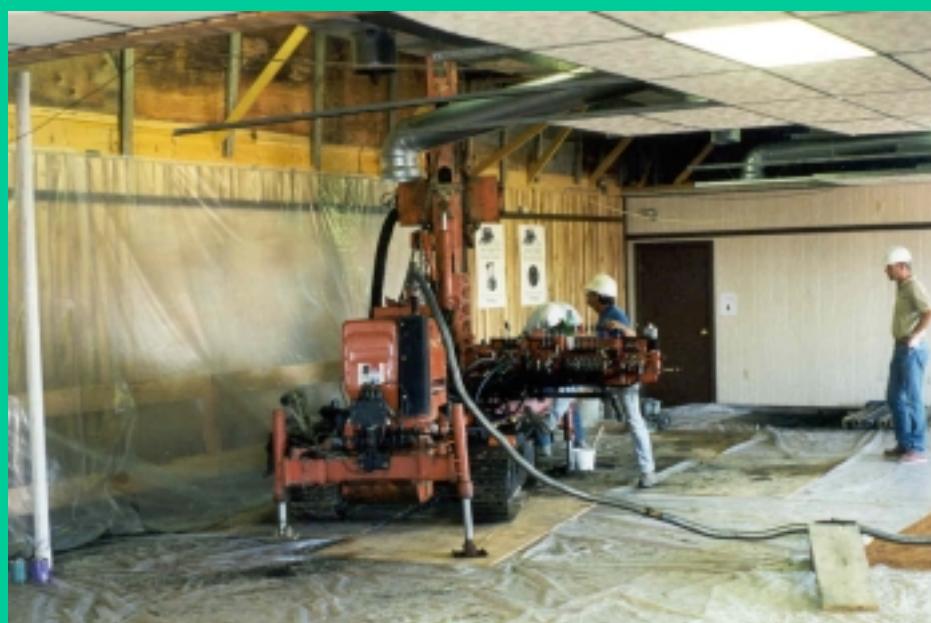
North Dakota AML Reclamation: Pressurized Grout Remote Backfilling

This slide shows drilling directly through the floor of a restaurant in order to fill the mine voids beneath it.

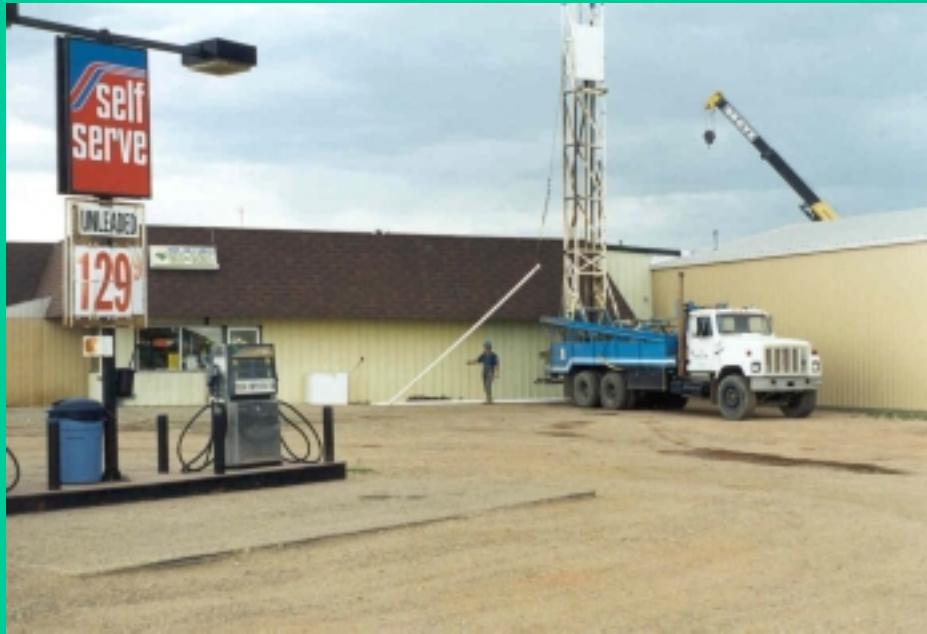
North Dakota AML Reclamation: Pressurized Grout Remote Backfilling

This shows the casing of a drilled hole with 3 inch ID Schedule 40 PVC Pipe. The casing was used as a conduit to pump grout into the underground mine beneath a gas station in Beulah.

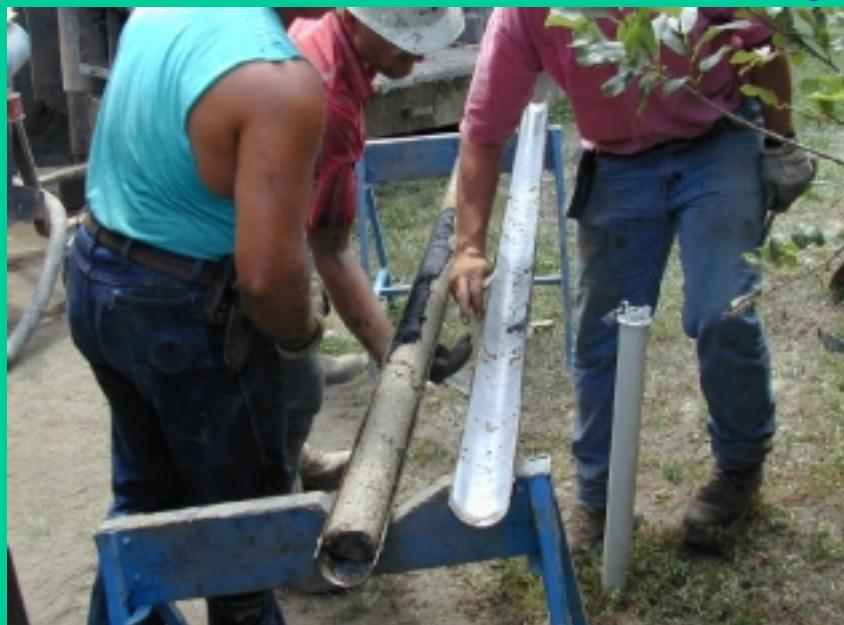
North Dakota AML Reclamation: Pressurized Grout Remote Backfilling

Confirmation drilling and coring are conducted to make sure the underground mine workings have been stabilized and that the grout has set properly. Note the groundwater monitoring well to the right of the core barrel.

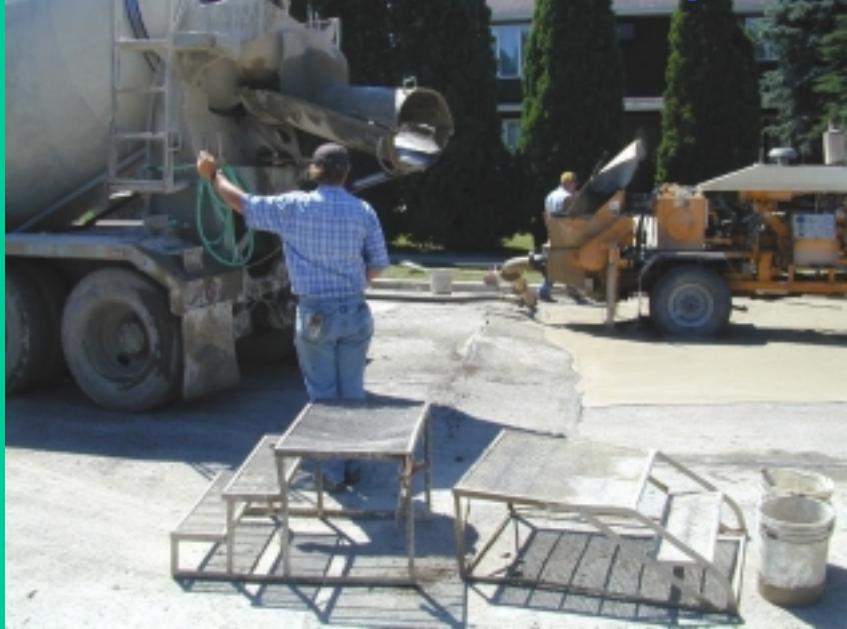
North Dakota AML Reclamation: Surface Lifting

Pressurized grout remote backfilling caused this lifting feature and blowout on 1st Street in Beulah. The "bulge" was about 20 feet long, 15 feet wide, and 1 foot high. It was leveled by the contractor and the City of Beulah repaved the street. Injection pressure was only about 10 PSI when this occurred.

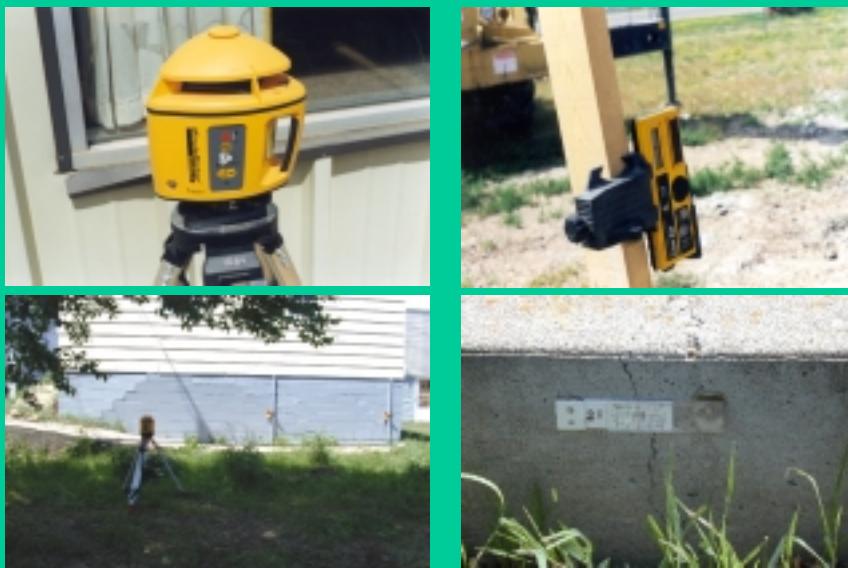
North Dakota AML Reclamation: Structural Monitoring

Because pressurized grout remote backfilling poses some risk of surface lifting and resultant damage to structures, specialized surveys and monitoring techniques are used. Pre- and post-construction elevation surveys, visual inspections, continuous laser level monitoring, and crack monitors are some of these techniques.

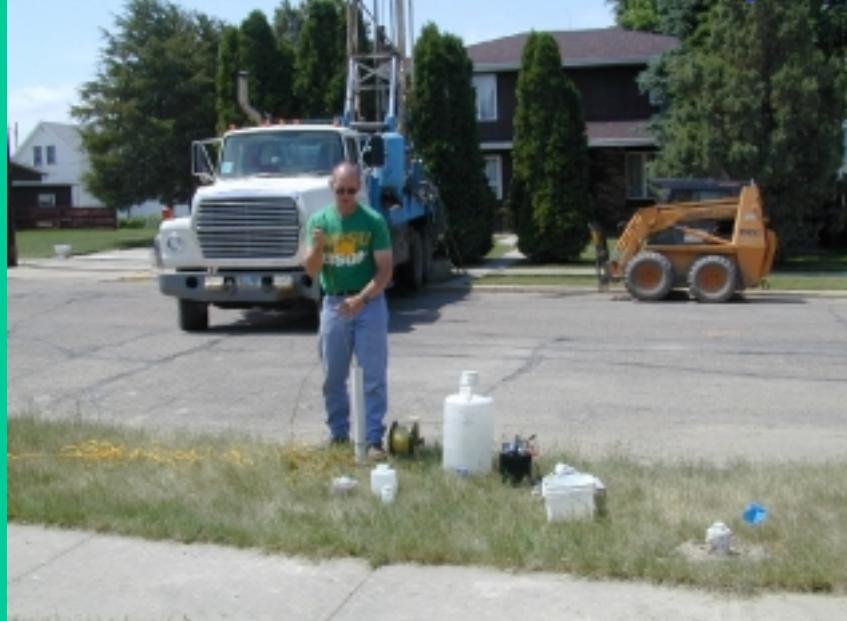
North Dakota AML Reclamation: Groundwater Monitoring

Pressurized grout remote backfilling can affect groundwater levels and quality in the mine or adjacent unmined coal seam. The AML Division works closely with the North Dakota Department of Health to ensure that groundwater resources are not adversely affected.

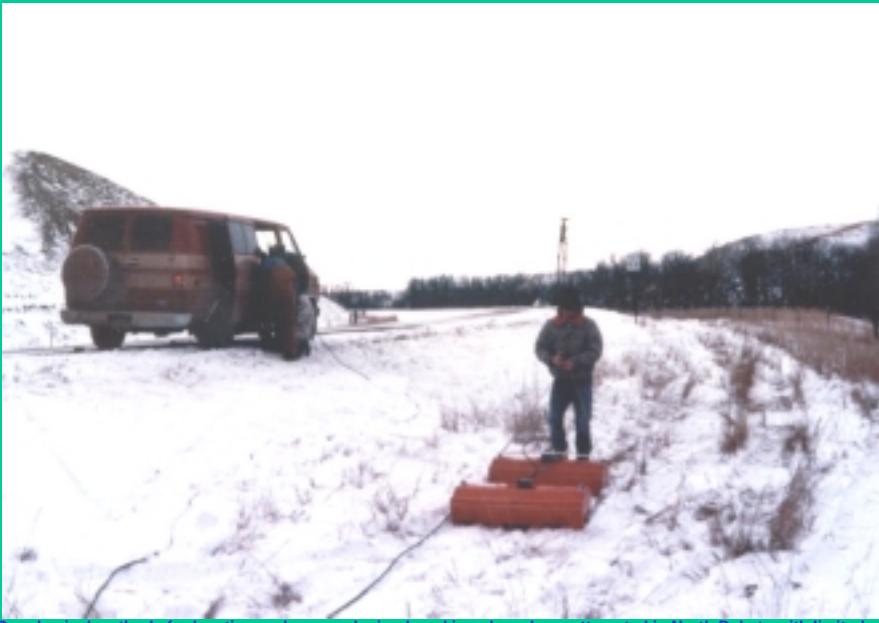
North Dakota AML Reclamation: Geophysical Void Detection

Geophysical methods for locating underground mined workings have been attempted in North Dakota with limited success. This shows Dr. Richard Faffak conducting a ground penetrating radar survey along Snake Road near Burlington, ND, in 1994. Wet clays in the glacial till overburden attenuated the signal and caused poor results.
