Summary Report
North Dakota Public Service Commission
2014 Dickinson-Bowman Emergency Project
Contract AM-679-13

The North Dakota Public Service Commission administers an Abandoned Mine Lands (AML) Reclamation Program on behalf of the State of North Dakota. The AML program is charged with eliminating existing and potential public hazards resulting from abandoned surface and underground coal mines. It is funded by a production fee on lignite coal mined in the state.

The 2014 Dickinson-Bowman Emergency Project was conducted to repair dangerous sinkholes caused by underground mine collapse along Lehigh Road near Dickinson and near the intersection of 81st Street and 146th Avenue north of Bowman, ND. The initial Dickinson sinkhole was reported on January 31, 2014 and the Bowman sinkholes were reported on February 19, 2014. Safety fences were constructed around the sinkholes to protect the public and sinkhole filling was conducted after the spring thaw. Sinkhole filling began May 1 and was completed June 16, 2014. The contractor was Pleasant and Sons Construction of Greenville, KY, who was already under contract. The contract cost for this work was \$23,530.

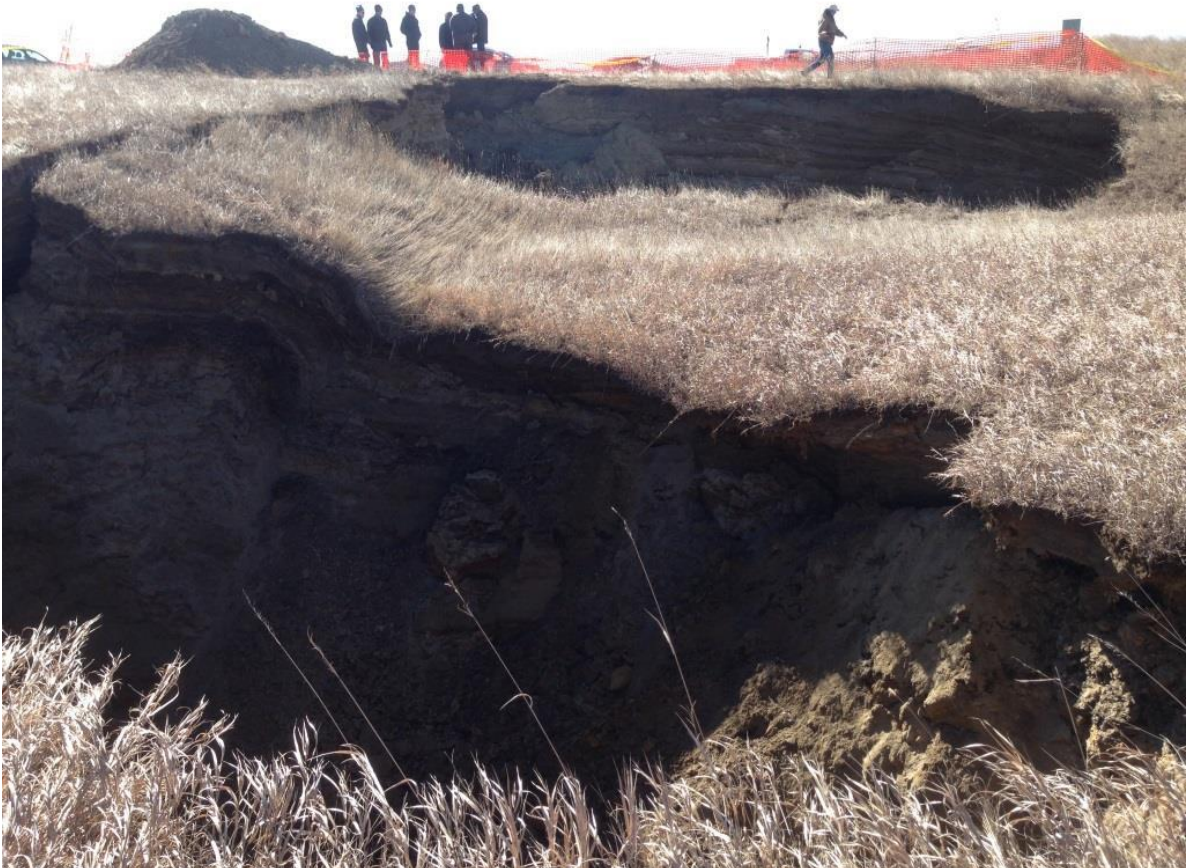
Bowman sinkhole inspection with representatives from TransCanada and City of Bowman on March 13, 2014

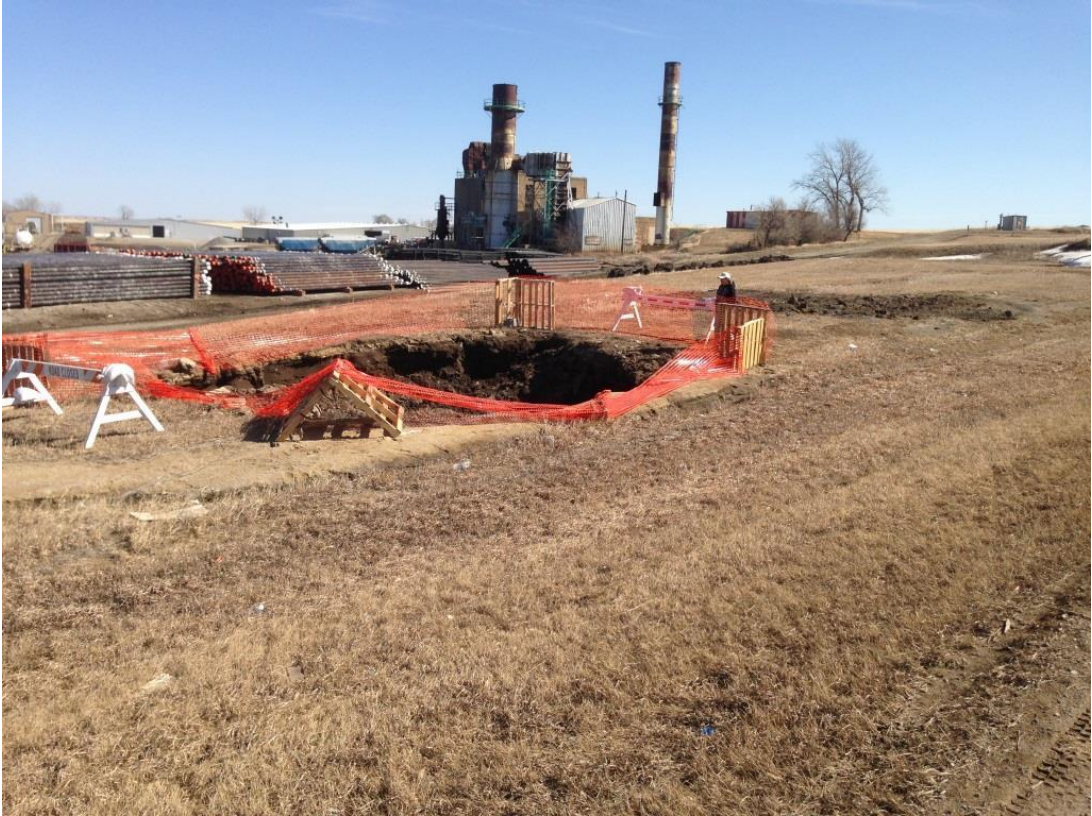
2014 Dickinson-Bowman Emergency, Dickinson (Lehigh Road) Site

This shows a dangerous sinkhole caused by mine collapse in the east ditch of Lehigh Road southeast of Dickinson, ND. Southwest Water Authority reported this sinkhole on January 31, 2014, after it completely severed a rural water line. Southwest Water repaired the line and erected a safety fence around the hole to protect the public.

- Jan. 31, 2014** Lee Messer, Southwest Water Authority, called Bill Dodd to report a dangerous sinkhole on the east side of Lehigh Road. He said the sinkhole had completely severed a rural water line but that it had been temporarily repaired and his crew had placed a safety fence around the hole. He said the hole was very deep and dangerous.

- Feb. 3, 2014** Bill Dodd and Matt Fischer, PSC, inspected the site. We met with Lee Messer, Tim Ridl (Roughrider Electric) and Al Heiser (Stark County) at the site. The sinkhole was 30 feet long and 26 feet wide with an average depth of 14 feet. Frozen conditions precluded repairs until spring, but Lee and Al agreed to monitor the hole and make sure it was fenced and barricaded so no one would fall in.

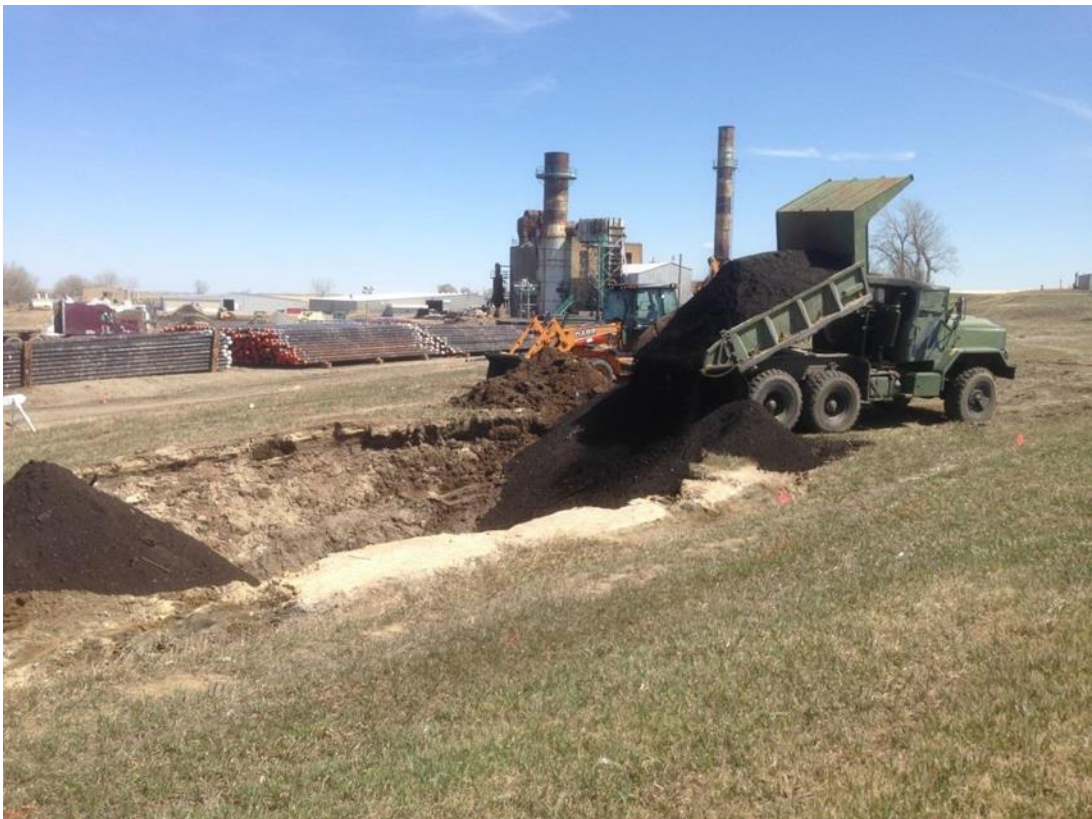
2014 Dickinson-Bowman Emergency, Dickinson (Lehigh Road) Site

This shows the filling of the sinkhole on May 1, 2014. The sinkhole was approximately 30 feet long and 26 feet wide with an average depth of 14 feet. The historic Lehigh Briquetting Plant is in the background.

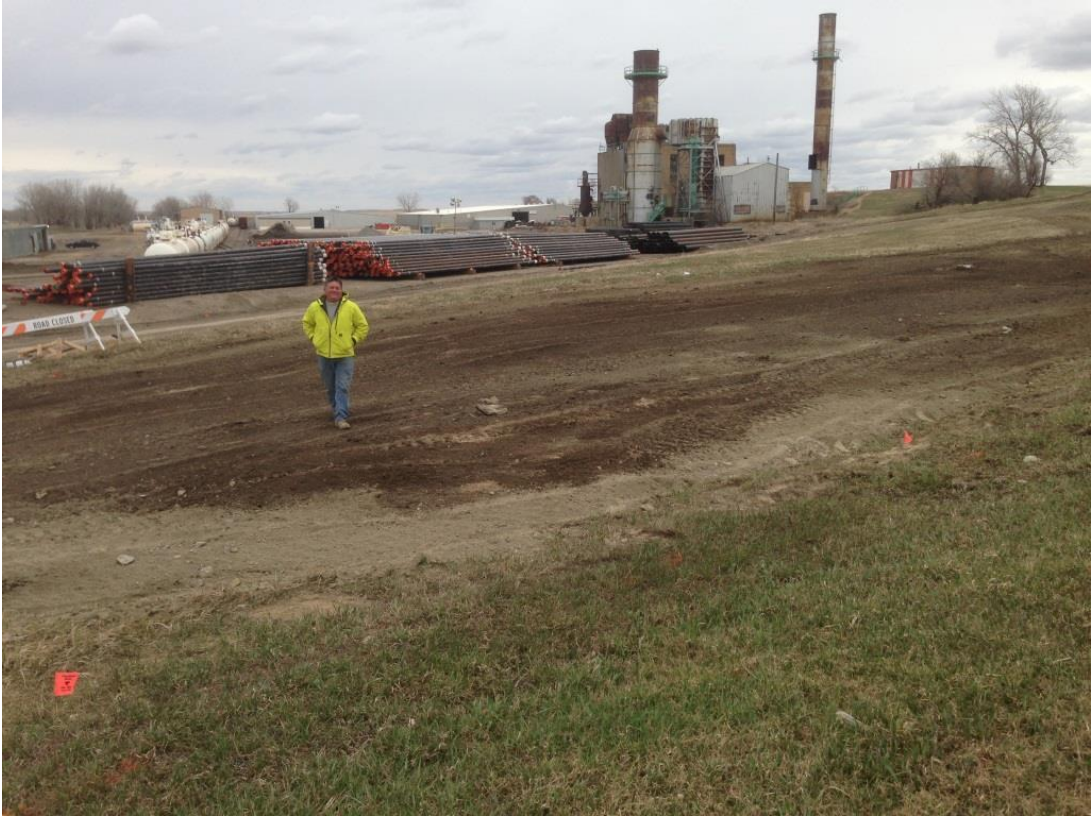
2014 Dickinson-Bowman Emergency, Dickinson (Lehigh Road) Site

This shows the same area after the sinkhole was filled. It took 31 truckloads of coal waste and dirt to fill it. The area was then tilled and seeded. The contractor, Steve Pleasant, was smiling as he walked across this area.

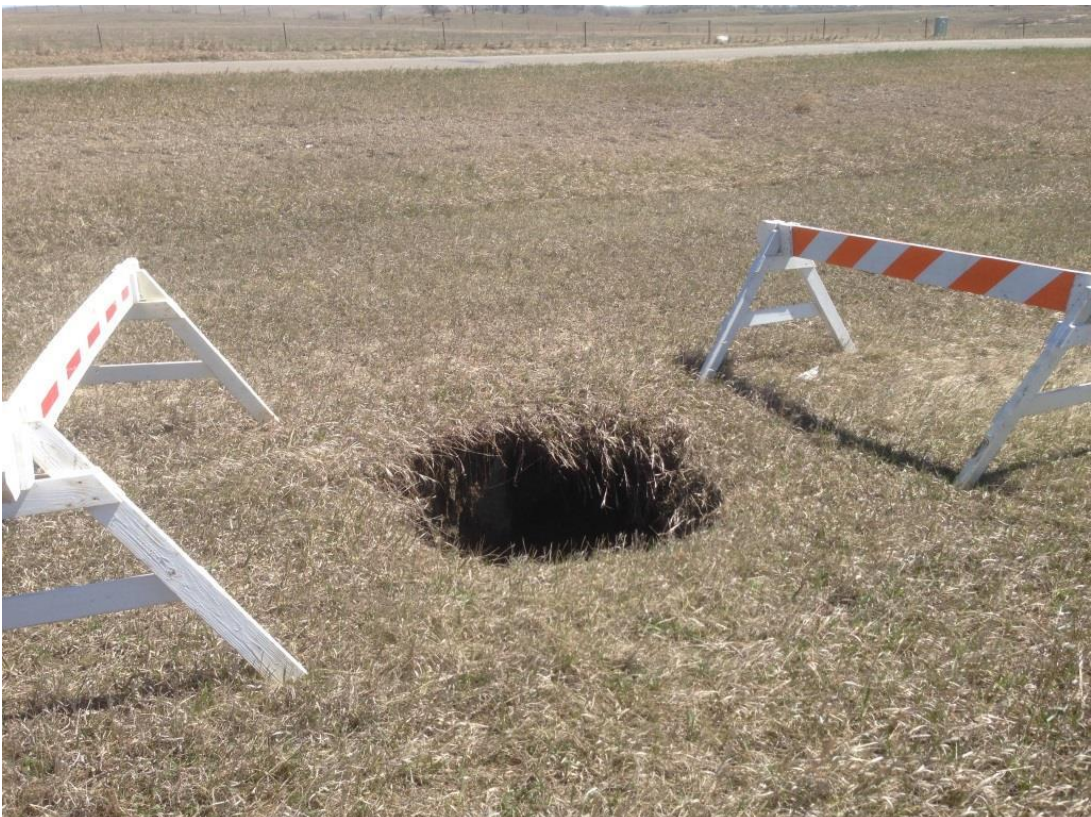
2014 Dickinson-Bowman Emergency, Dickinson (Lehigh Road) Site

This shows another sinkhole that developed on the west ditch of Lehigh Road in late April 2014. It was more than 6 feet in diameter just below the surface and 10 feet deep, and took 4 truckloads of dirt to fill. Sixteen dangerous sinkholes were filled near Lehigh Road and Lehigh Drive at an approximate cost of \$7692.50.

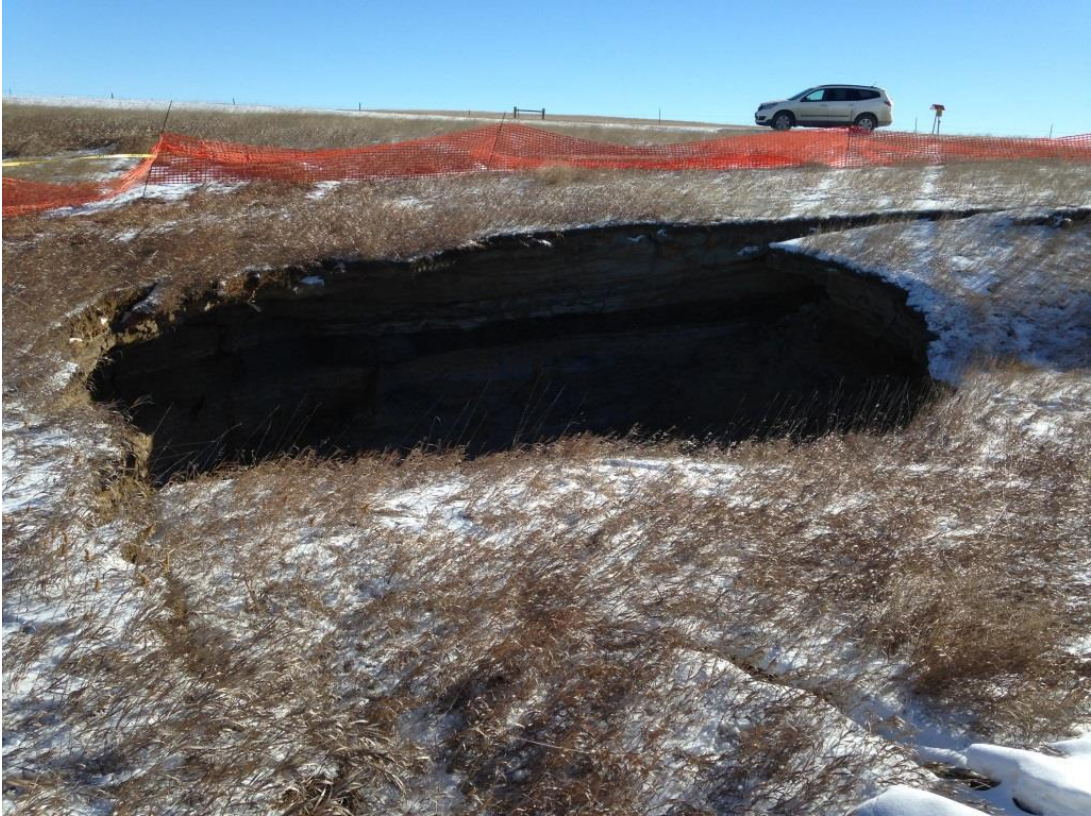
2014 Dickinson-Bowman Emergency, Bowman Site

This photo shows one of the two clustered sinkholes at the Bowman site when it was initially inspected on February 20, 2014. This one was about 38' X 20' with an average depth of 18', and the other was about 48' X 12' with an average depth of 21'.

- Feb. 20, 2014** Matt Fischer and Joan Breiner, AML Division, inspected the Bowman sinkholes with Todd Hofland. They found two sinkholes with a narrow land bridge between them. The southern opening was 48 feet X 12 feet with an average depth of 21 feet and the northern opening was 38 feet X 20 feet with an average depth of 18 feet. These sinkholes had severed a fiber optic telecommunication line and were within 100 feet of the TransCanada Bison Pipeline, a 30-inch high pressure natural gas pipeline, and also two public roads. Frozen conditions precluded sinkhole repairs until spring, but a safety fence was installed around the holes and Todd agreed to monitor it.

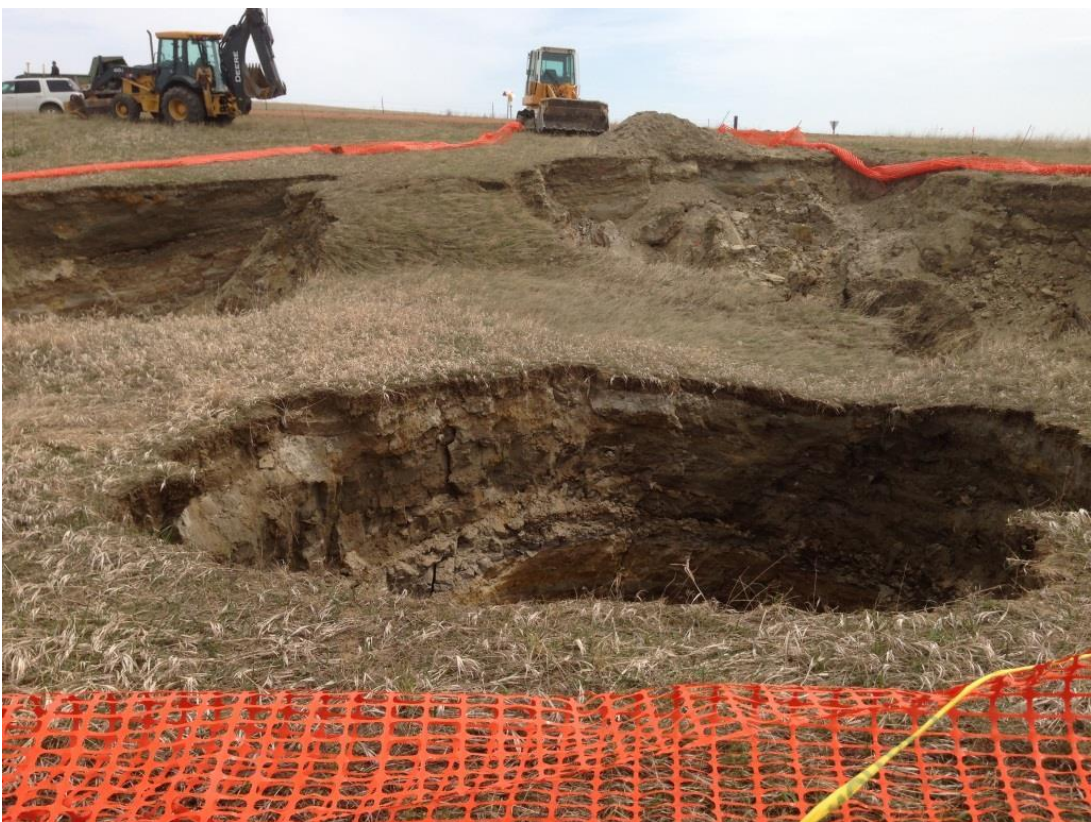
2014 Dickinson-Bowman Emergency, Bowman Site

By the time work began on May 5, additional caving had occurred and a third sinkhole, about 25' X 15' and 20' deep, had formed in the cluster as shown in the foreground. City personnel reported three additional smaller sinkholes and a settling feature nearby.

- May 5, 2014** Sinkhole filling began at the Bowman Site. The sinkholes had collapsed farther and there was an additional (third) sinkhole in the original cluster. Fill material included waste concrete and soil materials (clay) taken from the Bowman Landfill. Bowman City personnel showed us three other nearby smaller sinkholes.

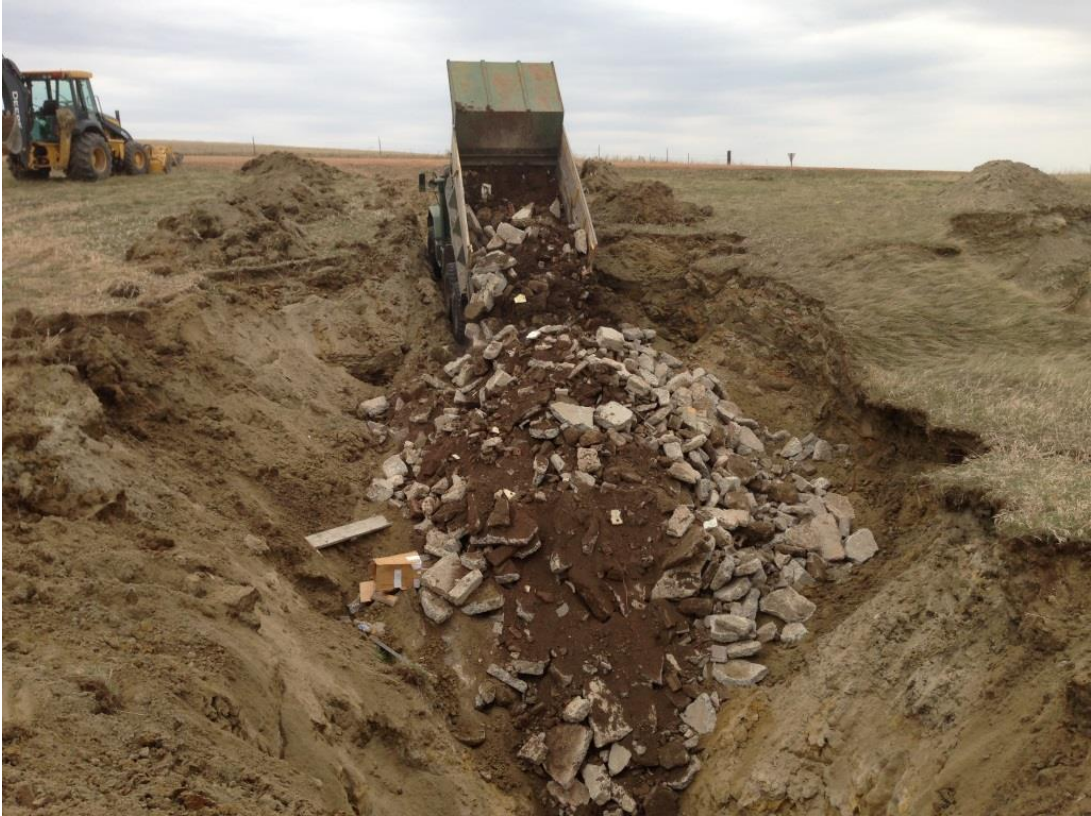
2014 Dickinson-Bowman Emergency, Bowman Site

After saving topsoil and excavating the sinkholes to the extent possible, the holes were filled with concrete waste and clay taken from the Bowman Landfill. Approximately 568 cubic yards of concrete and 672 cubic yards of clay were used - more than 150 truckloads in nearly 5 days of hauling. Additional topsoil was saved while filling the holes.

- May 10, 2014** Sinkhole filling was completed at the Bowman Site. Approximately 1300 cubic yards of waste concrete and clay was used to fill the sinkholes. All areas were tilled and seeded.

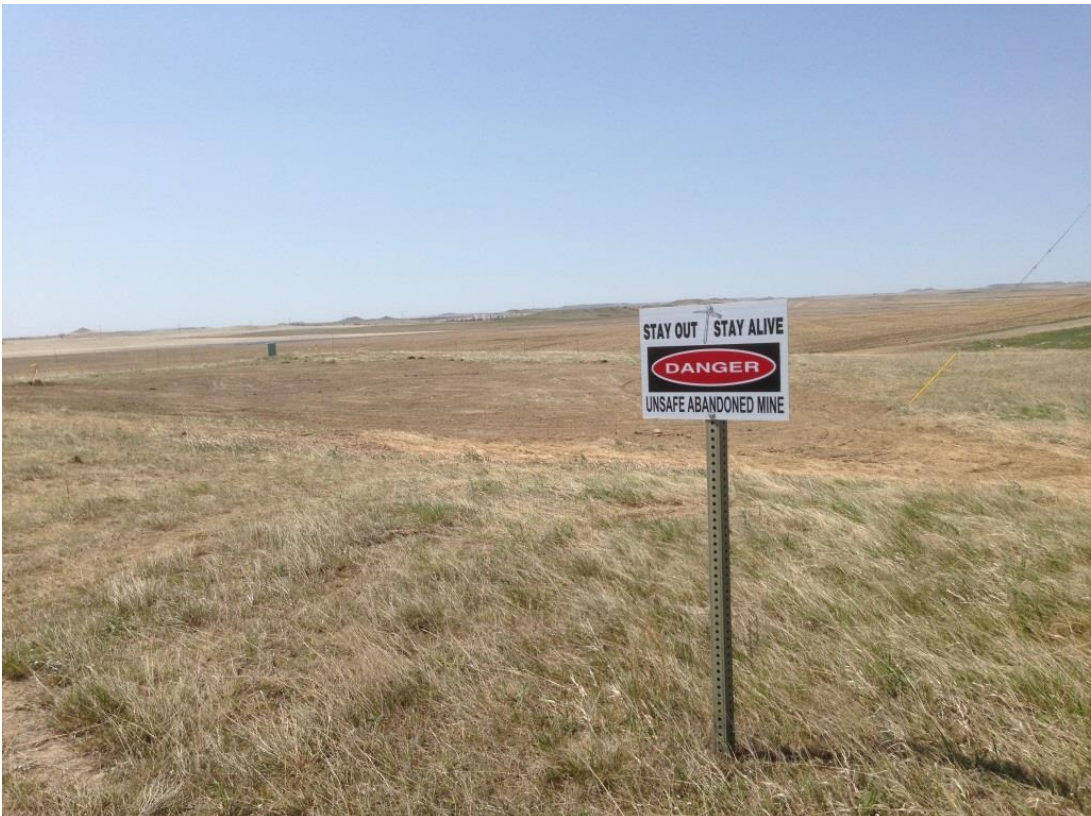
2014 Dickinson-Bowman Emergency, Bowman Site

This picture was taken May 14 after the cluster of three holes were filled, topsoil was replaced and the area of approximately 100' X 75' was tilled and seeded.

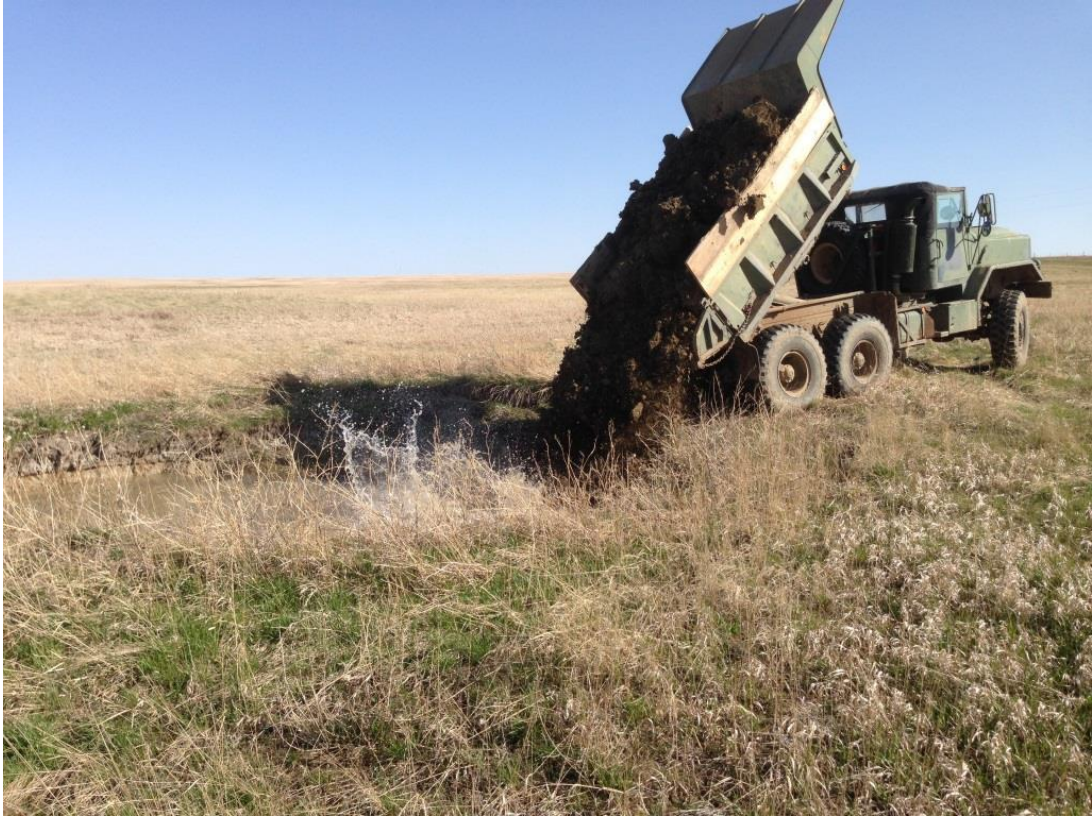
2014 Dickinson-Bowman Emergency, Bowman Site

This shows the filling of a smaller sinkhole at the Bowman site, located about 350 feet northwest of the large ones. It was about 22' in diameter and 5-6' deep and full of water. A trench was cut to drain out the water and it was filled with 10 truckloads of clay.

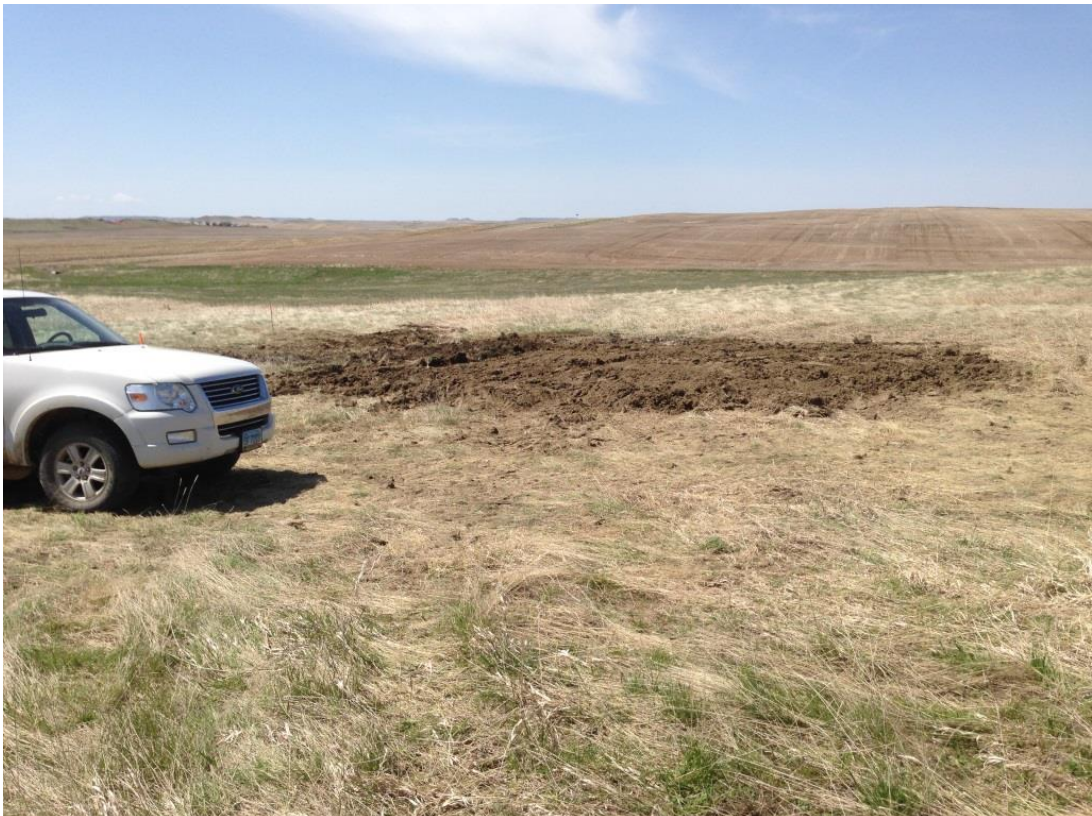
2014 Dickinson-Bowman Emergency, Bowman Site

This picture shows the same area after the sinkhole was filled but before tilling and seeding. The area was still pretty soft, so painted laths were put around it to alert people not to drive over it. The approximate cost of all work at the Bowman Site was \$13,832.50.

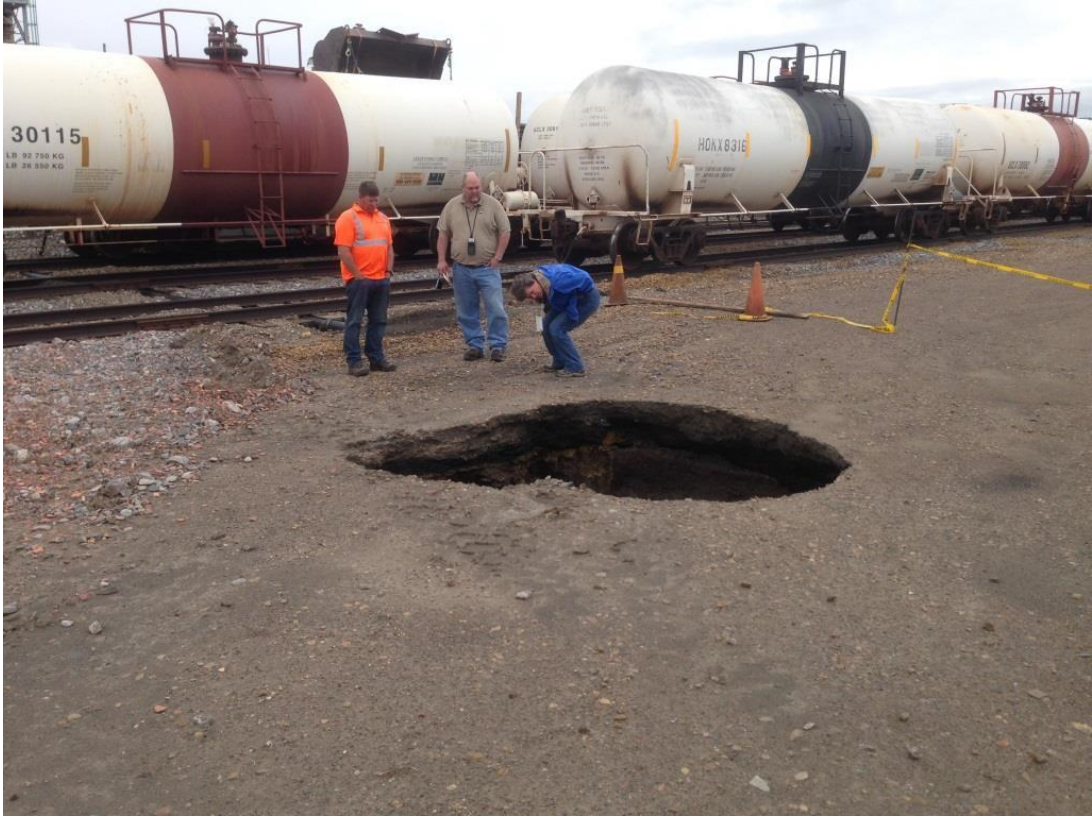
2014 Dickinson-Bowman Emergency, Dickinson M-Bar-D Site

This shows a sinkhole reported June 3, 2014 on the M-Bar-D plant site southeast of Dickinson. It was about 10 feet in diameter at the surface but much larger just beneath the surface. It was about 20 feet away from a railroad spur with tanker cars containing hydrochloric acid..

- June 3, 2014** Troy Gust of M-Bar-D Rail Tech called Jim Deutsch to report a dangerous sinkhole on the M-Bar-D plant site near Dickinson.
- June 5, 2014** Joan Breiner and Matt Fischer inspected the sinkhole report with M-Bar-D personnel. The sinkhole was approximately 36 feet long, 13 feet wide and 6 feet deep. About 20 feet of the length of the sinkhole was undercut and covered by a thin veneer of crushed rock. The sinkhole was about 20 feet north of a rail spur with tankers containing hydrochloric acid.

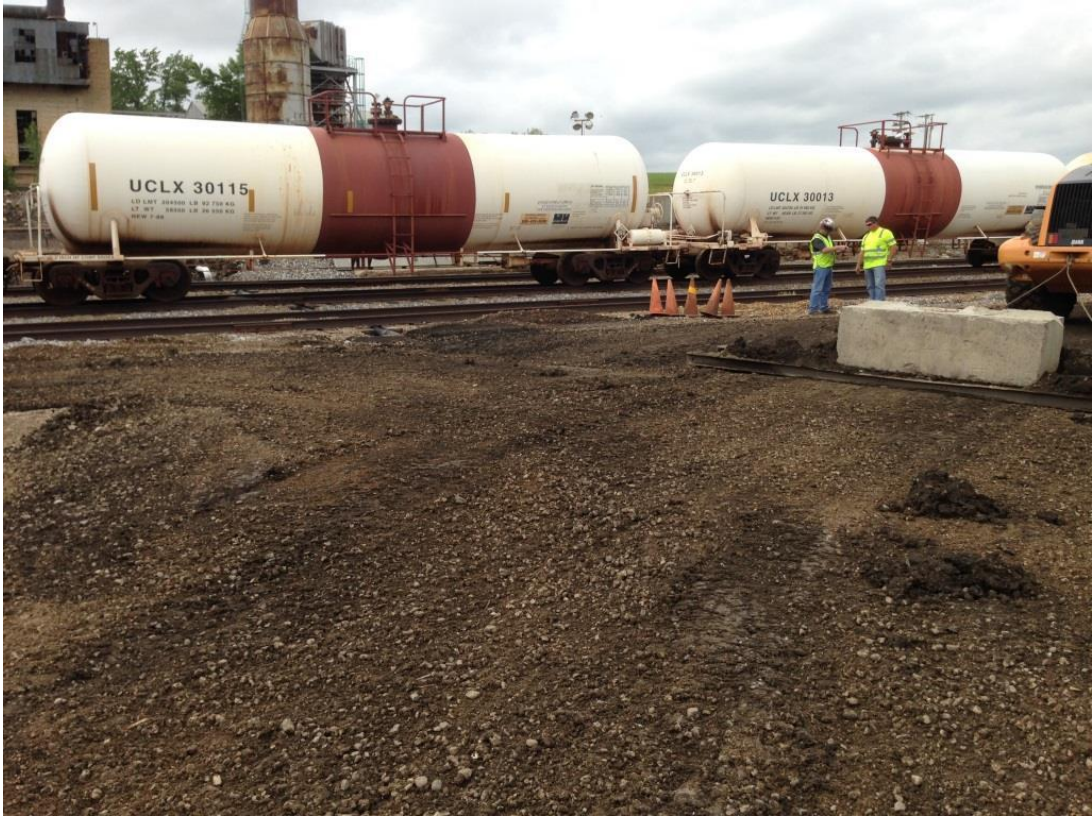
2014 Dickinson-Bowman Emergency, Dickinson M-Bar-D Site

This photo, taken June 17, 2014, shows the M-Bar-D sinkhole site after it was filled and road gravel was replaced. Approximately 100 cubic yards of soil materials were needed to fill the hole and the contract cost for this additional work was \$2000.

- June 16, 2014** Sinkhole filling was completed at the Dickinson (M-Bar-D) site. The sinkhole was excavated and approximately 100 cubic yards of soil materials were required to fill the hole. M-Bar-D placed road gravel over the repaired sinkhole and dragged it.

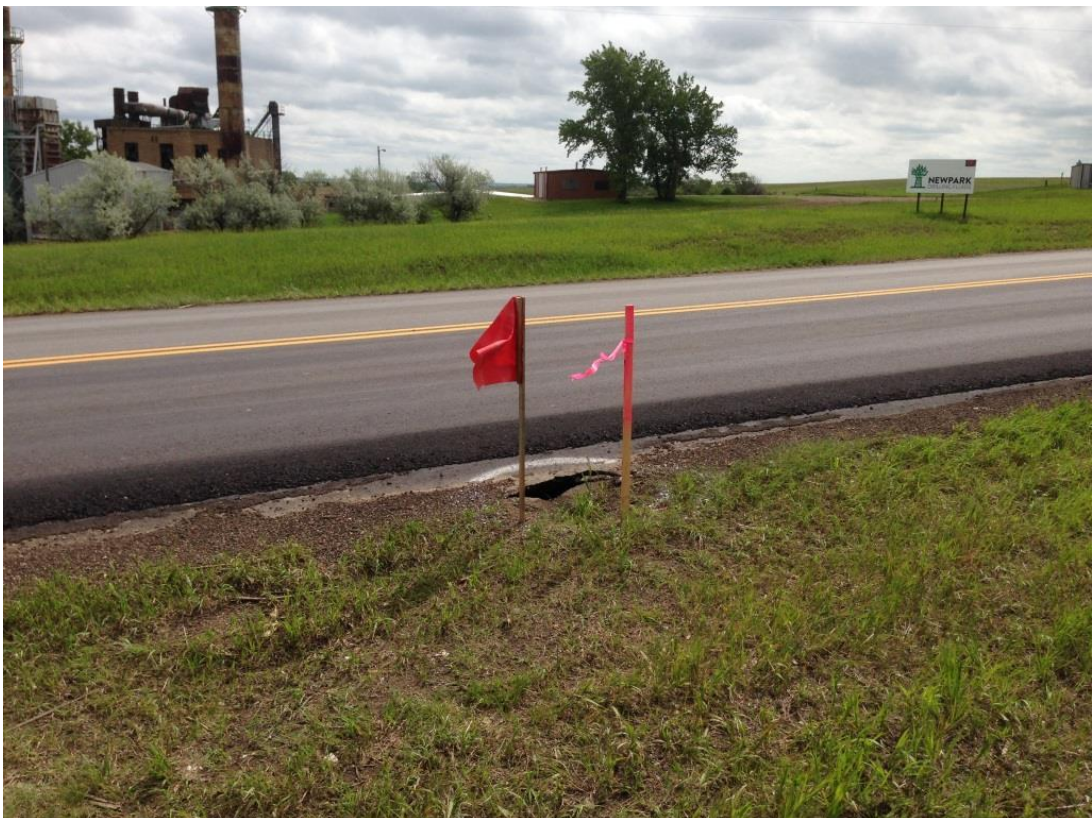
2014 Dickinson-Bowman Emergency, Dickinson Lehigh Road Site

This shows a small settling feature on the west side of Lehigh Road about 700 feet south of the entrance to M-Bar-D. It was about 18 inches in diameter and 6 inches deep. Stark County Road Superintendent, Al Heiser, agreed to fill the hole with gravel and continue to monitor the area for additional settling

- June 17, 2014** Bill Dodd made a final inspection of the repaired sinkhole. While there, he noticed a red flag along the west side of Lehigh Road. The flag was marking a settling feature approximately 18 inches in diameter and 6 inches deep on the edge of the asphalt. Bill called Al Heiser, the Stark County Road Superintendent and Al said he had just marked it that morning. Al was concerned the settling could develop into a sinkhole and affect the safety of the road. Al agreed to fill the settling feature with gravel or pea rock and continue to monitor the area for additional settling.
