# 2019 PROJECT SUMMARY

## 2019-2020 SINKHOLE FILLING PROJECT

### **Project Type: Sinkhole Filling**

Surface backfilling of dangerous sinkholes caused by collapse of underground mines.

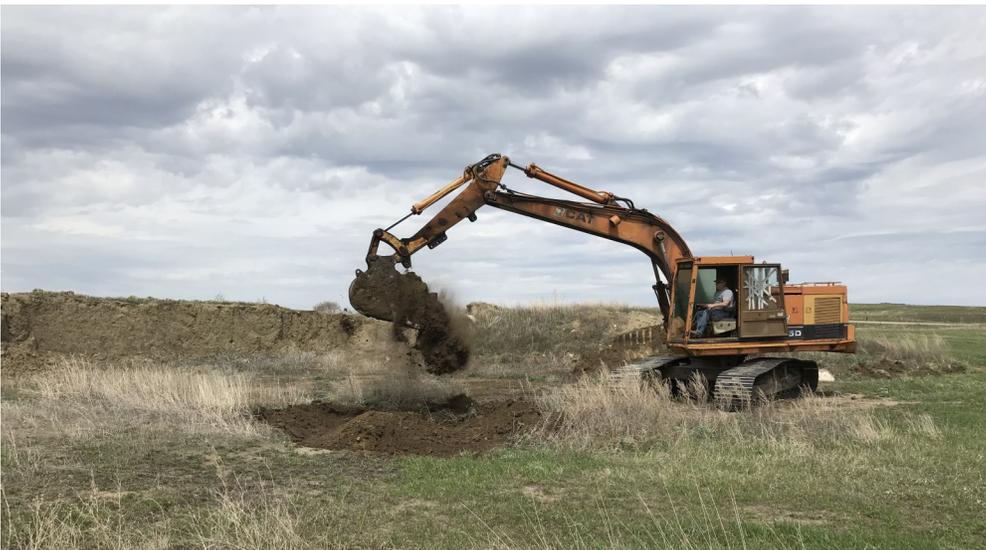
Contractor, Earthworm Excavating, respreading topsoil on a filled sinkhole near Wilton.

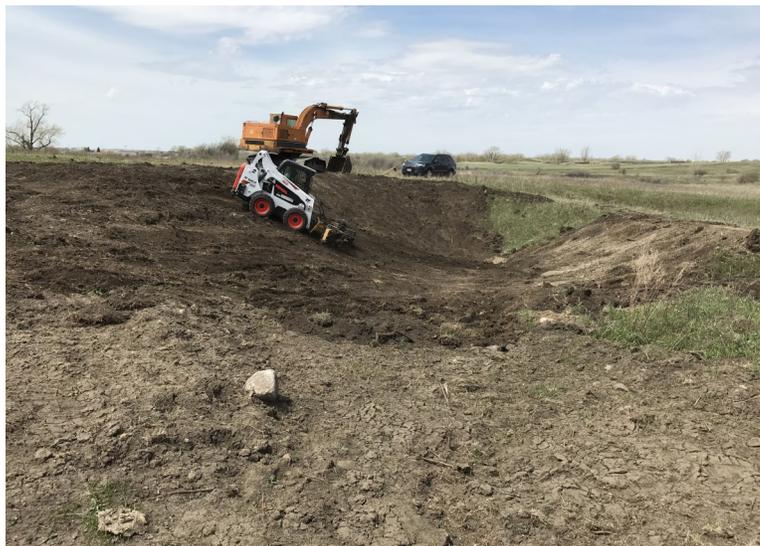
Reclamation of a borrow area at Wilton. A box rake is attached to the front of the Bobcat. This borrow area was a series of large non-hazardous sinkholes that were reshaped to fit the landscape.

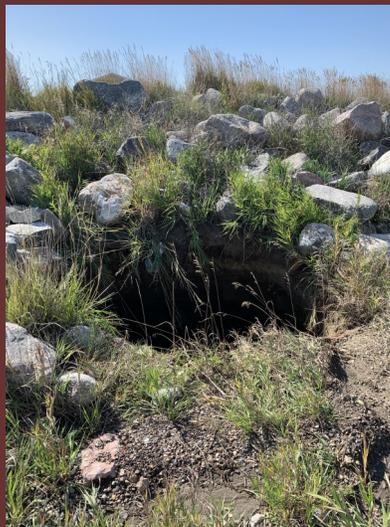
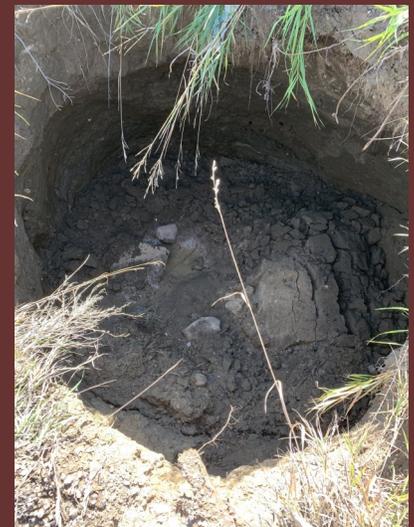
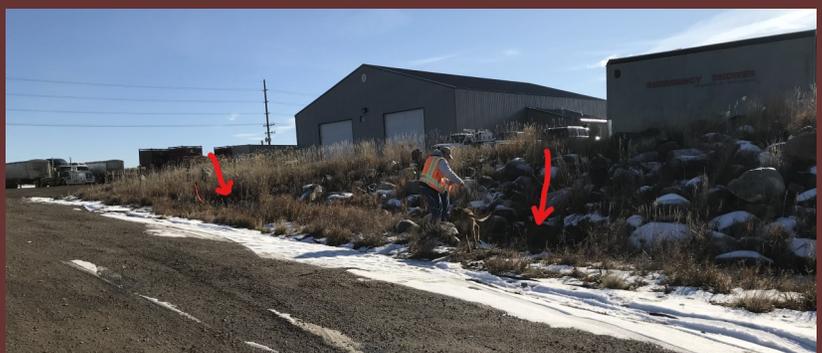
In October the PSC AML Division received a call reporting two sinkholes near the 2019 Williams County Road 9 AML project area. The sinkholes (Top pictures) occurred in a berm between the access road and the parking area (Bottom picture). In 2018 over 300 cubic yards of grout was pumped into holes in the parking area just above the sinkholes. We do the best we can with our drilling and grouting projects, but we cannot guarantee that subsidence will not happen in the future. While these were relatively large holes, even a subsidence of a few inches can be disastrous for a building foundation. We do not recommend building on land that is undermined. Anyone with questions may contact the Public Service Commission AML Division for further information on our inventory of abandoned coal mines in North Dakota.

These sinkholes have been filled temporarily with about 30 tons of fine earth material. The holes will be completely reclaimed as the weather improves in 2020.

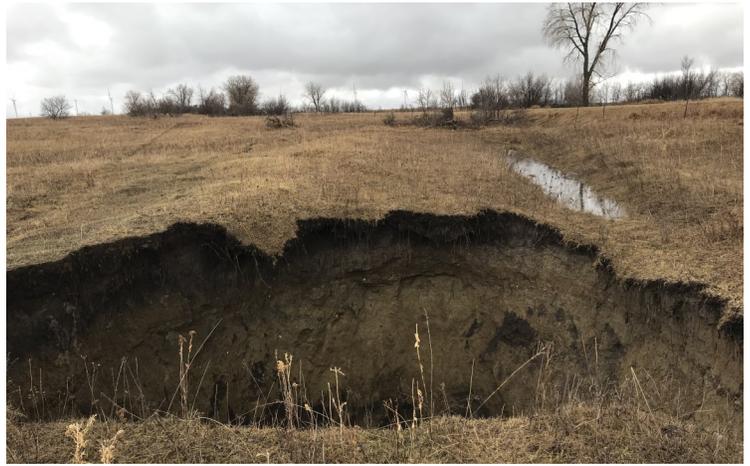
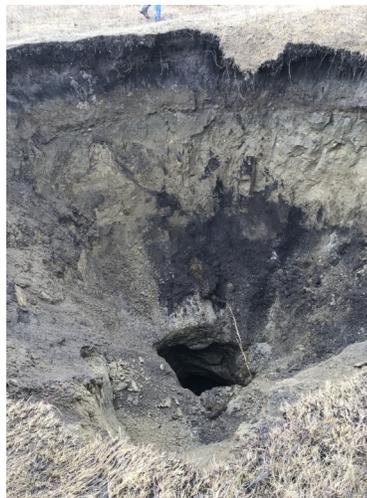
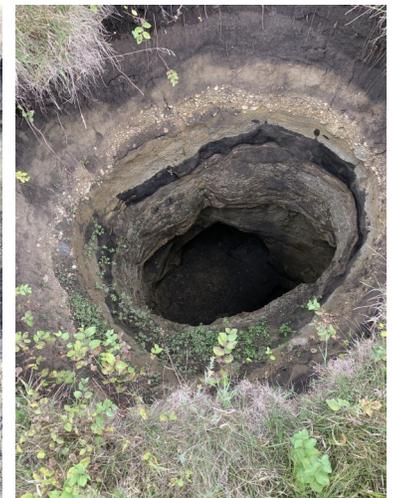
In April 2019, the ND Public Service Commission AML Division received a call from a renter about a large sinkhole in his pasture near Wilton (top picture and bottom left picture). The sinkhole measured 25 feet in diameter and over 30 feet deep. According to the tenant, the spot was full of water one day, the next day it was a large hole. The sinkhole was classified as an emergency due to its size and its proximity to a country road. During the emergency project 10 additional sinkholes in the vicinity were also filled.

Less than one month later, another tenant alerted the PSC AML Division to a sinkhole in his pasture less than one mile southeast of the emergency sinkhole (bottom right picture). This sinkhole measured 8 feet in diameter and 20 feet deep. Since the sinkhole was over 500 feet from a roadway, it was not designated as an emergency. The tenant fenced the sinkhole for filling in the fall. On the second mobilization to Wilton, this sinkhole and an additional 16 sinkholes were filled. The map on page 5 includes all the sinkholes filled near Wilton in 2019.

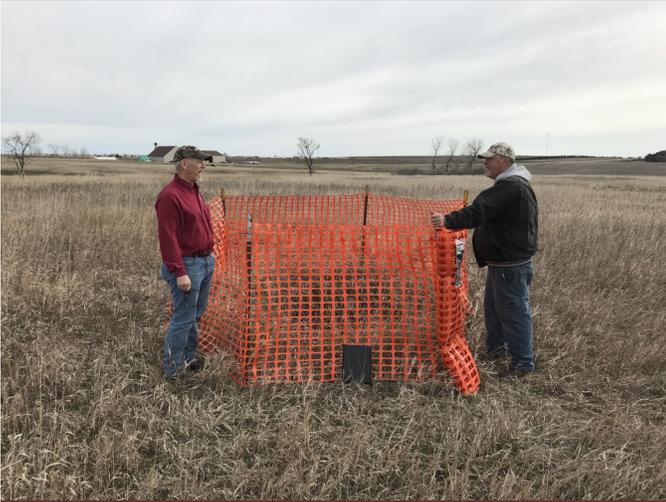
Former Assistant Director, Bill Dodd, and Curt Michaelson discuss a sinkhole Curt found while walking with his dog on Section 18 of the Game and Fish property near Beulah.

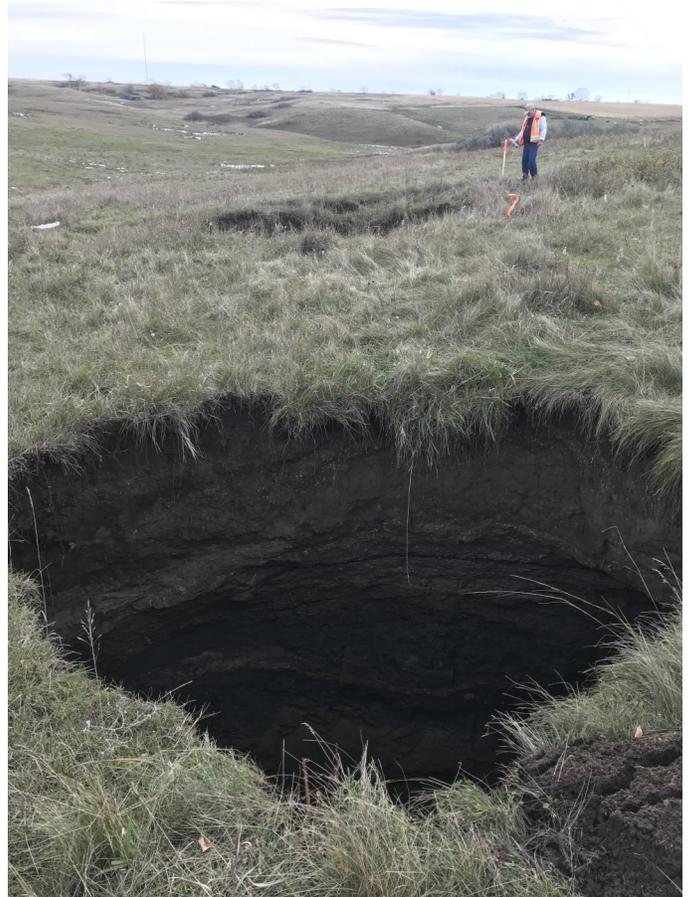
Inspector, James Thornburg, measuring and marking several holes on Section 13, T144N, R88W near Beulah.

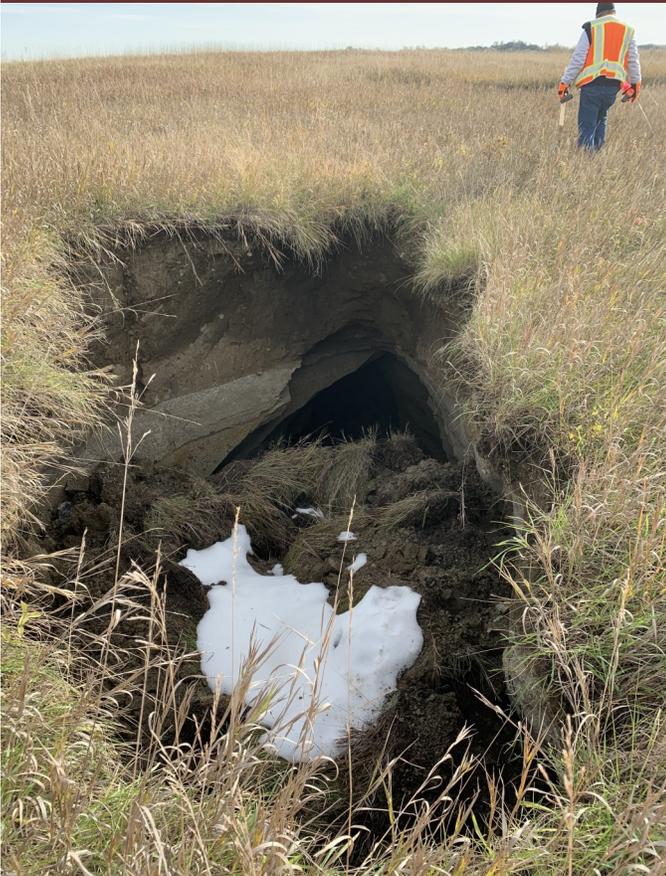
Inspector, James Thornburg, measuring a sinkhole near Beulah.

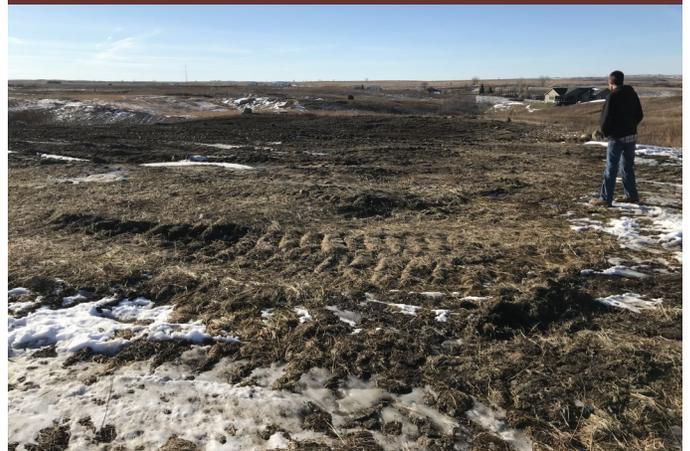
Shawn Nixon, PSC Engineer, inspects the reclaimed borrow area on Section 7 of the Game and Fish Property near Beulah.

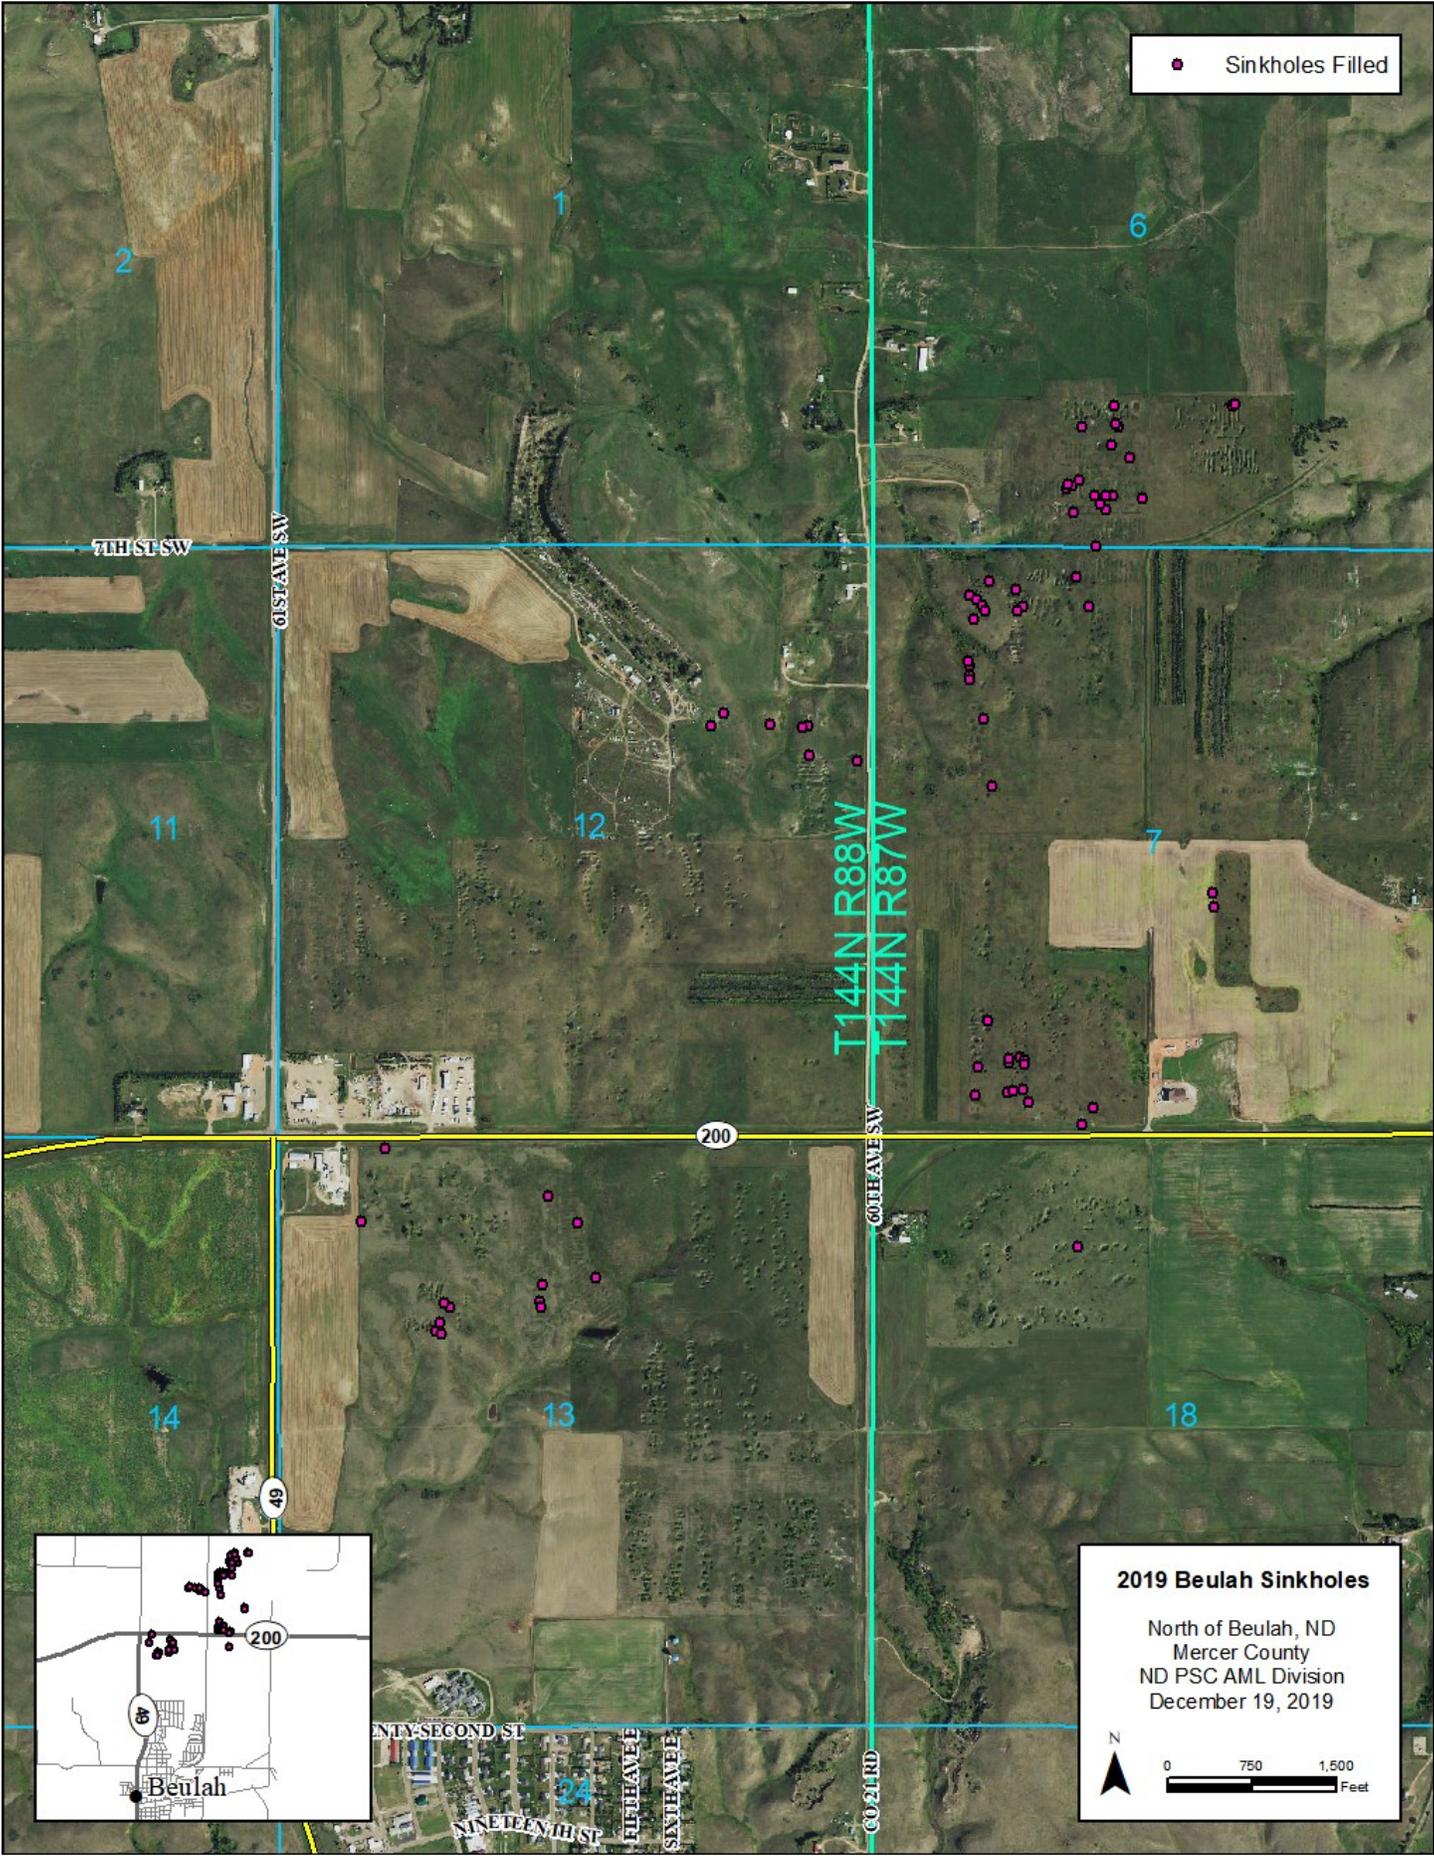
**2019 Beulah Sinkholes**  
 North of Beulah, ND  
 Mercer County  
 ND PSC AML Division  
 December 19, 2019

■ Sinkholes Filled

able to fill this sinkhole by October 25, 2019. Another 73 hole were filled at Beulah, 22 on privately owned land and the remaining on ND Game and Fish properties. Much of the Game and Fish access is closed to public access for safety reasons. The sinkholes are large and deep as shown by the photos below. Although 74 holes were filled at Beulah, hundreds of sinkholes remain to be filled. It is also very likely that new sinkholes will appear as the ground thaws in the spring. The map on page 7 includes locations of all the sinkholes filled near Beulah in 2019.

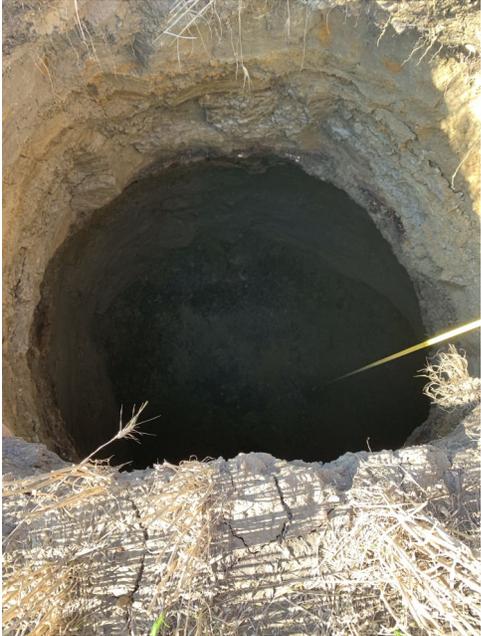
If you live or work near an abandoned underground coal mine, please use caution. The ground can give way without warning. The sinkhole (8 feet diameter by 7 feet deep) in this photo was in a harvested soybean field. Luckily the farmer saw the hole before driving into it during harvest.
