2024 Dakota Collieries AML Project

Location: Three miles southeast of Zap, ND within portions of Section 36, T144N, R89W, and Sections 31 and 32, T144N, R88W, Mercer County

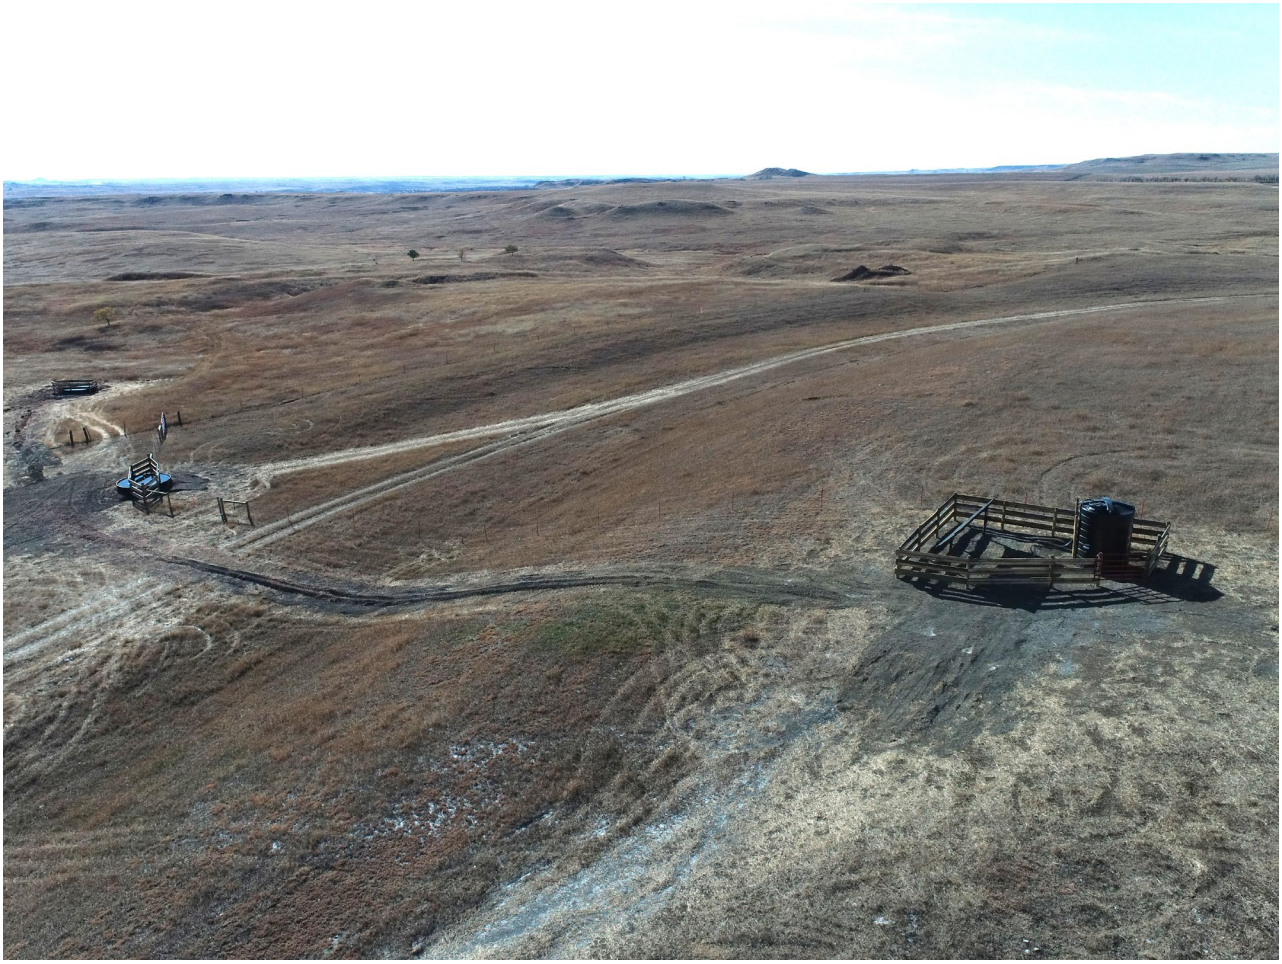
Figure 5: A solar well watering system was installed because the abandoned mine reduced surface and groundwater availability.

The central site was an abandoned surface coal mine characterized by a steeply eroding highwall, 50 feet high and 915 feet long. Work on the central site began with stripping and stockpiling all available topsoil and subsoil. The contractor then backsloped and backfilled the highwall with earthen material from adjacent spoil piles in July. Approximately 115,000 cubic yards of spoil material were moved to reclaim the surface mine on the central site (**Figures 2 and 3**). An unexpected sinkhole opened up when heavy equipment was grading the highwall (**Figure 4**). The sinkhole was caused by an undocumented abandoned underground mine. The large sinkhole was promptly filled and compacted. Following backfilling and backsloping, subsoil and topsoil were respread, and soil amendments were incorporated. Engineered drainage channels lined with erosion control blankets were installed to direct surface water runoff on the reclaimed area. A solar well and two stock tanks were constructed (**Figure 5**) to replace a developed spring that was destroyed by an abandoned mine.
