2016 AML PROJECT SUMMARY

Wilton Phase 2

Drilling and pressurized remote backfilling with cementitious grout

Contract AM 757-16 (Construction)

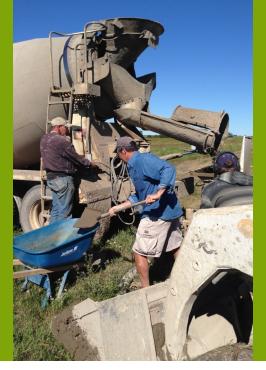
For our grout projects, flowability is measured with a slump test. The higher the slump the more flowable the mixture. When we want the grout to flow a long distance or into the rubble of a collapsed portion of the mine, we us a grout with slump between 10 - 11 inches.

If we have an open void or don't want the grout to travel as far we use a lower slump grout between 6 and 8 inches. Just for comparison, most poured cement has a 1-3 inch slump-very stiff.

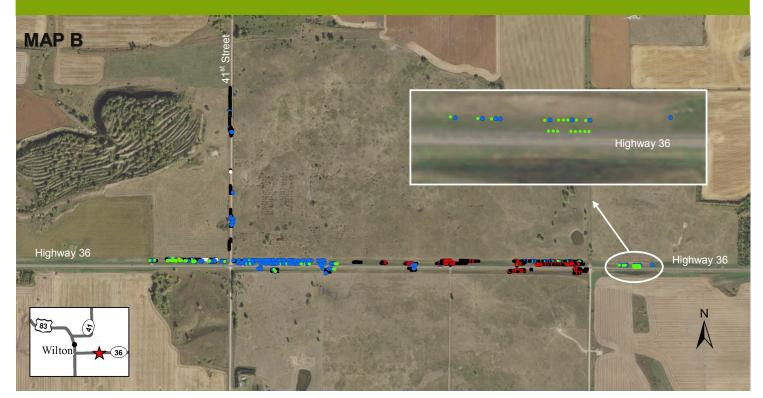
Maps A, B & C: North Dakota Highway 36 runs east and west. The north-south road is 41st Street. Each dot represents one drill hole. Blue dots were void holes that were pumped with grout. At **black dots**, drilling encountered solid coal. **Red dots** are holes that intercepted voids and were cased for future grouting. **Green dots** are holes that were filled with grout by pumping on another hole. **Orange dots** are core holes, and **white dots** represent no coal was encountered. All holes were filled with grout on Map A inset and Map B. Additional work is needed in both the north and south ditches of Highway 36 as shown on Map C.

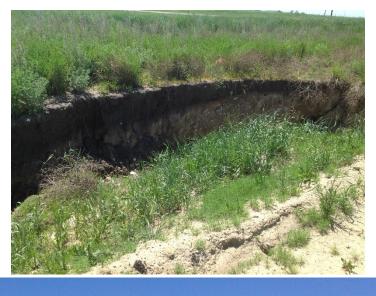
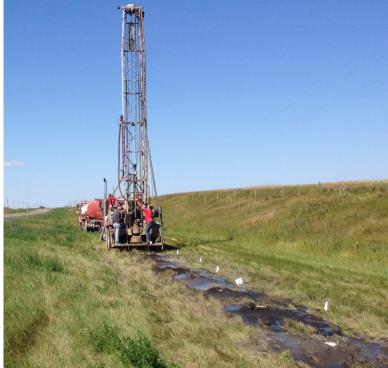
Early in June, 2016 the Falkirk Mining Company informed us of several subsidence features on the abandoned Figenskau Mine near Highway 200. In 2007, an exploratory drilling project along Highway 200 did not encounter any voids; however the current sinkholes are more than 1000 feet to the east of that project extent. The Figenskau mine is about 3 miles east of Underwood, ND.

The sinkholes were outside the right of way of Highway 200; however the proximity to the highway and unknown extent of mining of the Figenskau mine provided justification of a small exploratory drilling investigation. Forty-one holes were drilled in the north ditch of Highway 200 for a total of 2,317 feet. No mine voids were encountered.
