Project Summary

2019 Morton County Phase 2 AML – Project

Abandoned Mine Lands Division

North Dakota Public Service Commission

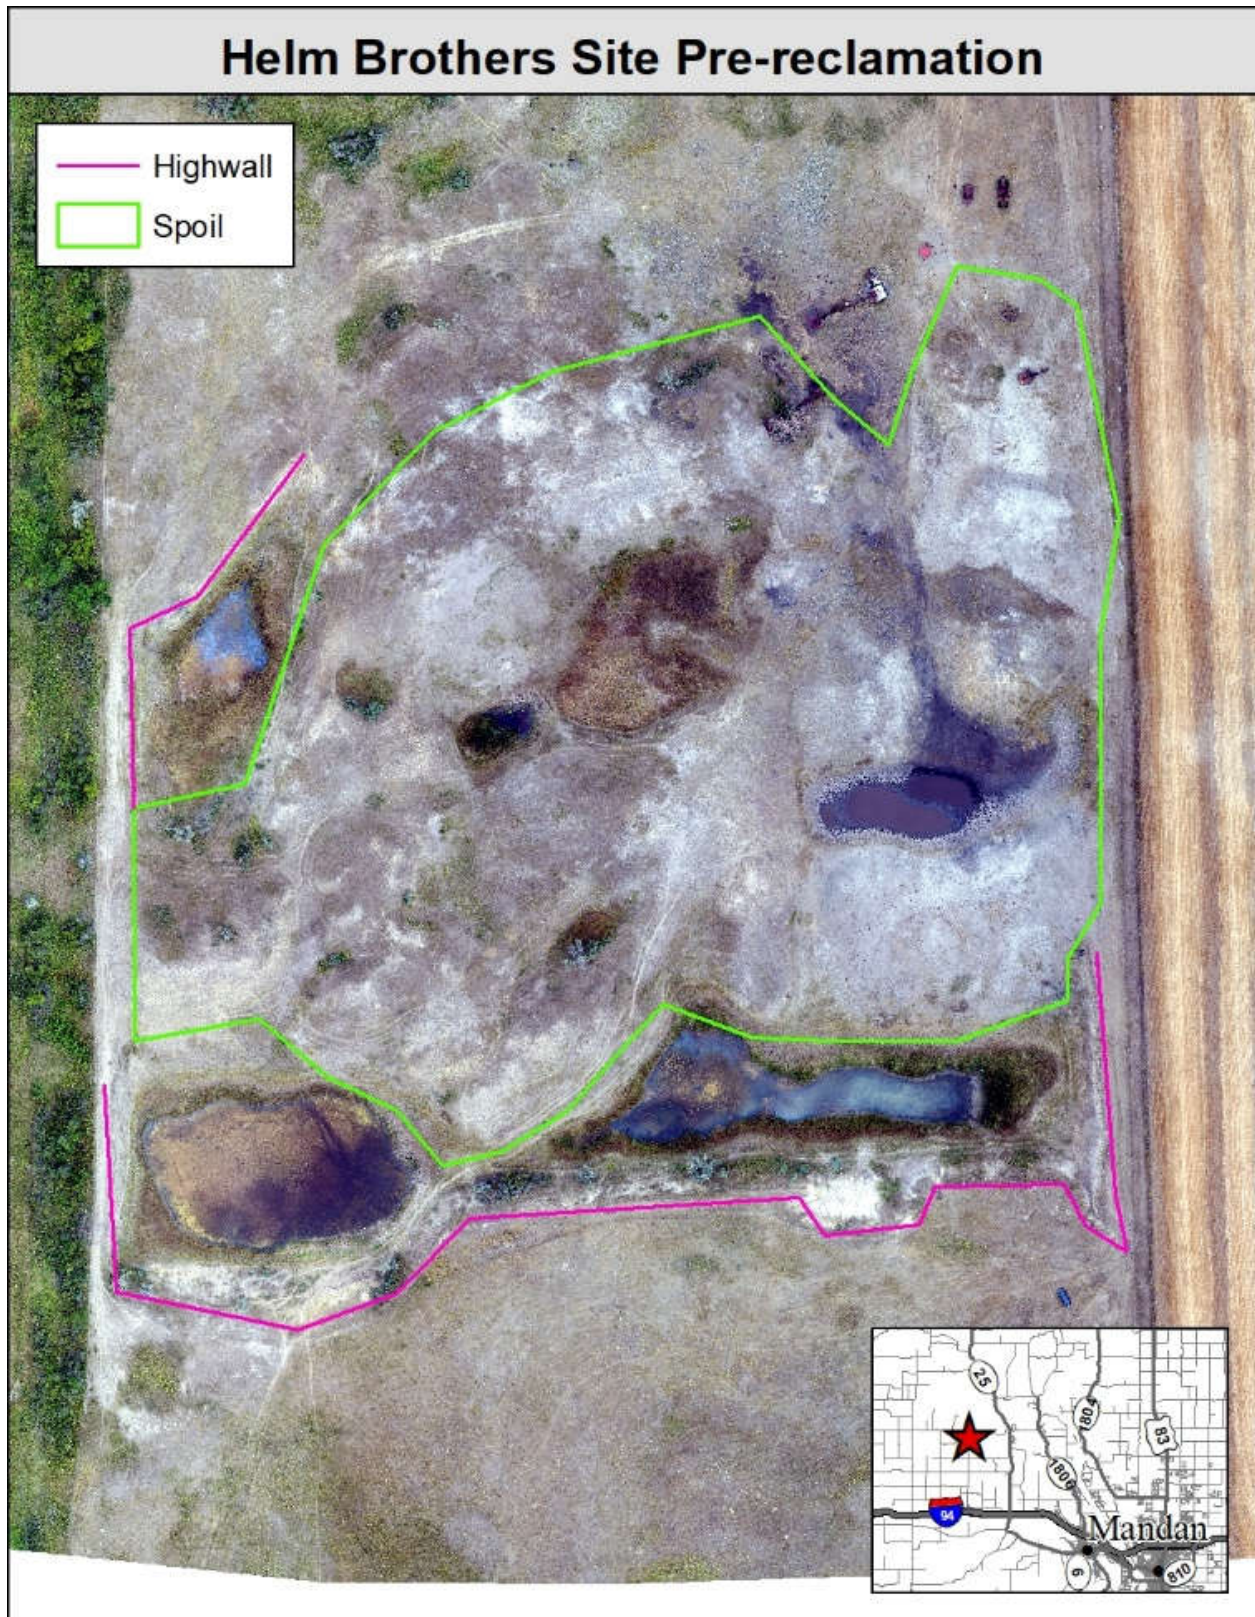
Figure 2 - Helm Brothers site - Pre-reclamation

The Helm Brothers site was the largest of the five project areas. The site contained three dangerous highwalls that total 2,000 feet in length and averaged twenty-five feet in height. The site also contained three water filled pits and several pieces of historic mining equipment. The property owner requested that the mining equipment not be disturbed. The abandoned mine site is primarily used for grazing cattle and hunting, with a portion of highwall bordering cropland. A well-established trail allowed public access to the highwalls. The property owner was also concerned about erosion in the southeast corner of the site.

At the request of the property owner, the site was fully reclaimed and all of the existing ponds were eliminated. The site was graded to an average slope of 3.2%. Approximately 101,300 yd³ of earthen material was moved at this site. A small hill, which supports the abandoned mine tibble, was reshaped and left in place. All of the historic mining equipment remained undisturbed throughout the project.

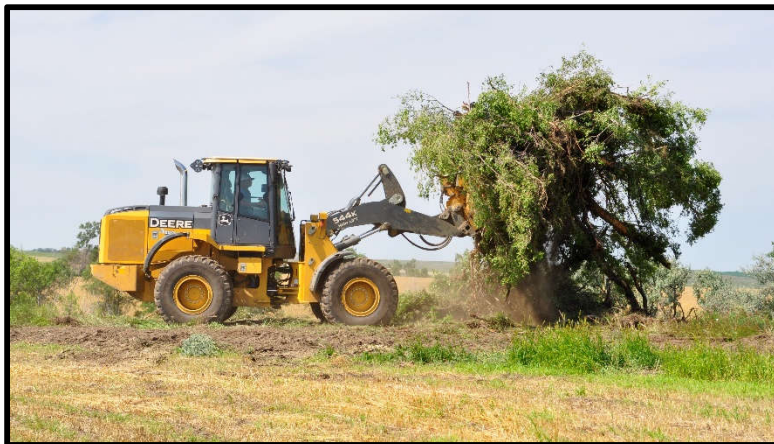
Photo 15 - David Doll, property owner, piling trees on site

Earthmoving operations started at the Flemmer site on August 5 and were completed August 8. Topsoil re-spread was completed on August 13. For this site, the contractor used two 850C JD Dozers, one Deere 160D excavator and one Cat 627B Scraper. Approximately 15,730 yd³ of earthen material was moved at this site. David Doll, the property owner, assisted the contractor by piling trees and spreading manure before the seeding contractor arrived.

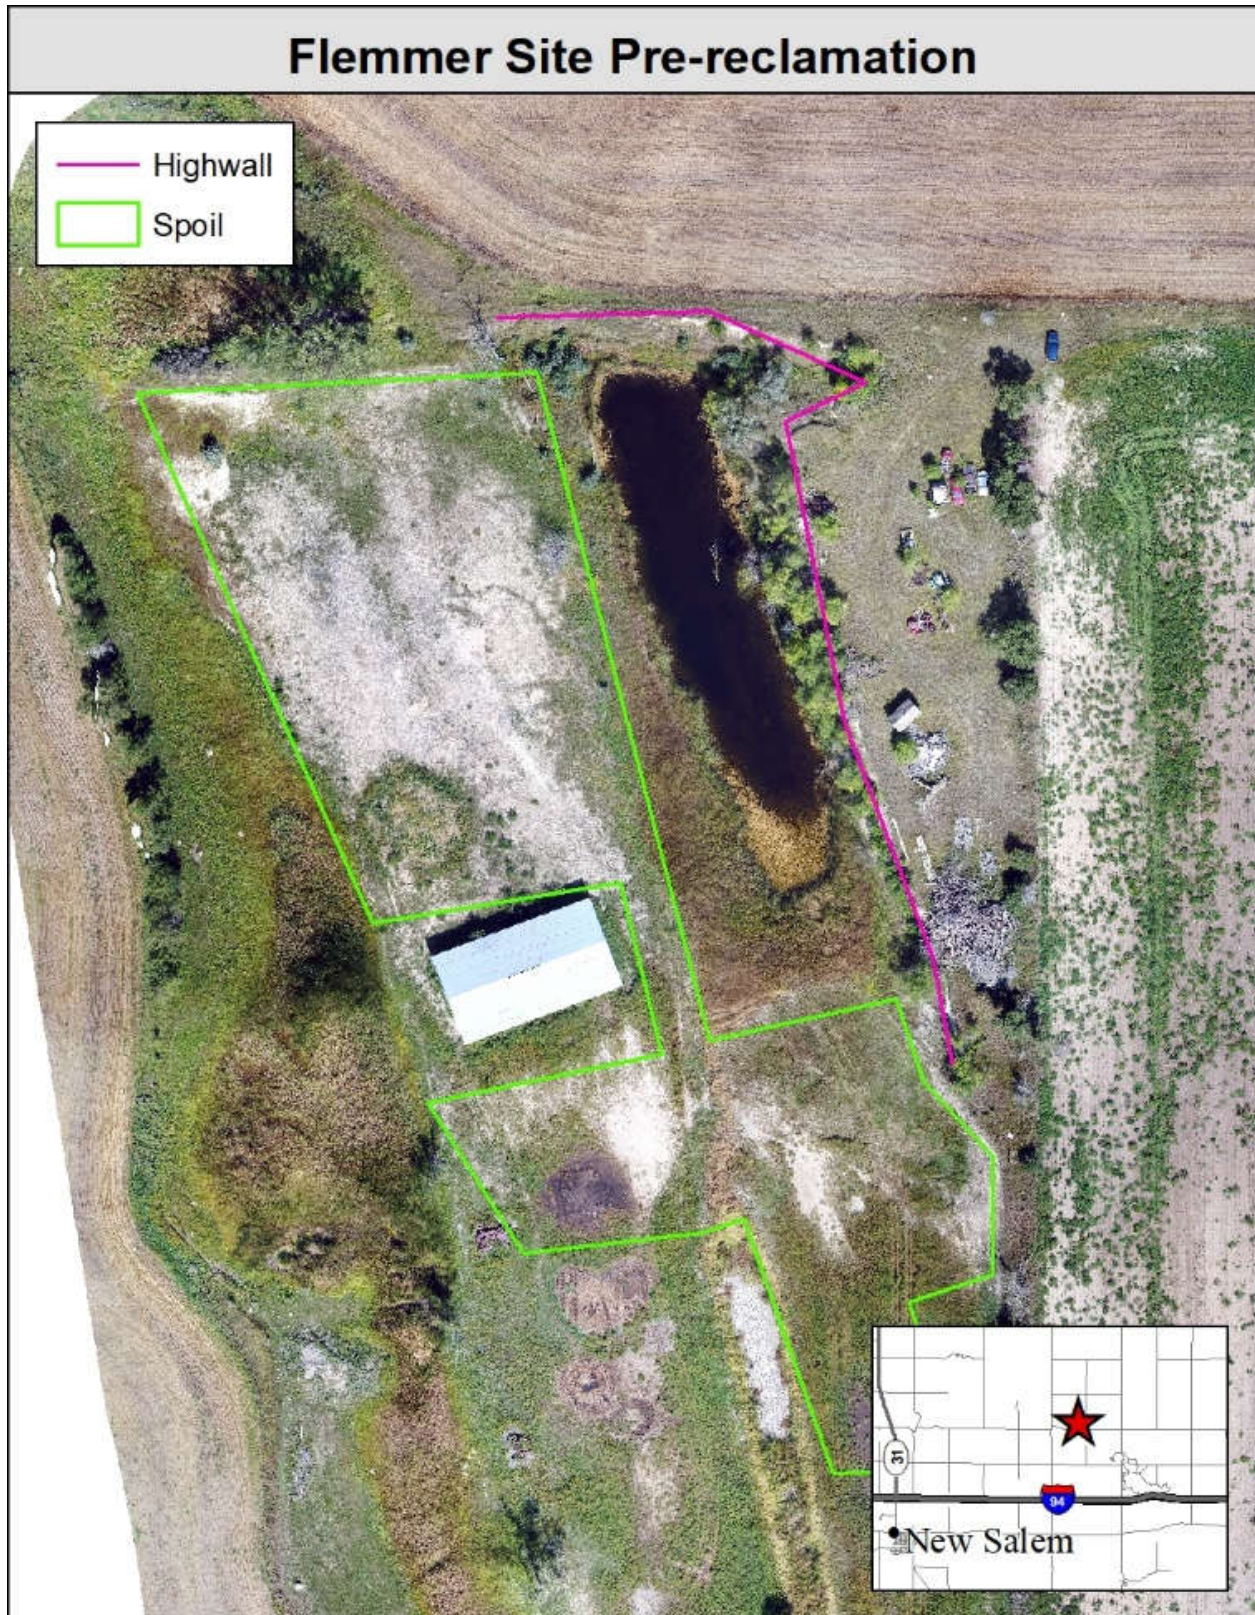
Figure 6 - Flemmer Site - Pre-reclamation

The Flemmer site contained one highwall, approximately 25 ft high, and one water filled pit. The spoil piles, located on the west side of the pit, were not used in the reclamation process. Instead, the design consisted of backsloping the highwall approximately 100 ft into a cultivated field owned by the property owner. The post-reclamation topography has an average slope of 9.1%.

The original design relocated the water by constructing a new pond to the south of the existing pit. After construction began it was discovered that the ground was too saturated to accomplish this task. The property owner was informed of the conditions and it was decided to direct the water into an adjacent drainage ditch owned by the property owner.

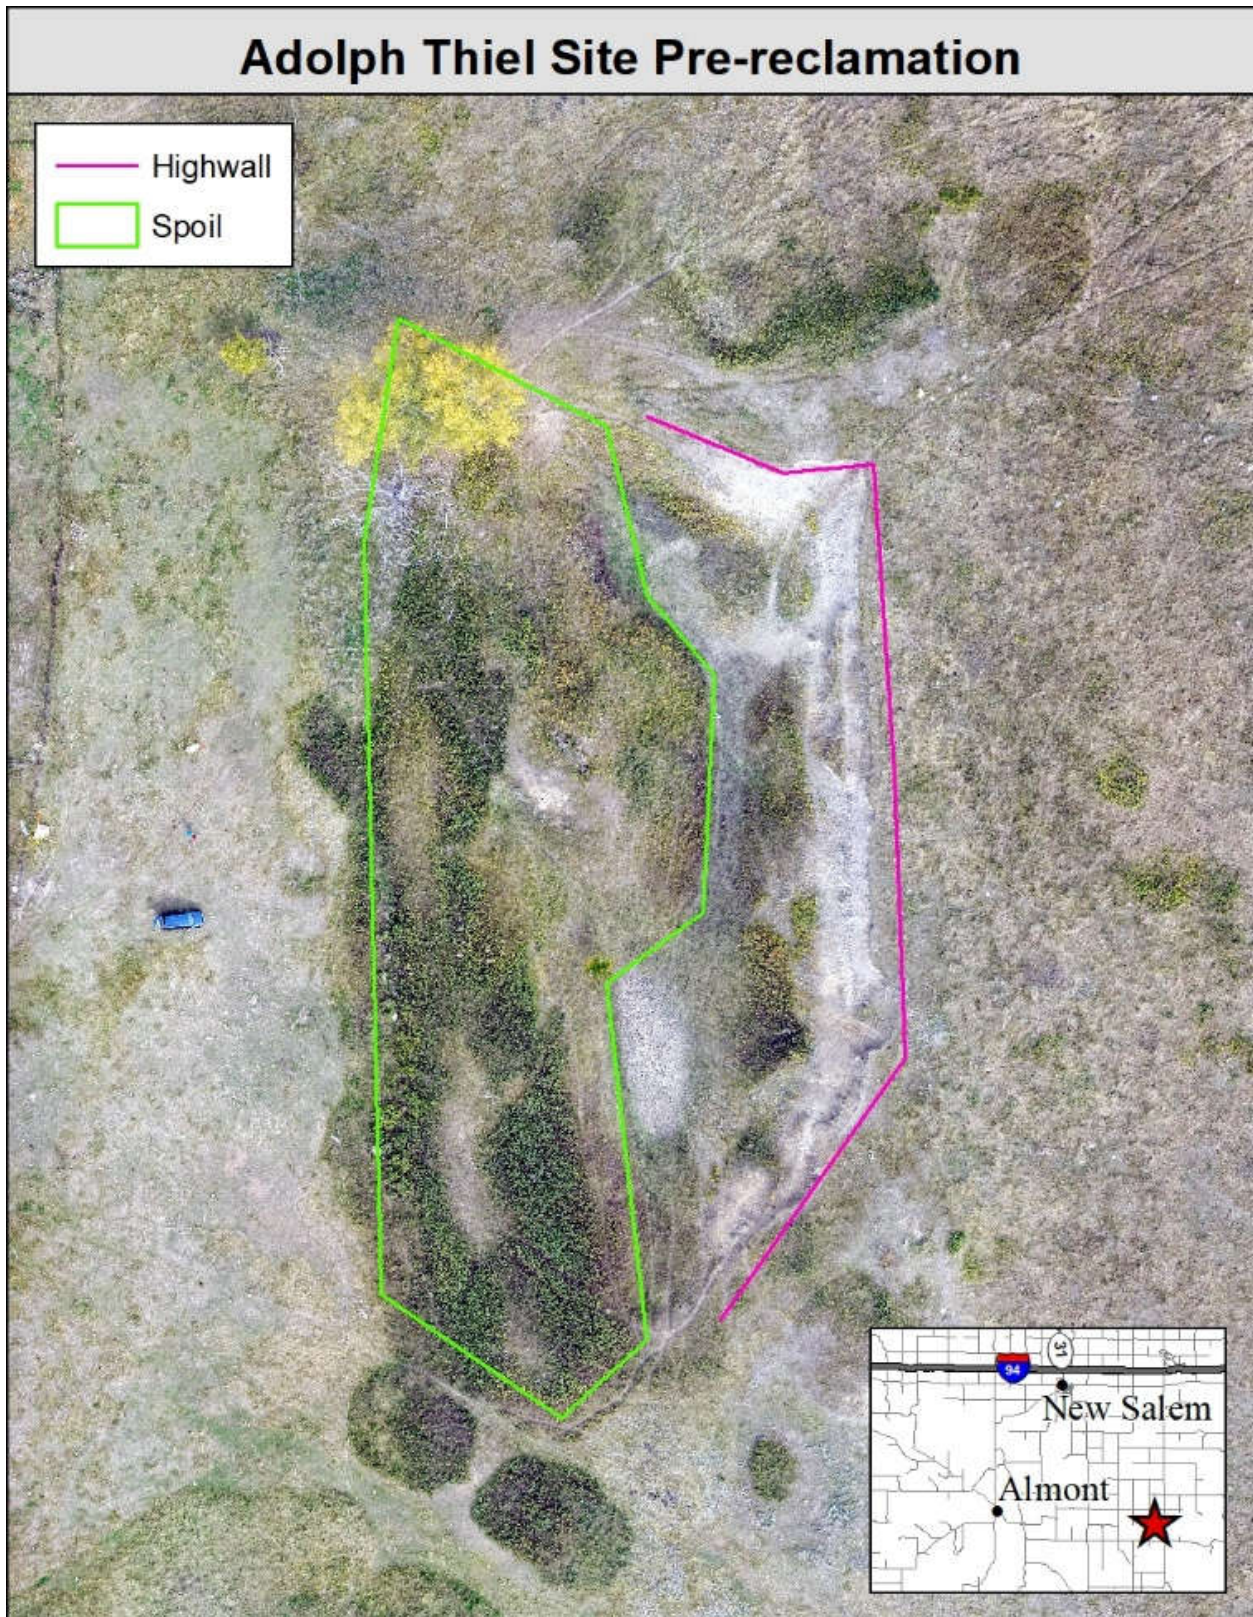
Figure 8 - Adolph Thiel Site - Pre-reclamation

The Adolph Thiel site contained one small highwall approximately 20 ft in height. The property owner requested that the spoil material be used to backfill the highwall and that the reclaimed topography be graded to a slope with allows an ATV to safely pass through the area. The reclaimed area will once again be used as grazing ground for cattle.
