Project Summary
2014 Beulah/Zap Phase 15
Contracts AM-695-14 & AM-396-14

March, 2015

**North Dakota Public Service Commission
2014 AML Project Summary
Beulah, North Dakota**

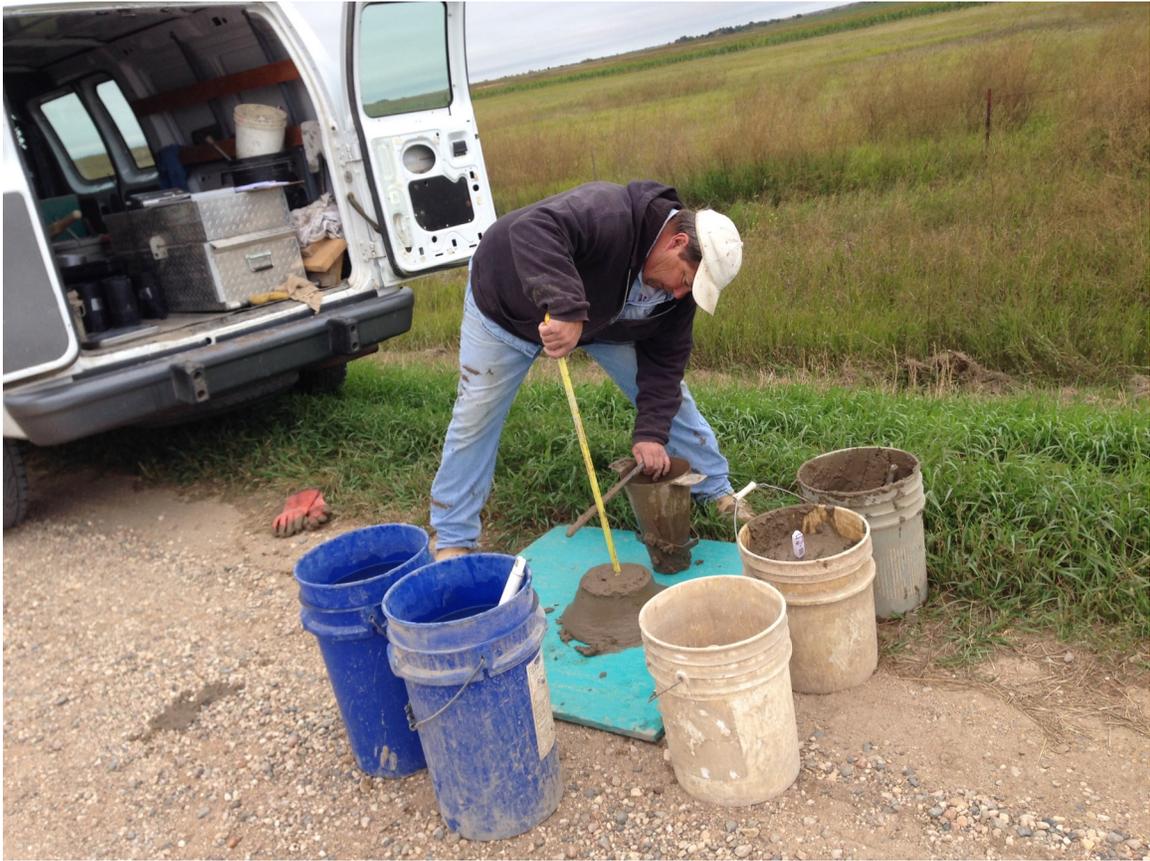
Above: Material tester, Max Tschosik (GEOSERV) is measuring the slump of the grout. Grout is tested every 50 cubic yards for slump, yield and temperature, and cylinders are cast for compression strength testing.

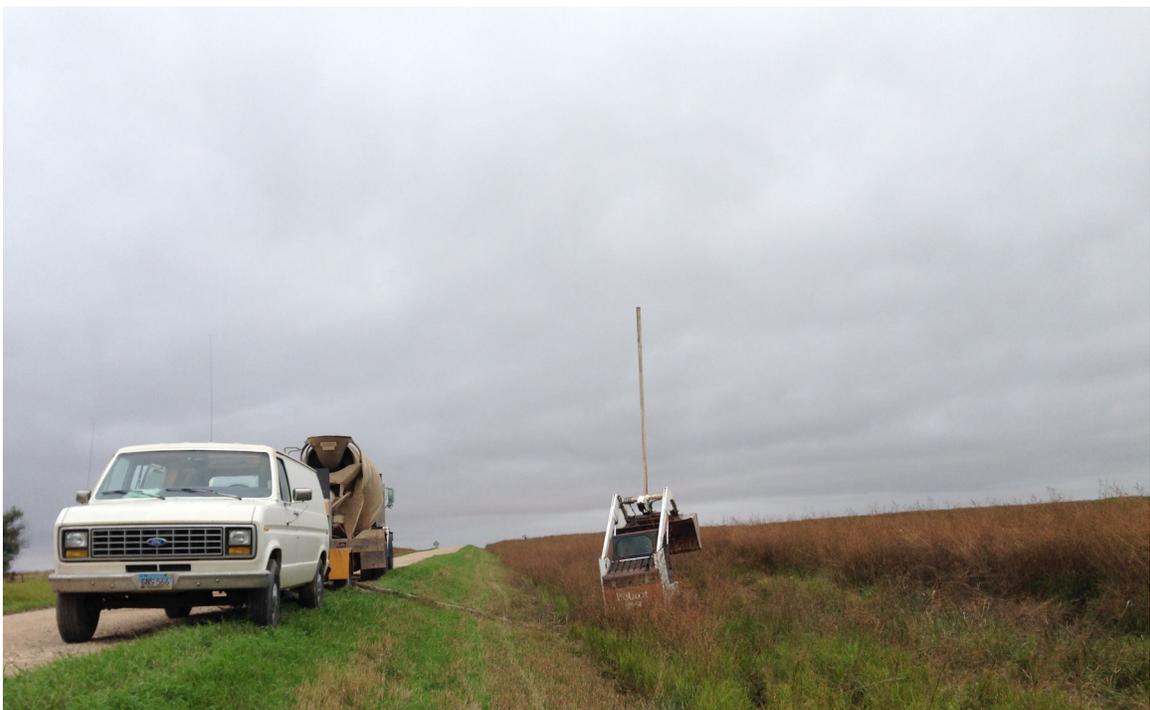
Below: Casing being removed in the east ditch of 60th Ave. SW. Once grouting is complete on a hole, the casing is removed.

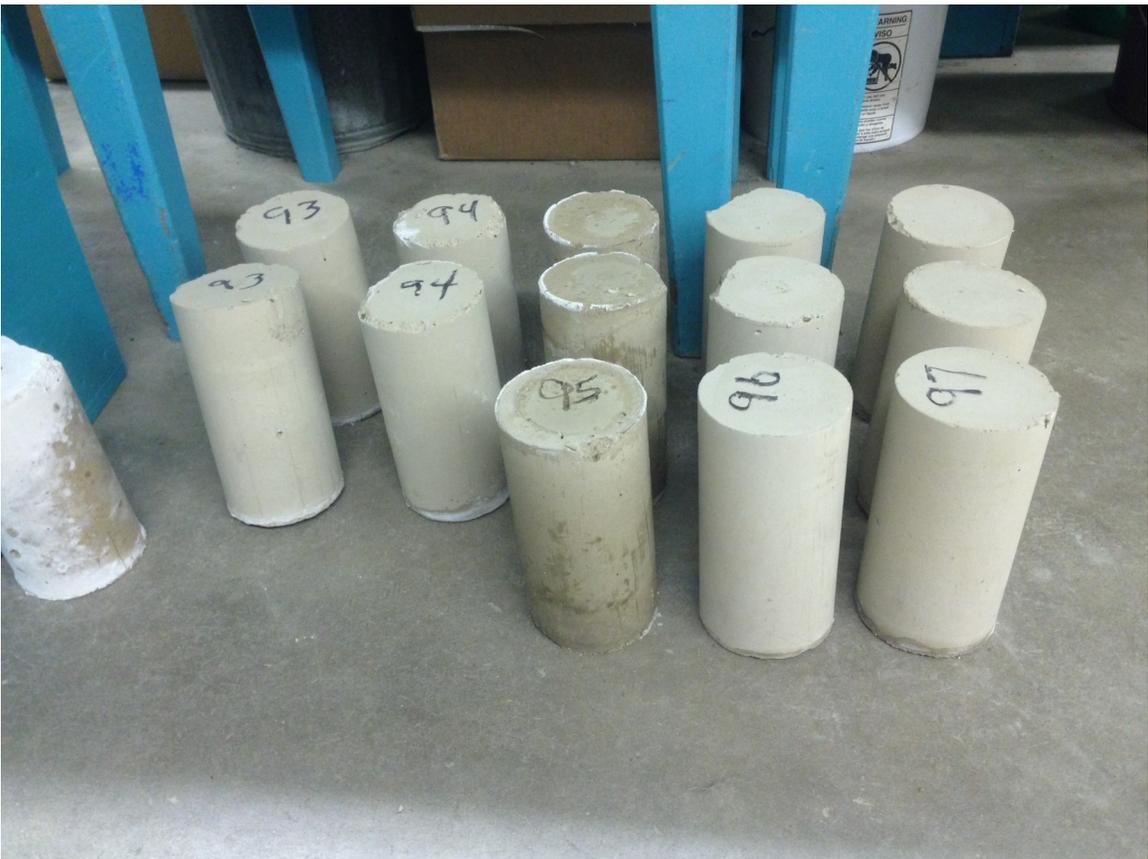
Below: Cured test cylinders waiting for compressive strength testing.

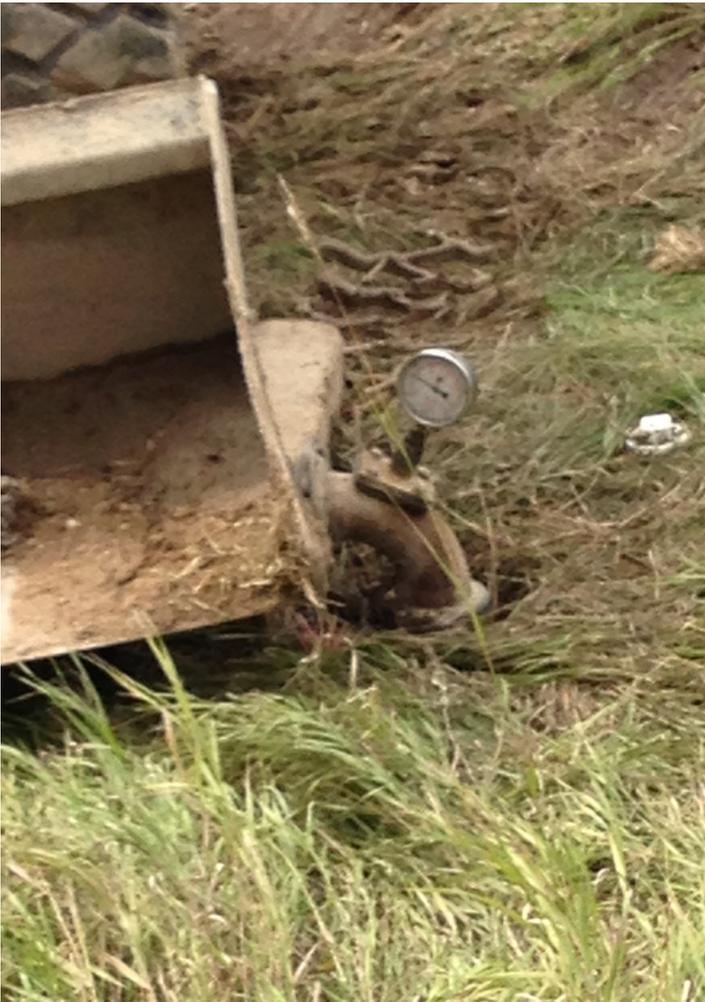
Upper Left: The pressure can often reach 50-100 psi when pumping grout into underground mine voids as shown by the pressure gage in the picture.

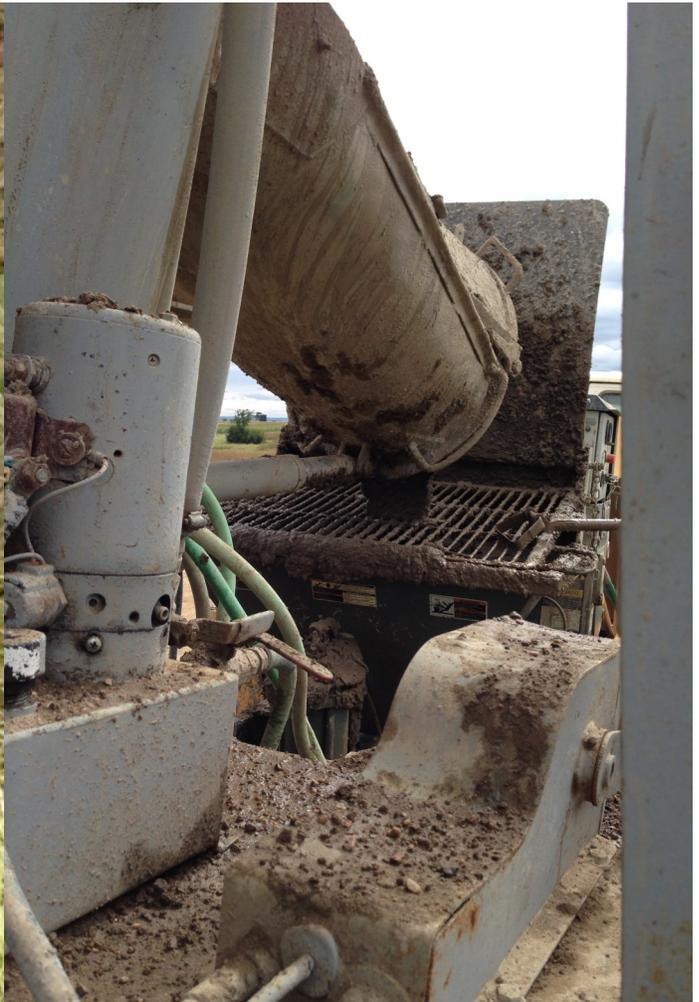
Upper Right: Grout being discharged from the concrete mixer truck into the grout pump.
