## 2003 Beulah/Zap Phase VII AML Project Photos

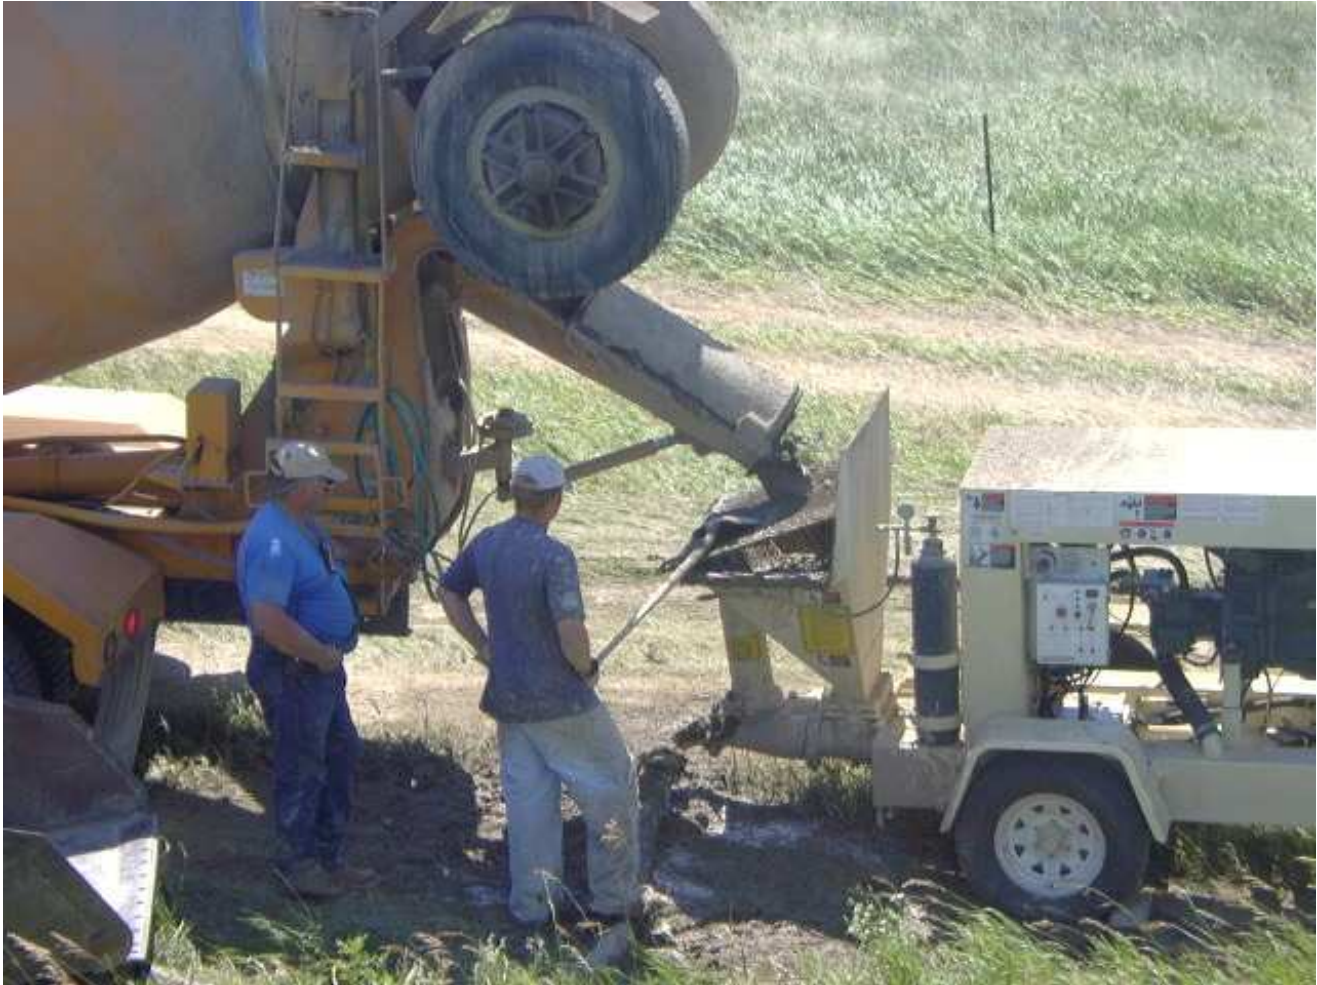
**Photo 2:** Grout injection in the right of way of US Highway 200. Grout was dumped from cement trucks into a grout pump and pumped into underground mined workings.
