# **COAL OUTCROP FIRE SUPPRESSION IN THE NORTH DAKOTA BADLANDS**

**Abandoned Mine Lands Division  
North Dakota Public Service Commission  
600 East Boulevard Avenue, Department 408  
Bismarck, North Dakota 58505-0480**

## **ABSTRACT**

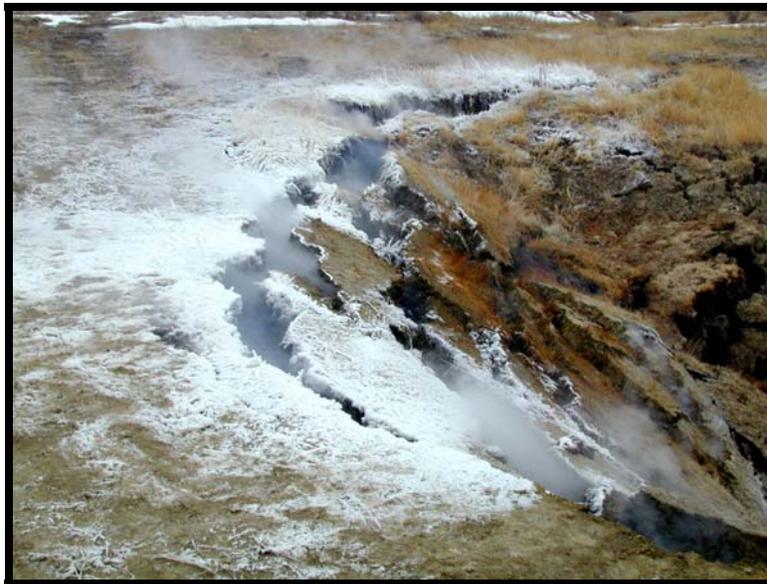
**Condensation is formed by steam venting from a burning coal seam.**

Fumaroles venting steam and smoke were also common at all of the fire sites. In the context of this project, a fumarole is described as a crack or opening in the overburden which allows for the escape of combustion gasses into the atmosphere. Most of the fumaroles exhibited a slowly-venting characteristic, although fumaroles at a couple of the sites exhibited an intense, thrusting characteristic inherent with very aggressive, hot fires. Many of the sites displayed hot “runners”. These runners or burn areas, typically 3-6 feet in diameter, shoot out in front of the burn face following fractures in the coal seam. Most of the runners were not observable from surface, although an occasional runner would surface 50-75 feet in front of the burn face. A large percentage of work time at all of the sites was dedicated to chasing down and eliminating these runners with the excavator.

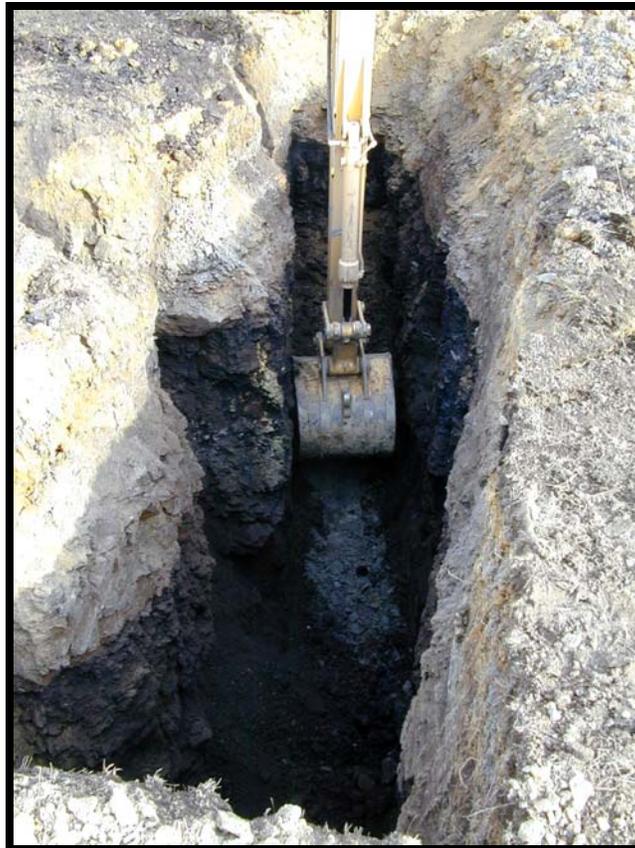
**Excavation of an intercept trench.  
Note the “runner” to the left of the bucket.**

One of the sites was considered to be too big for complete excavation, based on the size of the project, thickness of the coal and overburden, and available funding. A 2-tiered series of intercept trenches was excavated around all burning portions of the site. Trench excavations were approximately 4 feet wide and completed to one foot below the bottom of the coal seam into the blue underclay and backfilled with inert, noncombustible

material. In time, the burn front will come into contact with the intercept trench and extinguish the fire due to removal of the fuel supply.

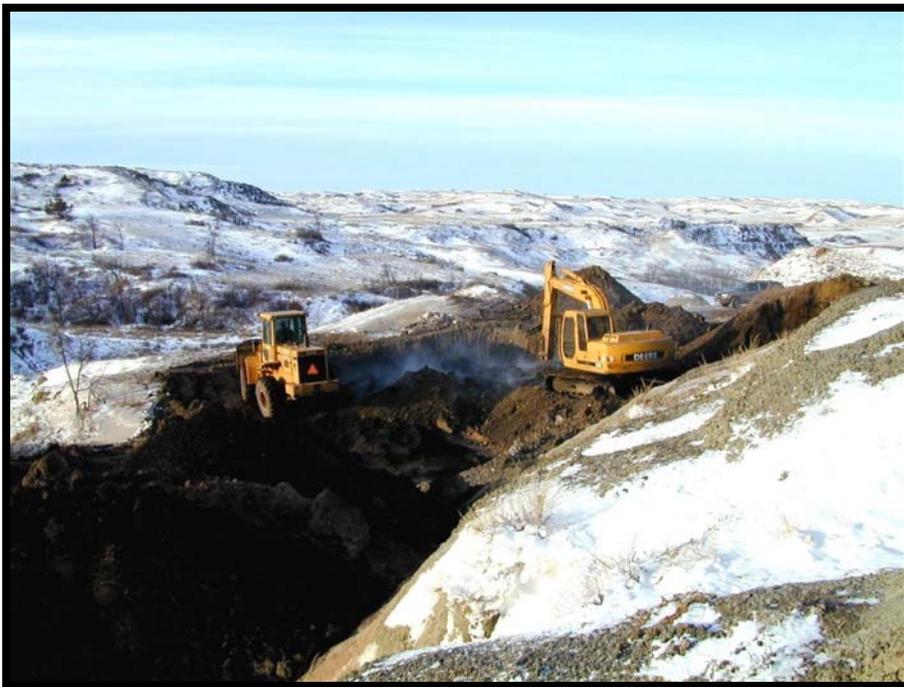
**Typical badlands topography associated with the coal outcrop fires.**

Fractured and slumping overburden was typical at all of the coal outcrop fire sites. As the coal fire progressed farther into the hill, this fracturing and slumping process allowed combustion gasses to escape and a new supply of oxygen to feed the burning underground coal. The visibly slumped areas are where the coal seam had previously burned, leaving nothing behind but ash, scoria and sterile soil.

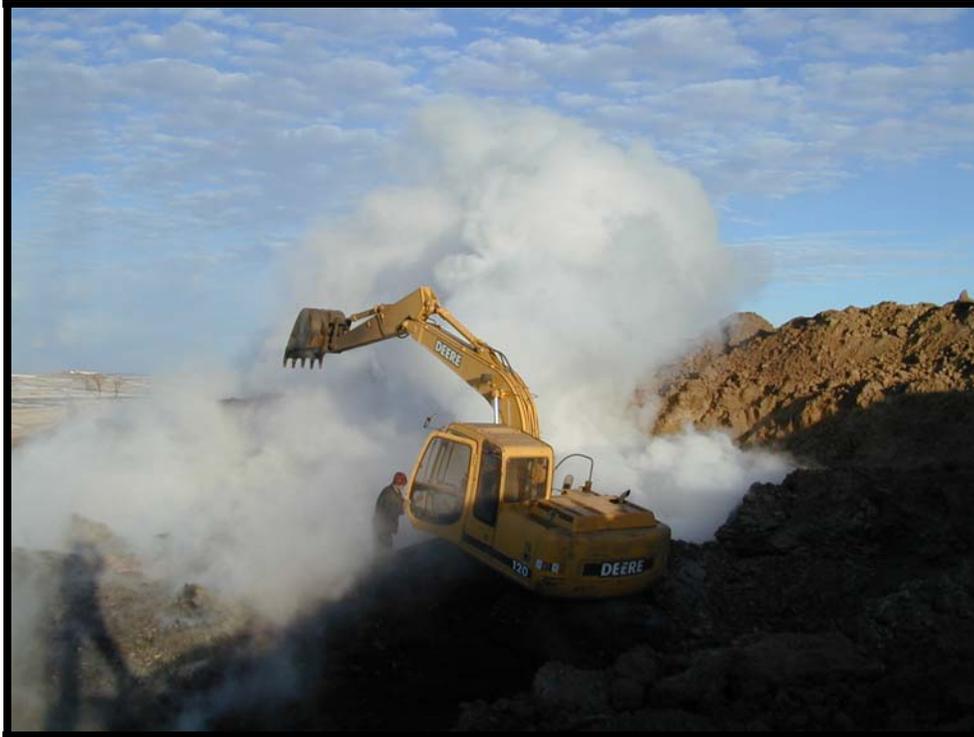
**The plume of steam and smoke from this site was visible for miles.**

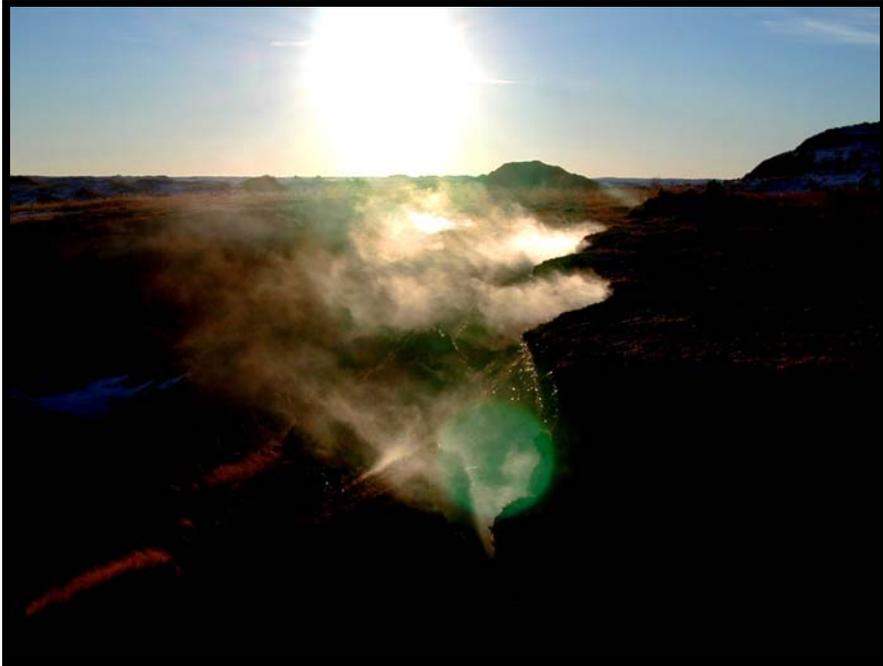
**Steam and smoke venting from an outcrop fire at sundown.**
