Project Summary
2015 Lovejoy Avoca Coal Fire Emergency
Contract AM-720-15

North Dakota Public Service Commission 2015 Lovejoy Avoca Coal Fire Project Summary

Project Type:	Surface burning of coal screening near the entrance of an abandoned underground coal mine.	
Primary Location:	Section 10 T154N, R100W	Lat. 48.1779° Lon. -103.5269°
Project Dates:	June 3-10, 2015	
Contractor:	Earthworm Excavating of Tolna, ND	
Project Cost:	\$18,110

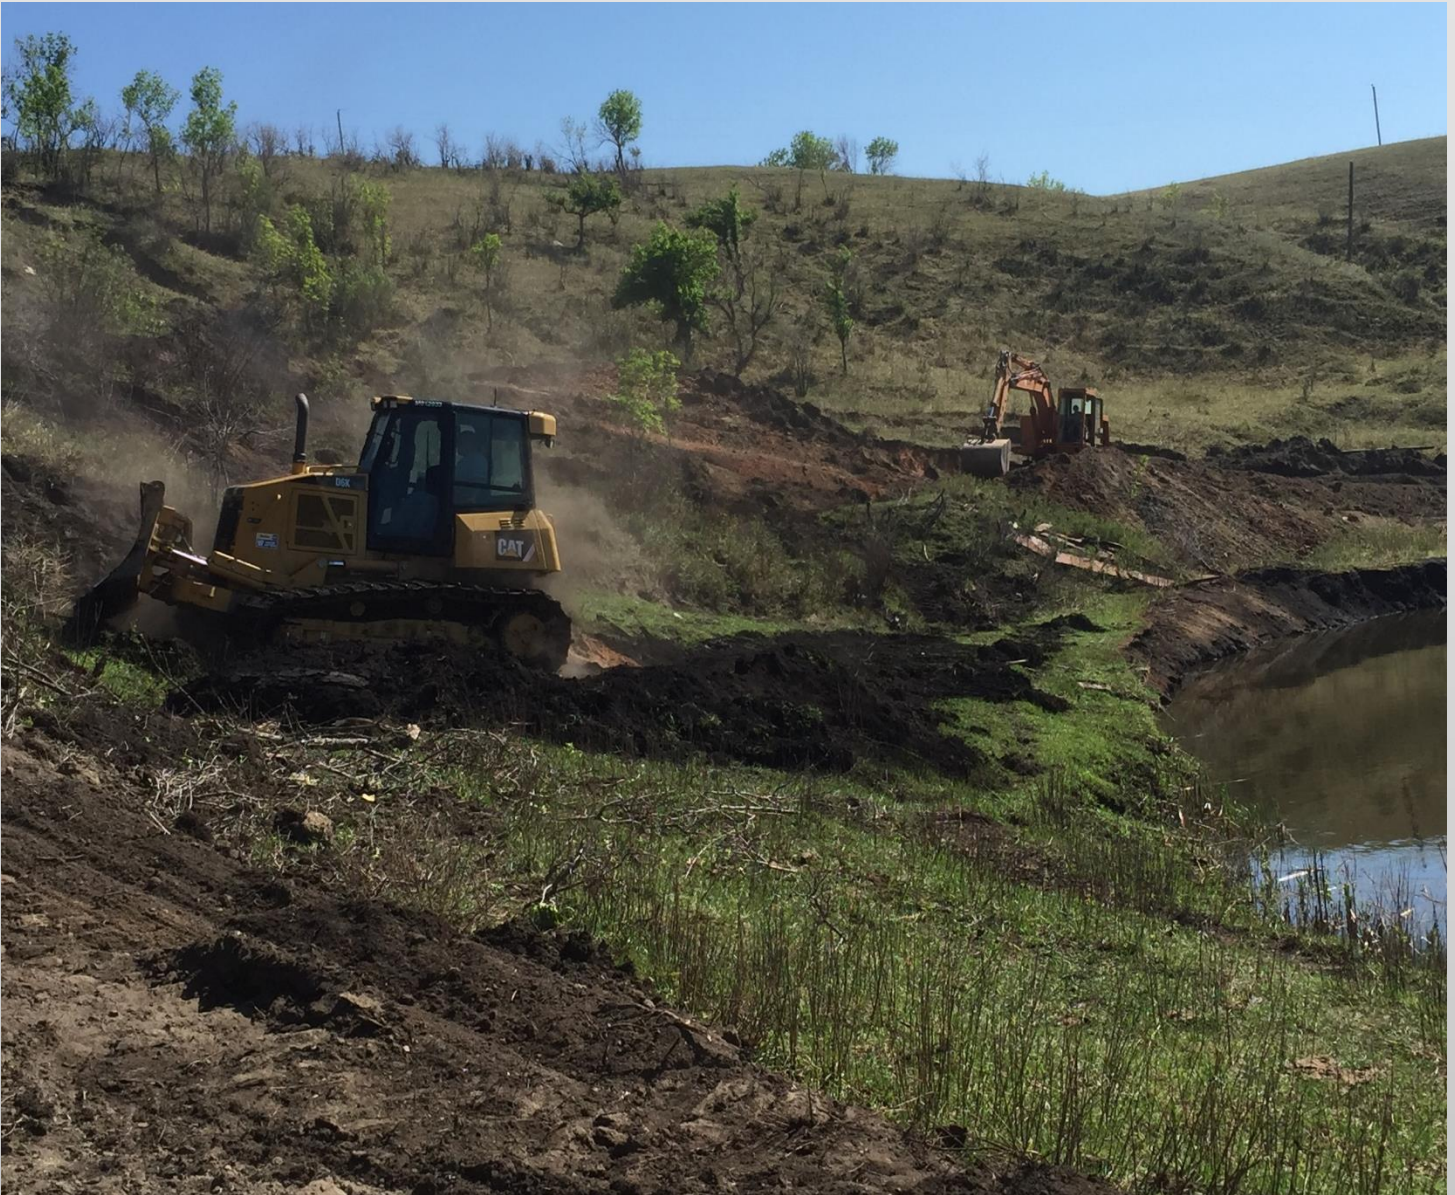
Cover Photo: The cover photo shows a D6 bulldozer pushing coal fines adjacent to burning pile, and in the background an excavator digging a pit for mixing of wet clay and burning coal screenings. June 3, 2015.

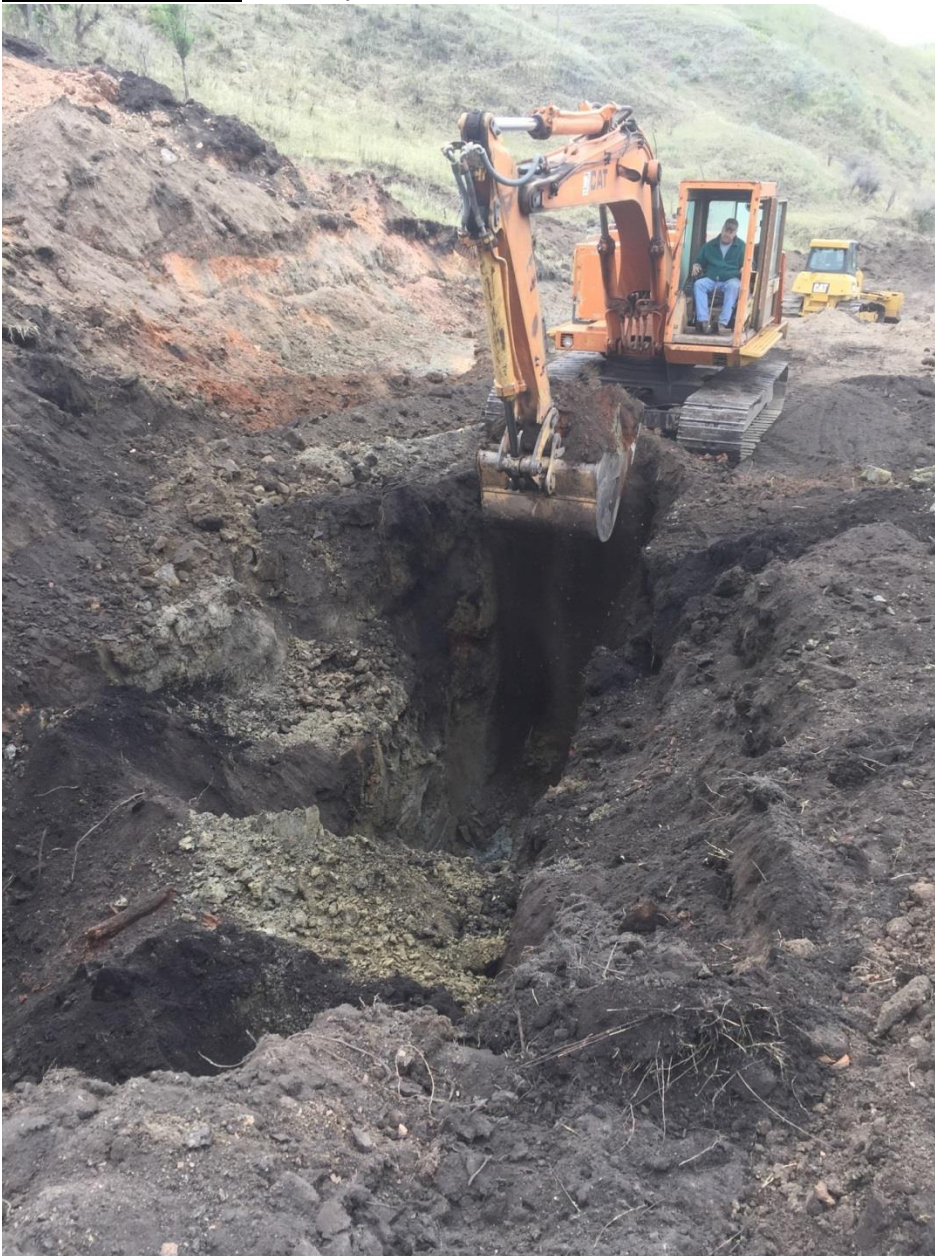
Trenching in the area where the Coal Refuse has already burnt through. This was used for both burial of burning coal refuse, and to see total extent of depth of coal fines in area. The average burial depth was 8-10 feet deep, with average thickness of coal fines 3-5 feet.

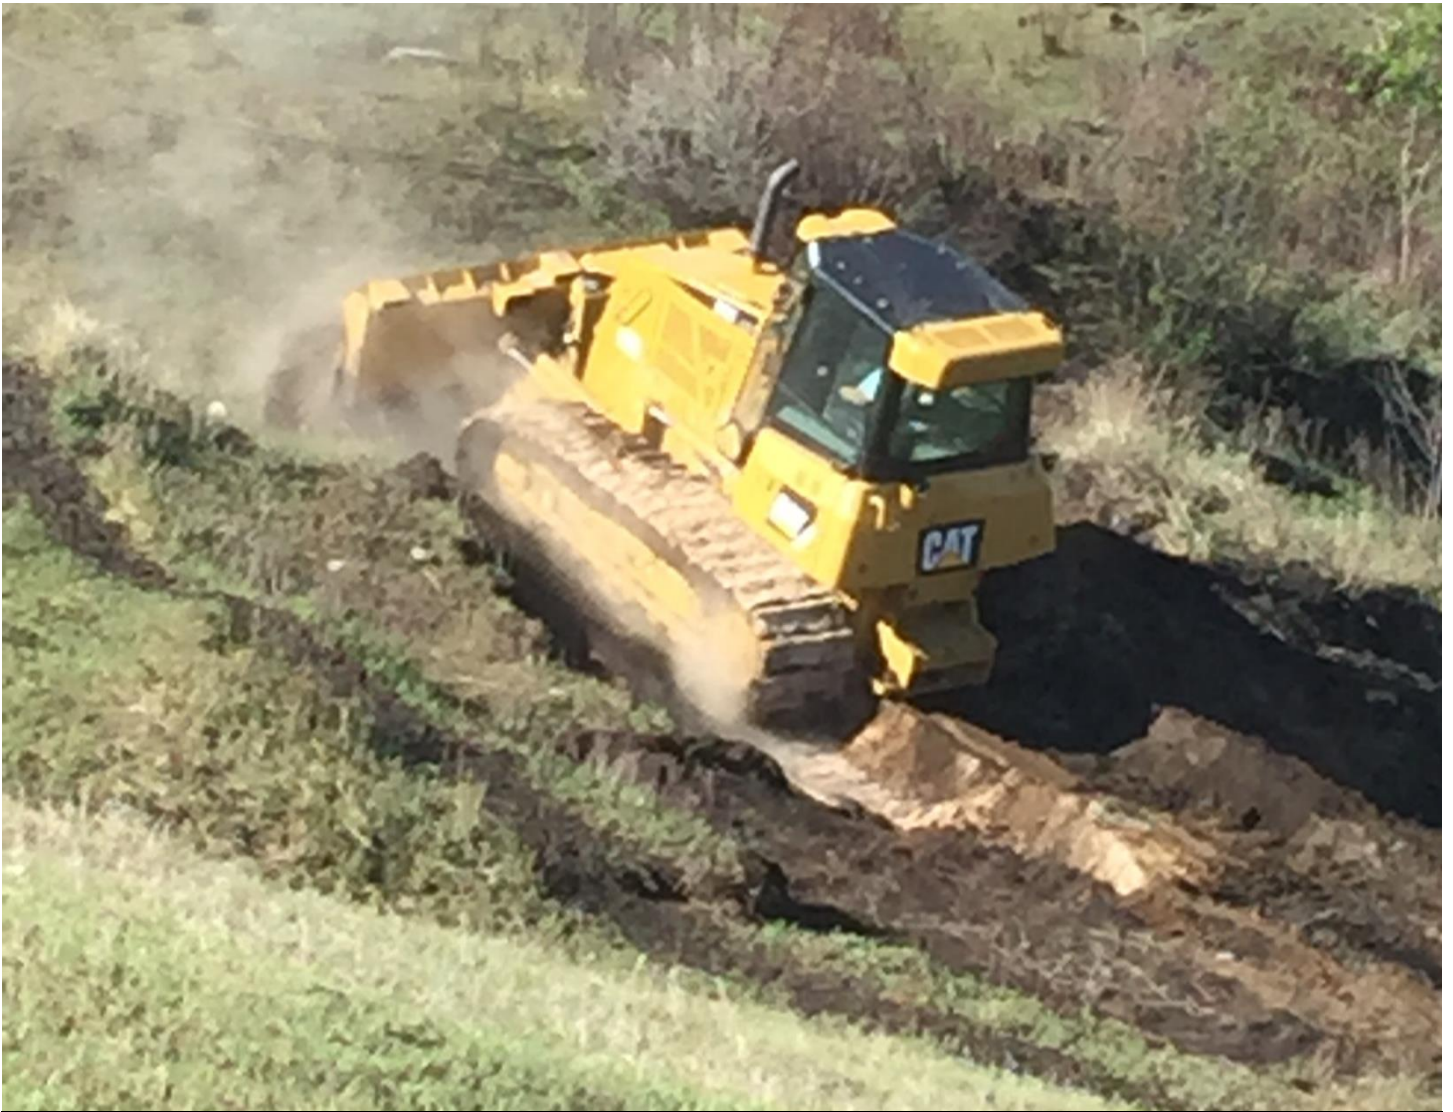
Above: Dozer pushing hot ash into pile for burial, average temperature 500°.

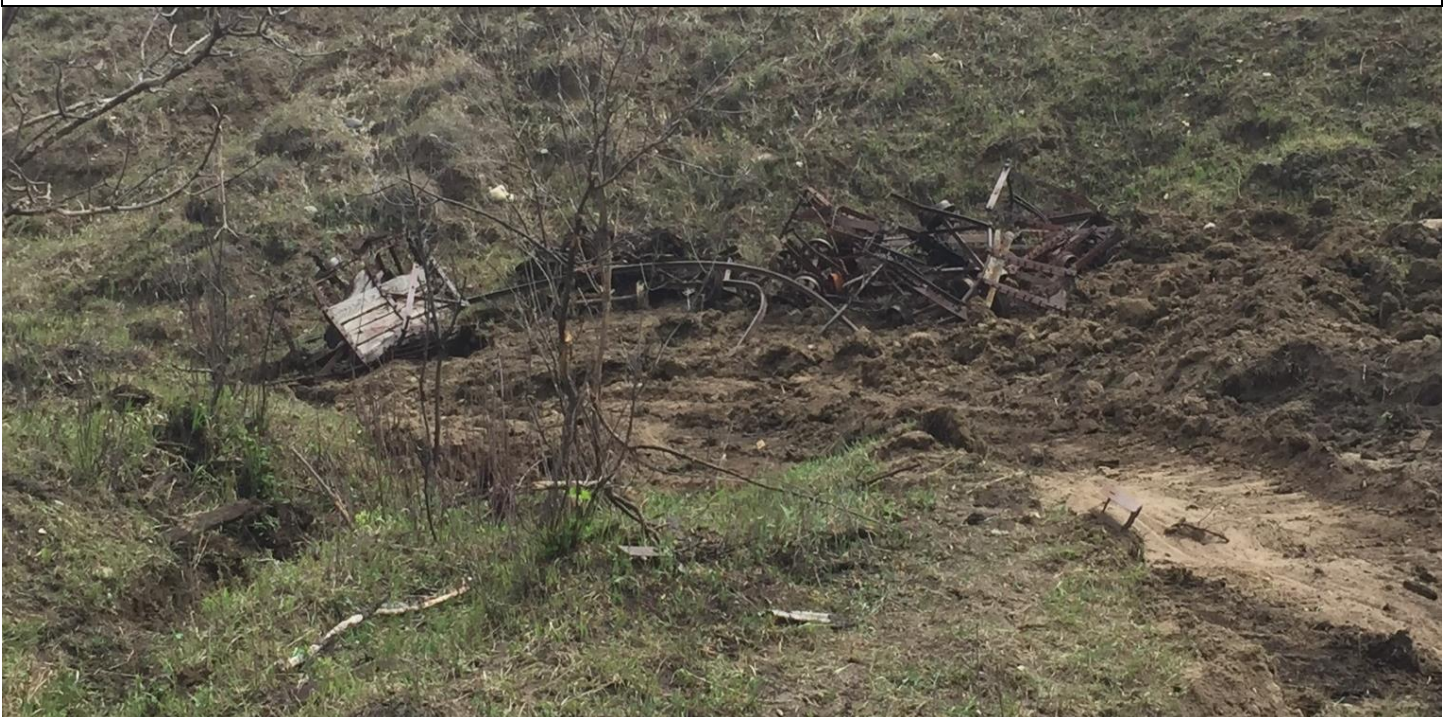
Below: Historical pieces were set aside on a terraced area.

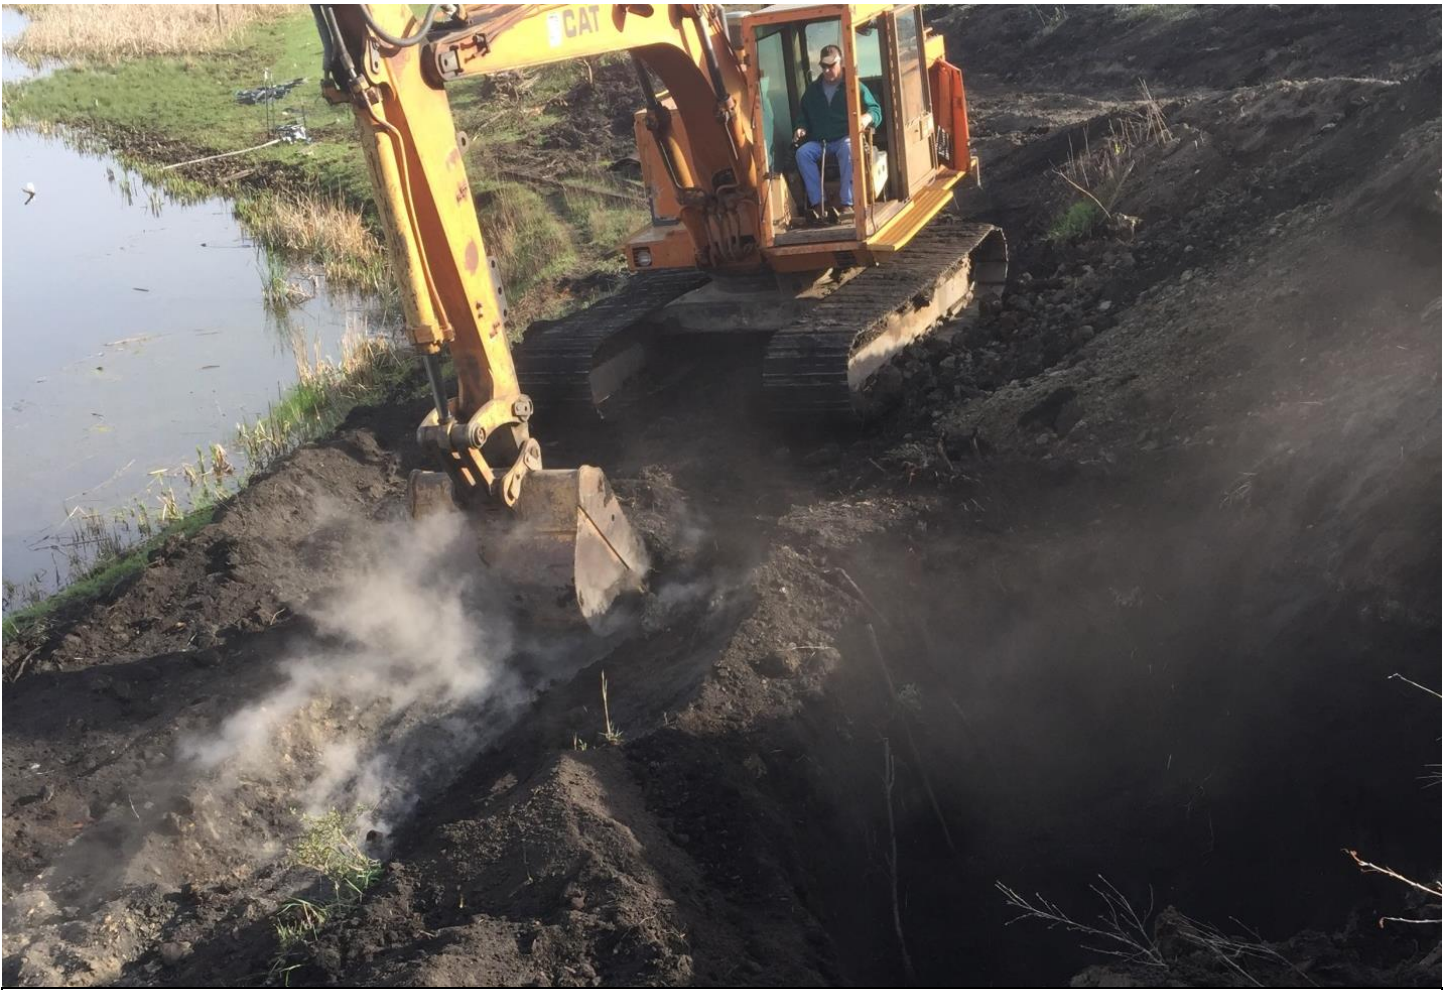
Above: Moving burning materials into pit, where it was mixed with wet clay and buried. Photo date June 4, 2015

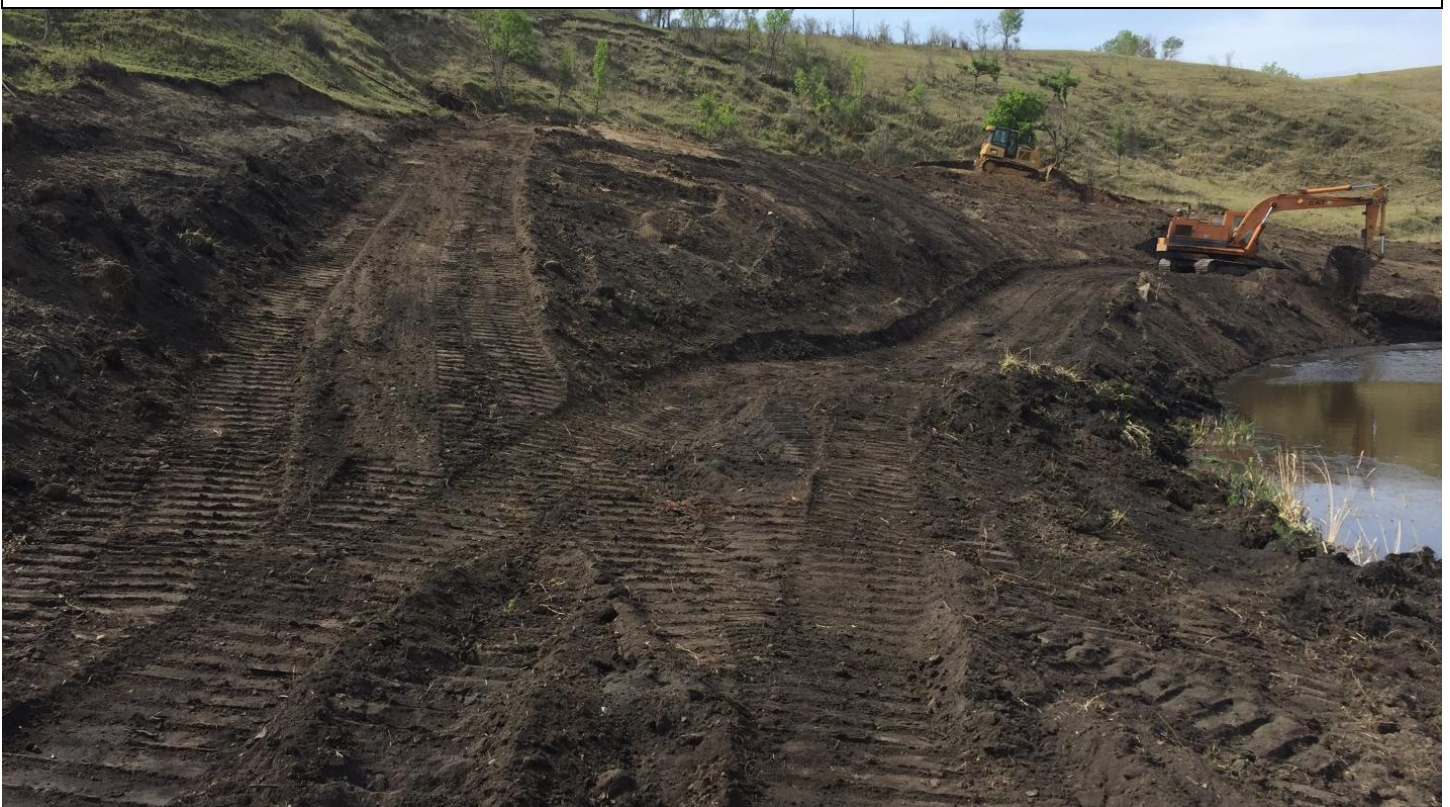
Below: Nearing completion, final mixing of coal refuse that hadn't been burnt yet by excavator while dozer pushes topsoil across area on June 5, 2015

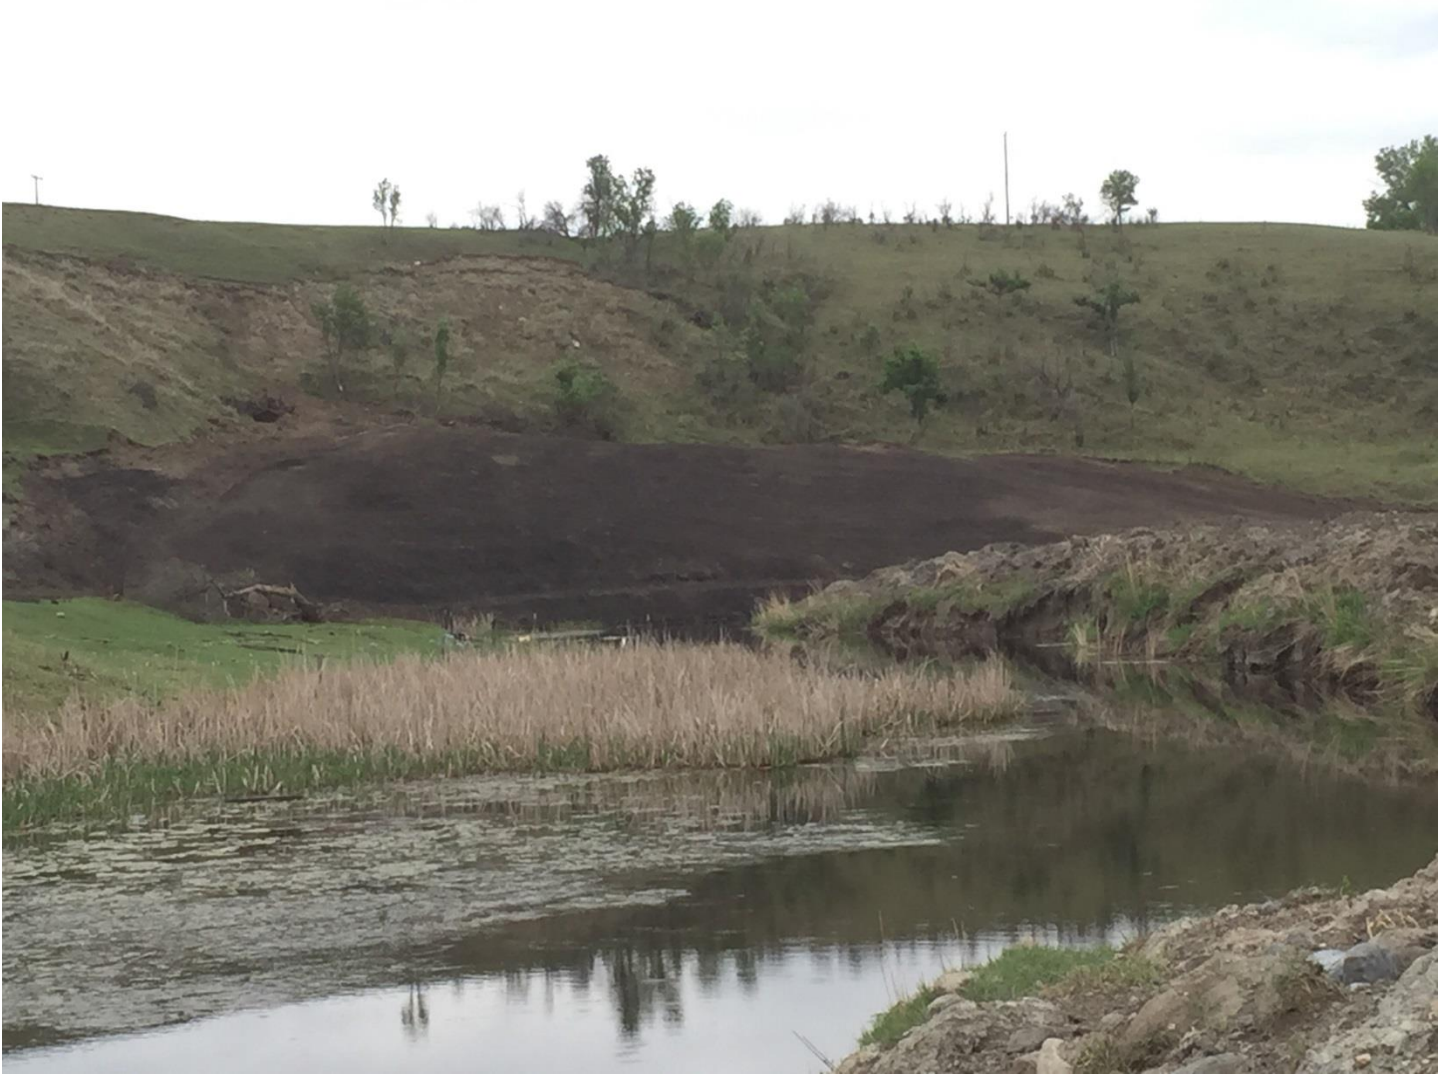
This shows the site when all work was completed. It was graded with swale on top and terraced bottom. The total disturbed and seeded area was 0.87 acres and the final contract cost was \$18,110.
