2017 Beulah Highway 200 Emergency Project

Contract AM-779-17

**North Dakota Public Service Commission
2017 Beulah Highway 200 Emergency Project Summary**

AML EMERGENCY INVESTIGATION

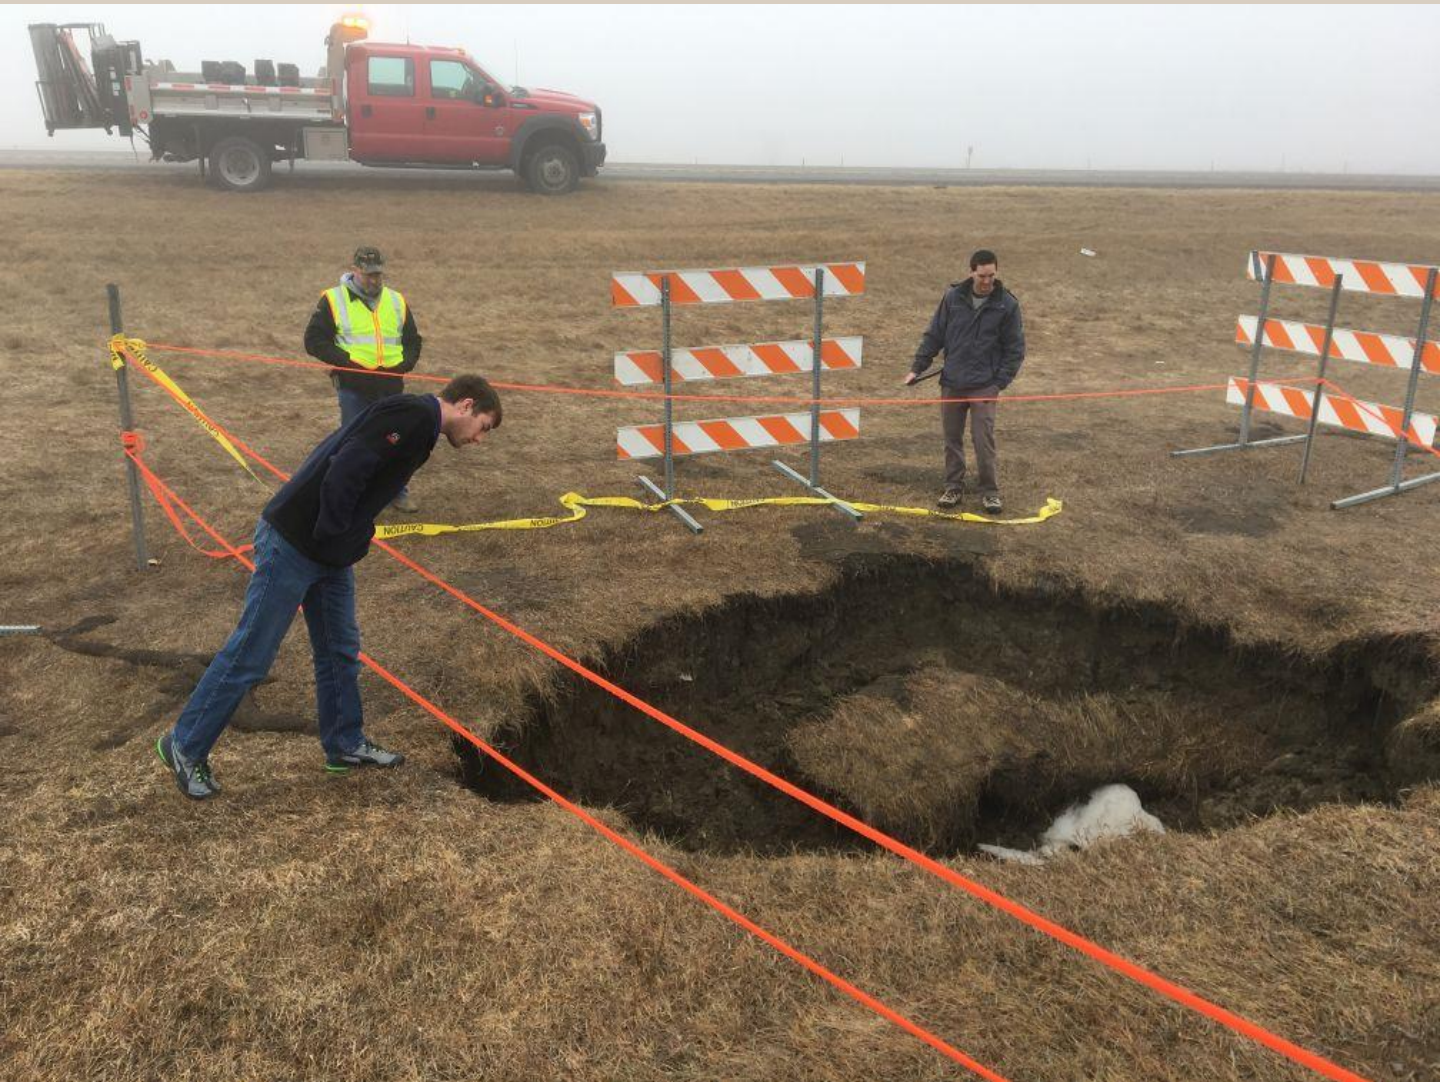
Cover Photo: *The cover photo shows the initial investigation of a sinkhole reported by the North Dakota Department of Transportation. This sinkhole was in the ditch of ND Highway 200 near Beulah, ND. It was about 15 feet long, 12 feet wide and 8 feet deep. This sinkhole was reported March 27 and investigated March 28, 2017.*

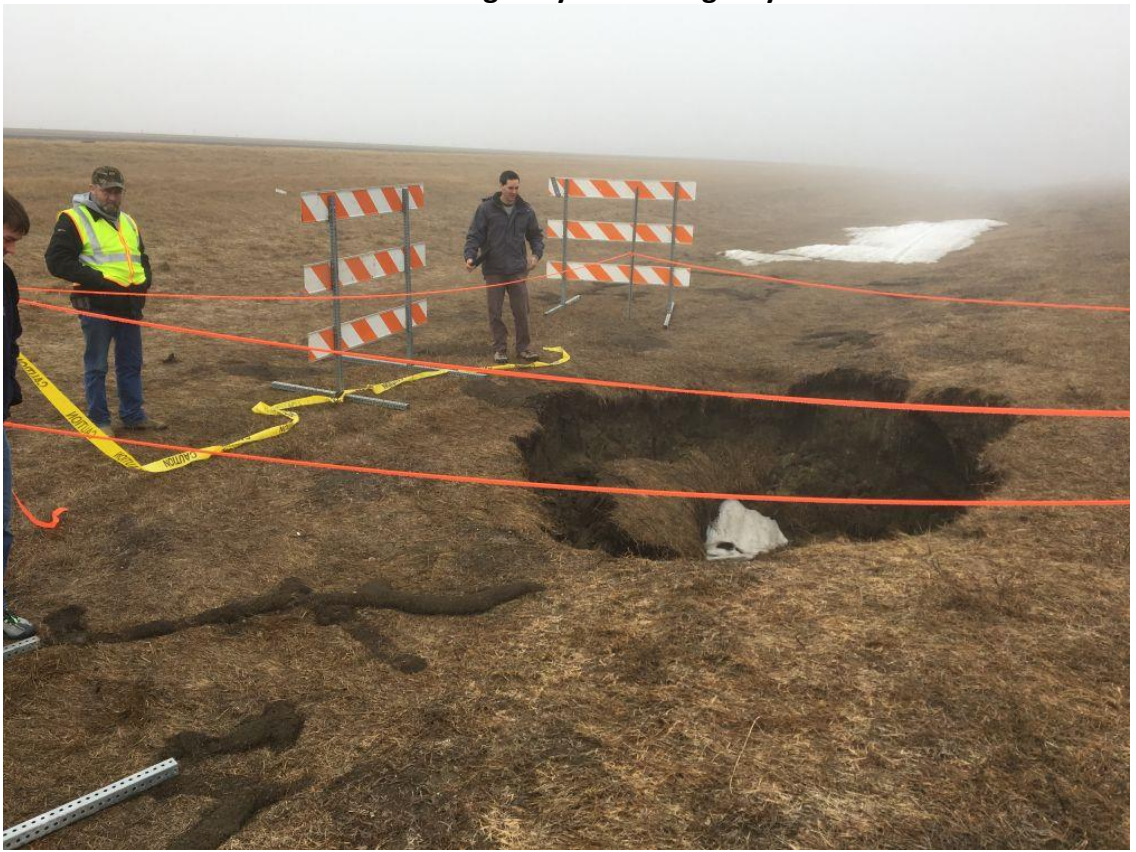
On March 27, 2017, Aaron Auer, NDDOT, reported a dangerous sinkhole on the north ditch of Highway 200 near Beulah. On March 28, Jordan Burns, Matt Fischer and Bill Dodd (PSC) met with Kevin Kaley, NDDOT Beulah Section Supervisor, at the site. The sinkhole was 15 feet long, 12 feet wide and 8 feet deep. NDDOT had already deployed barricades to protect the public.

- Excavate the sinkhole with an excavator or backhoe.
- Fill the excavated sinkholes with fill dirt and compact to the best extent possible.
- Seed all disturbed areas.

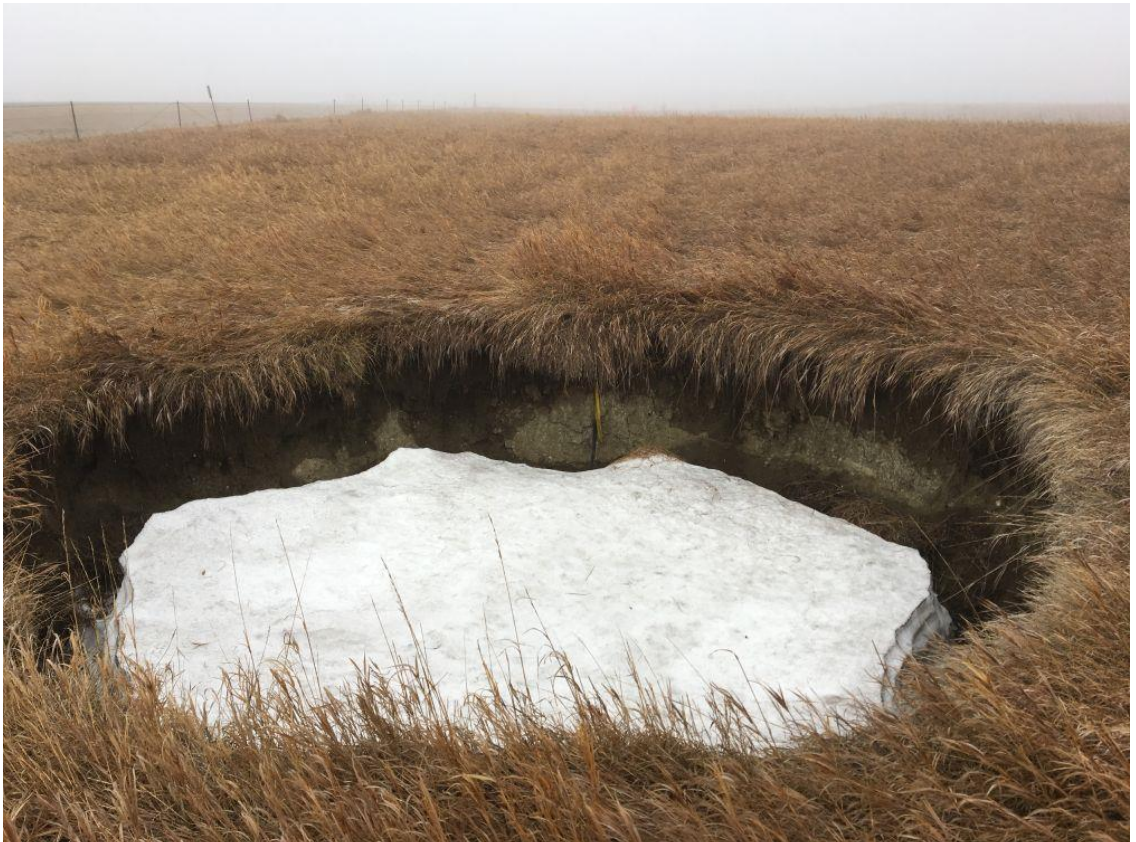
This shows another sinkhole about 75 feet from the first one. Although it was off the highway right-of-way, it had two buried West River Telecommunications fiber optic cables exposed and running across it.

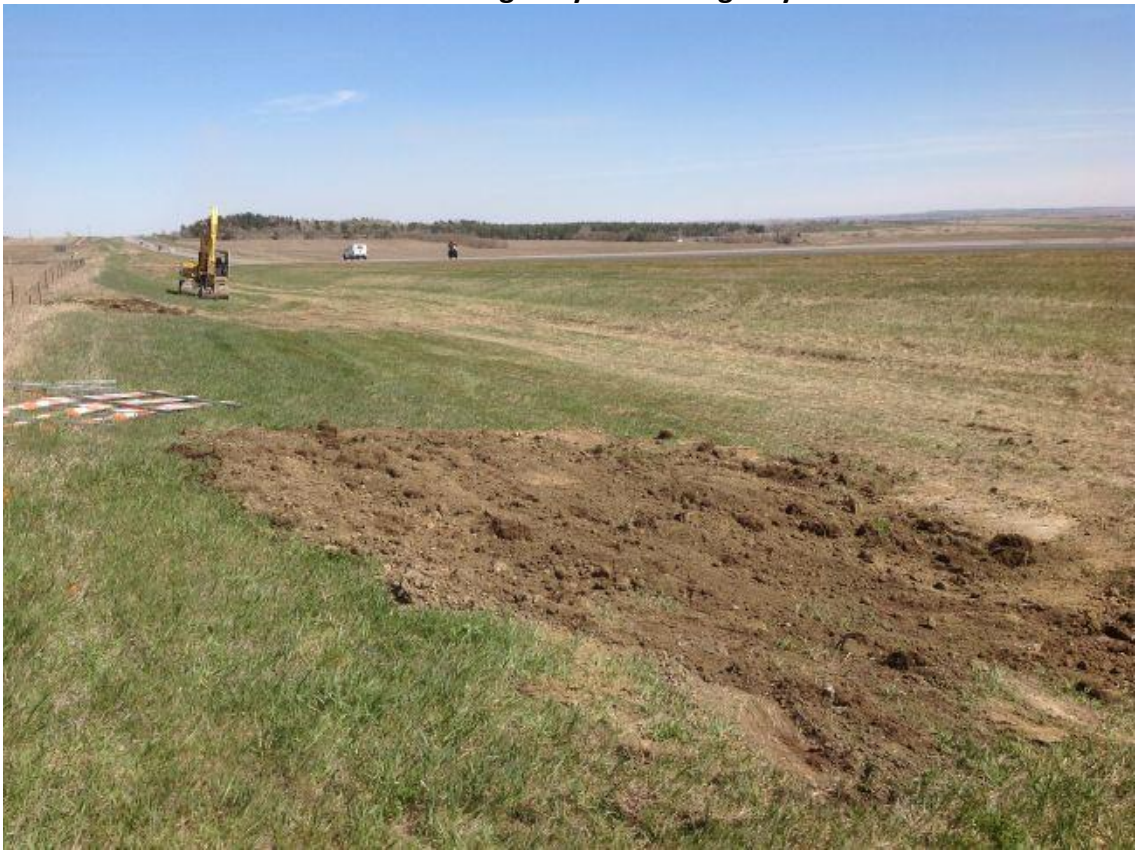
This photo shows the sinkholes on the ditch of Highway 200 on April 28 after they were filled and topsoil was respread.

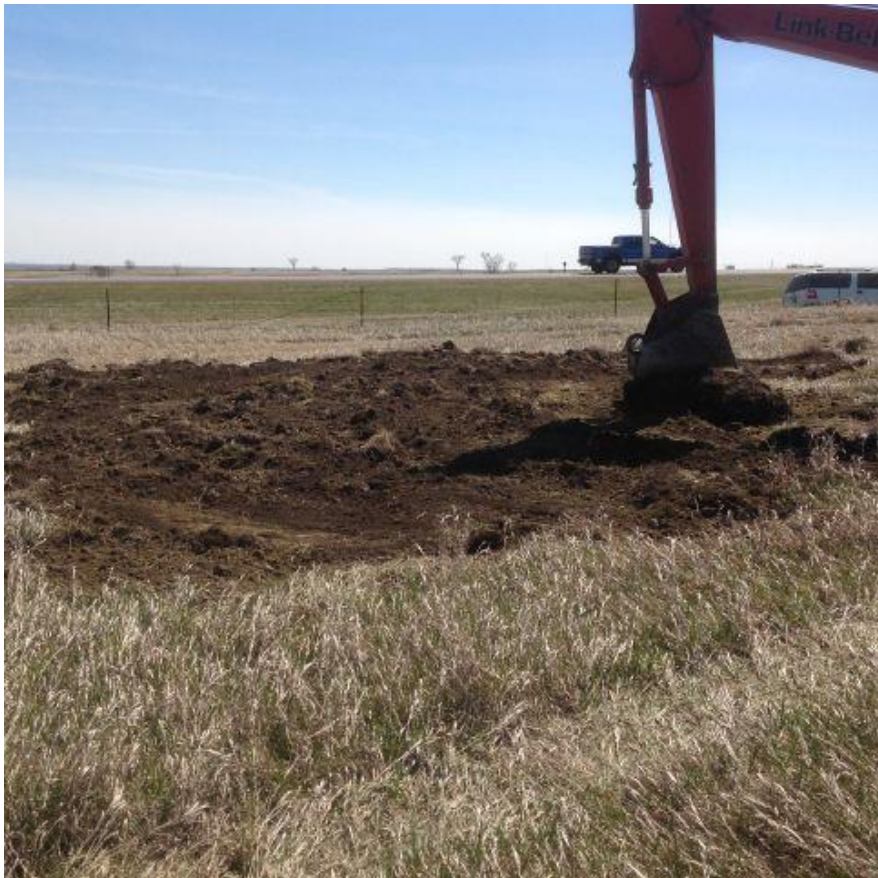
This photo shows the sinkhole with the fiber optic cables after it was filled and topsoil was being replaced. Five dangerous sinkholes were filled in this emergency project and the contract cost was \$4945.
